## STORMWATER MANAGEMENT FACILITIES OPERATION AND INSPECTION REPORT

Quarter Section 26 NE Name of Business/Subdivision MILL RIDGE NO. 5 SUBD  
Property Tax ID Number 0101158 Address of Property (INDEX NO. 01.15)  
\_\_\_\_\_  
\_\_\_\_\_

Description: SWP26N002  
P-0144  
Location Of Pond WEST OF LILLY RD  
NORTH OF MANHARDT DR  
\_\_\_\_\_  
\_\_\_\_\_

Mill Ridge No. 5 (Lilly Rd)  
Retention Pond – SWP26N002  
Overview

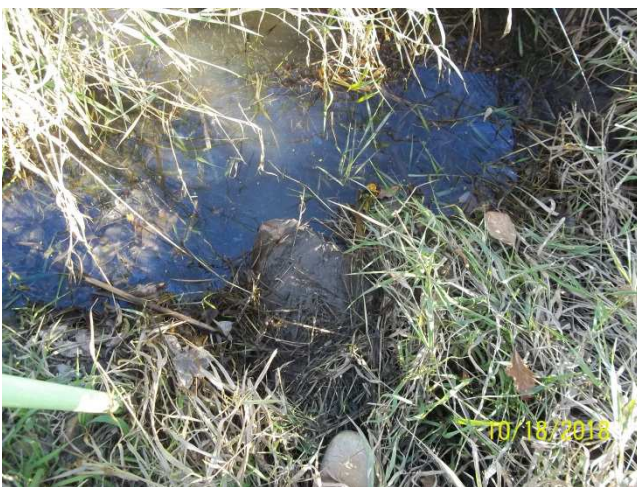
ST012544

| Compliance Verification | Design<br>(Non-AsBuilt) | Actual<br>(GPS) | Compliant<br>Yes No | Comments<br>(Condition of Structure) |
|---|---|---|---|---|
| Opening Diameter<br>(inches) | 12" CMP | 12" CMP | | ***REPAIR NEEDED***<br>12" CMP PARTIALLY CRUSHED AT<br>POND SIDE OF BERM |

Four (4) 12" Culverts Service Pond  
Through Westerly Bank into stream.

- 1) Fix crushed northerly most (ST012503) and southerly most (ST012544) culvert ends.
- 2) Markers placed at each damaged culvert .

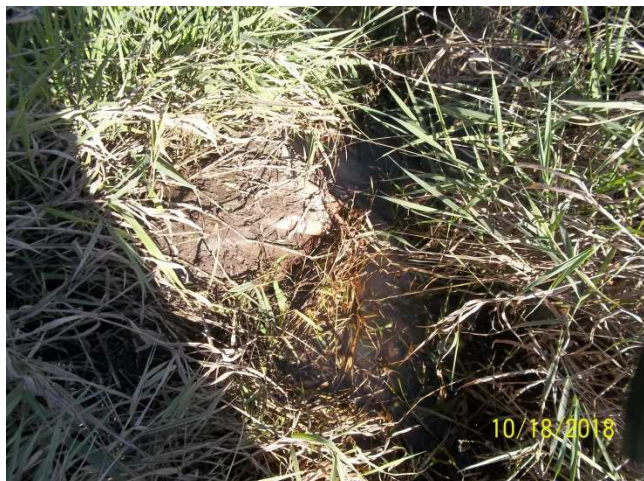
ST012500

| Compliance Verification | Design<br>(Non-AsBuilt) | Actual<br>(GPS) | Compliant<br>Yes No | Comments<br>(Condition of Structure) |
|---|---|---|---|---|
| Opening Diameter (inches) | 12" CMP | 12" CMP | | 12" CMP IN GOOD CONDITION |

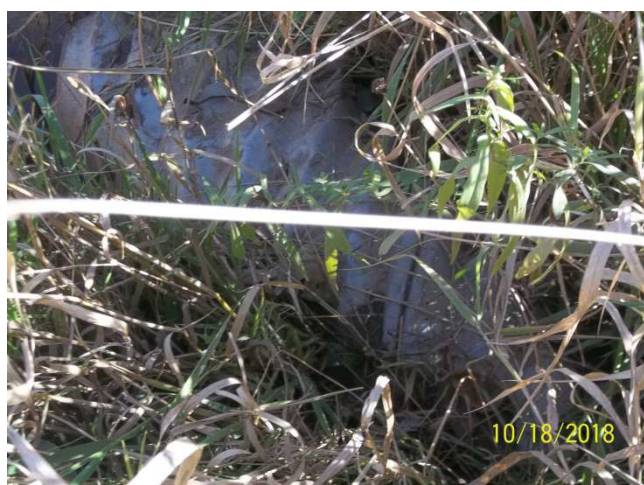
ST012501

| Compliance Verification | Design<br>(Non-AsBuilt) | Actual<br>(GPS) | Compliant<br>Yes No | Comments<br>(Condition of Structure) |
|---|---|---|---|---|
| Opening Diameter (inches) | 12" CMP | 12" CMP | | 12" CMP IN GOOD CONDITION |

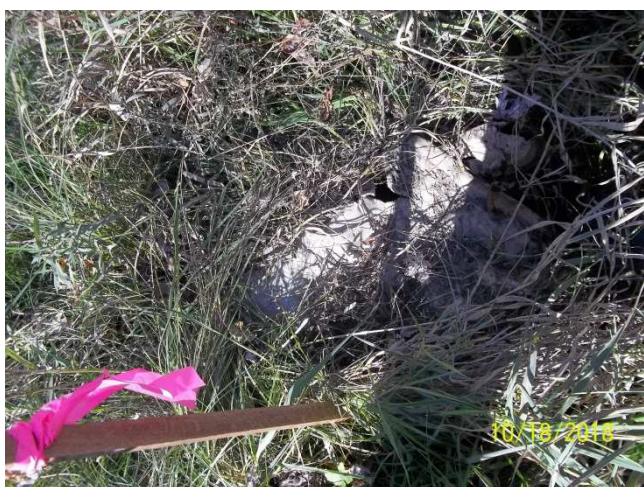
ST012503

| Compliance Verification | Design<br>(Non-AsBuilt) | Actual<br>(GPS) | Compliant<br>Yes    No | | Comments<br>(Condition of Structure) |
|---|---|---|---|--|---|
| Opening Diameter   (inches) | 12” CMP | 12” CMP | | | ***REPAIR NEEDED***<br>12” CMP CRUSHED AT POND SIDE OF BERM |
