## STORMWATER MANAGEMENT FACILITIES OPERATION AND INSPECTION REPORT

Description: SWP03N009  
P-0176

Location Of Pond  
NORTHEAST OF  
GRAND AVENUE &  
FOREST DRIVE

Grand Avenue Bio-Retention Basin – SWP03N009

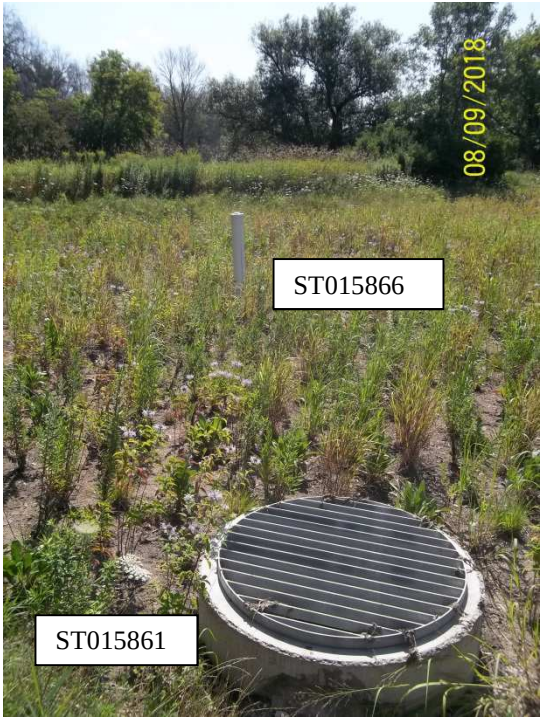
Outlet ST015861 &  
Clean-out ST015866

| Compliance Verification | Design | Actual | Compliant<br>Yes    No | | Comments | |
|---|---|---|---|---|---|---|
| Outfall 2 (ST015861) | RCP – 15" | | NORTHWEST EMBANKMENT | | RCP IN GOOD CONDITION | |

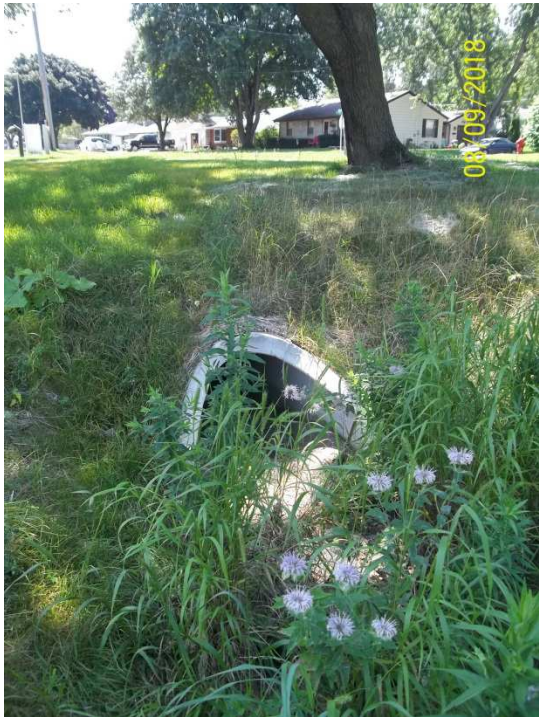
Outlet ST015863

| Compliance Verification | Design | Actual | Compliant<br>Yes    No | | Comments | |
|---|---|---|---|---|---|---|
| Outfall 1 (ST015863) | RCP - 18" | | SOUTH EMBANKMENT | | RCP IN GOOD CONDITION, RIPRAP IN END SECTION | |

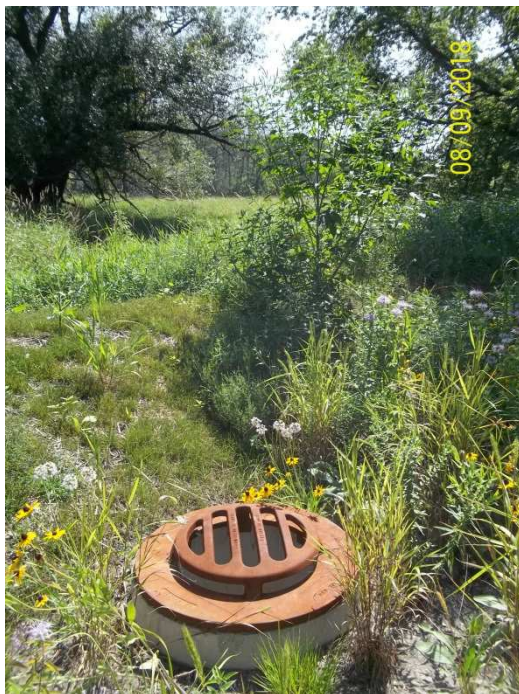
Inlet ST015864

| Compliance Verification | Design (Non-AsBuilt) | Actual (GPS) | Compliant Yes No | | Comments (Condition of Structure) |
|---|---|---|---|---|---|
| Opening Diameter (inches) | 6" PVC | 6" PVC | - | - | 6" PVC IN GOOD CONDITION |

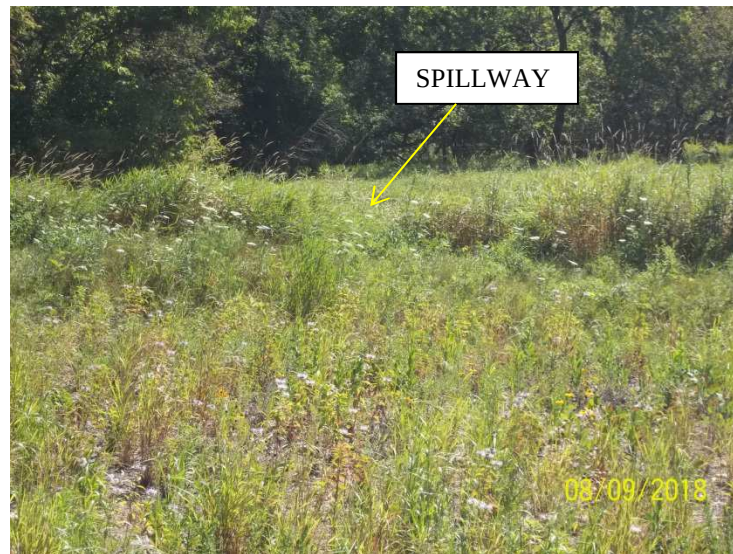
Spillway (NE Corner)

| Compliance Verification | Design | Actual | Compliant<br>Yes    No | | Comments | |
|---|---|---|---|---|---|---|
| Elevation | 838.00 | | - | - | SPILLWAY CLEAR OF VEGETATION | |

Repairs Needed (8/2018)  
None

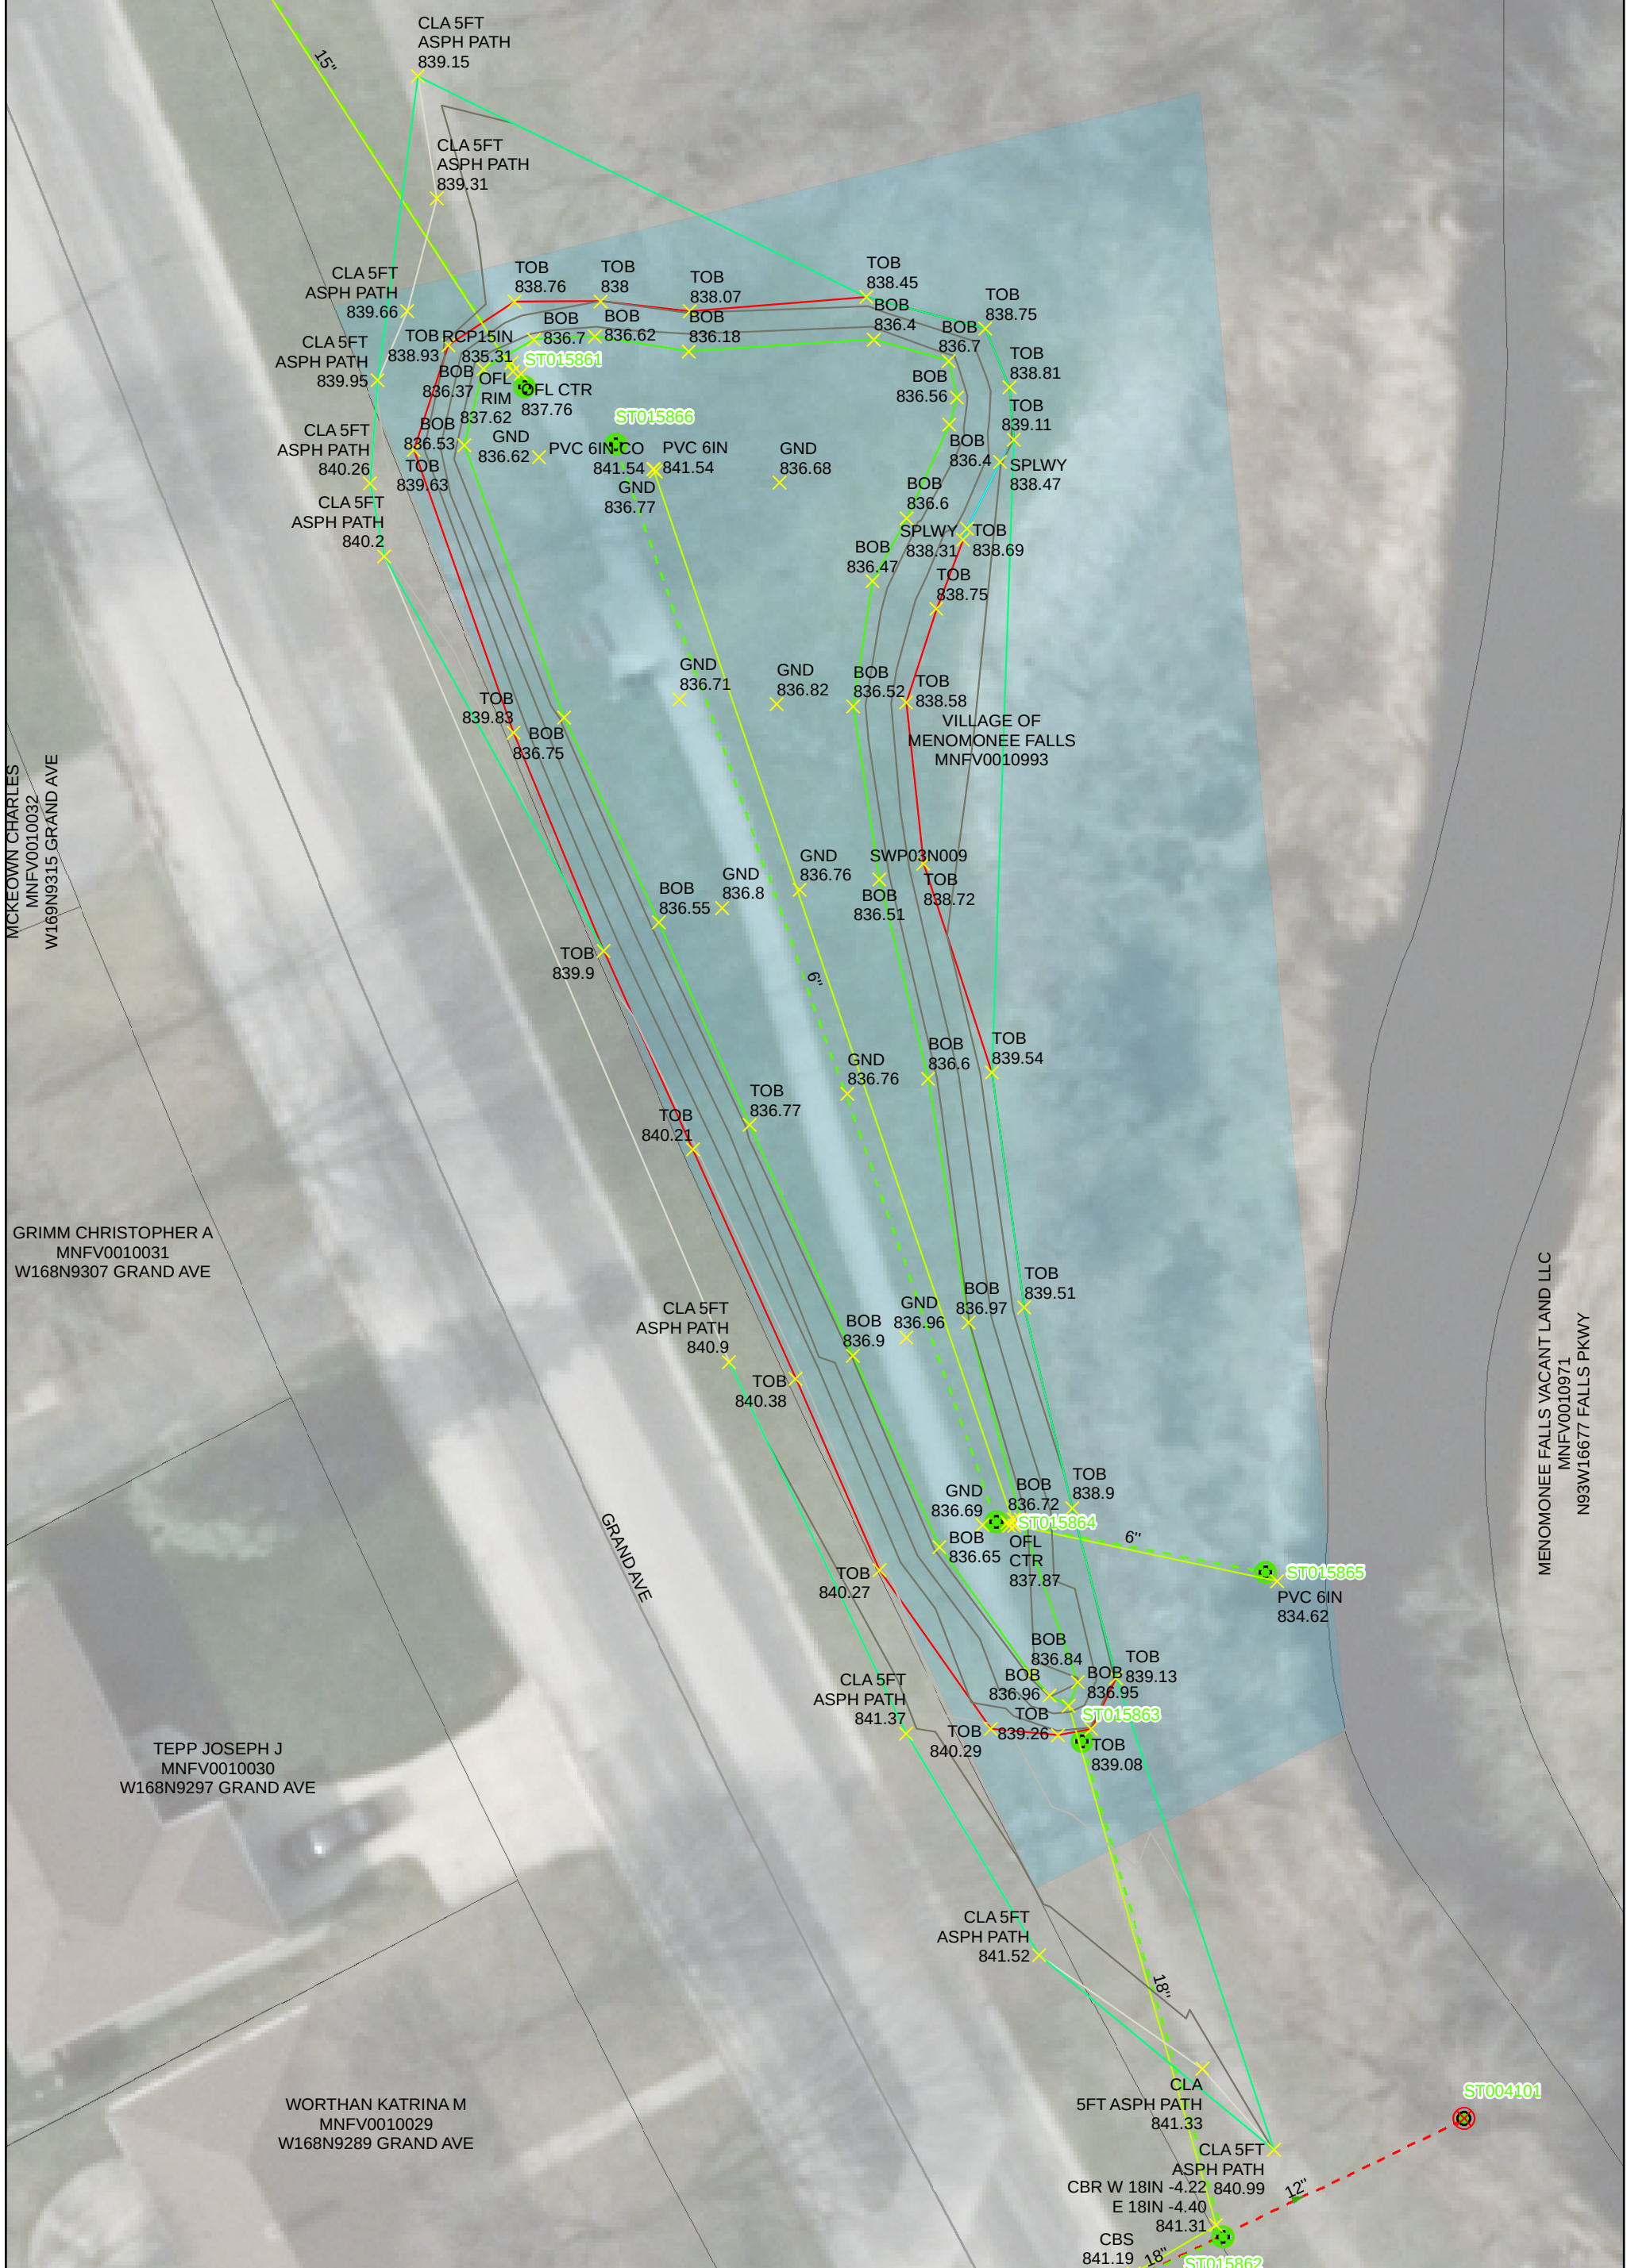
SWP03N009  
GRAND AVE BIO-RETENTION BASIN  
SURVEY DATA 08102018 CMG BC

| Compliance Verification | Design | Actual | Compliant<br>Yes    No | | Comments | |
|---|---|---|---|---|---|---|
| Design High Water Elevation | 838.00 | 838.40 | - | - | | |
| Area at Design High Water Elevation (Ac) | 0.169 AC | 0.196 AC | - | - | | |
| Pond Bottom Area (Ac) | 0.110 AC | 0.122 AC | - | - | | |
