## STORMWATER MANAGEMENT FACILITIES OPERATION AND INSPECTION REPORT

Quarter Section 33 SE Name of Business/Subdivision RIDGEFIELD SUBDIVISION  
Property Tax ID Number 0132176 Address of Property WETLAND

Description: SWP33S006  
Q-166 U-331 U-337 U-377

# Ridgefield Subdivision Retention Pond – SWP33S006 (Sheffield & Greenview)

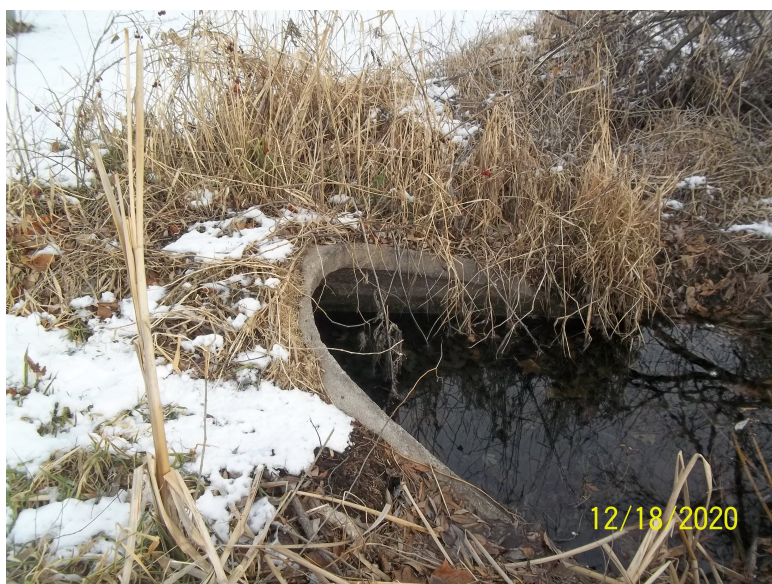
Outlet ST007816

| Compliance Verification | Design | Actual | Compliant<br>Yes    No | | Comments | |
|---|---|---|---|---|---|---|
| Outfall 1 (ST007816) | RCP – 27” | | N POND BETWEEN N50 | | W17525 & W17555 GRNVW AVE | |

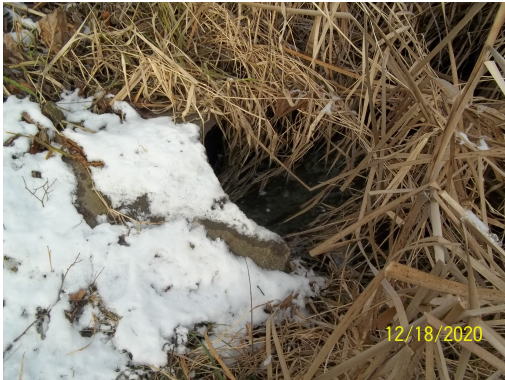
Inlet ST011276

| Compliance Verification | Design (Non-AsBuilt) | Actual (GPS) | Compliant Yes | No | Comments (Condition of Structure) |
|---|---|---|---|---|---|
| Upstream Invert (ST011276) | 888.30 | 888.42 | Y | - | |

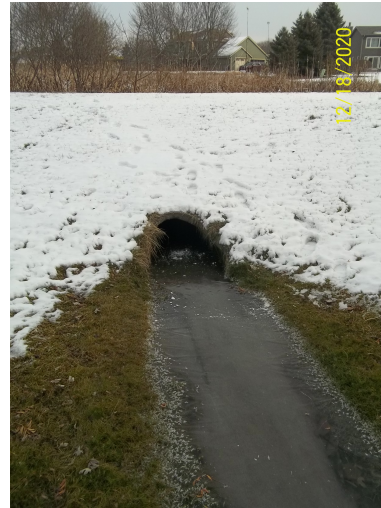
Outlet ST011275

| Compliance Verification | Design (Non-AsBuilt) | Actual (GPS) | Compliant Yes | No | Comments (Condition of Structure) |
|---|---|---|---|---|---|
| Opening Diameter (inches) | 15" RCP | 15" RCP | - | - | 15" RCP IN GOOD CONDITION<br><br>ELEVATIONS TO VARY SLIGHTLY FROM YEAR TO YEAR DUE TO GPS TECHNOLOGY |
| Downstream Invert (ST011275) | 888.10 | 888.09 | Y | - | |

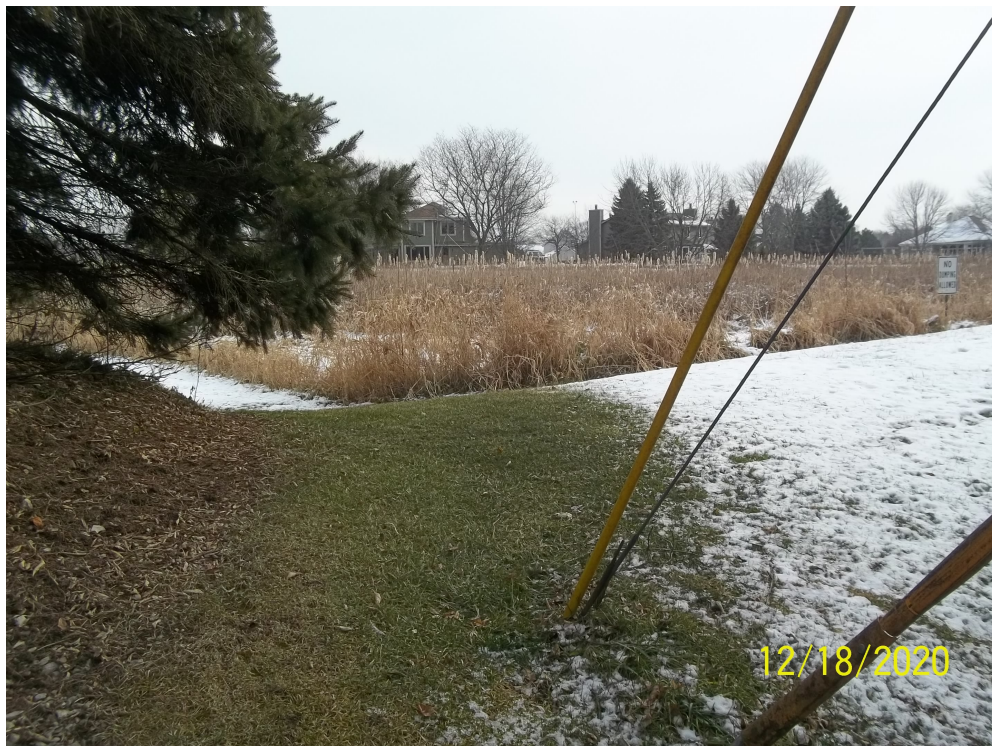
Emergency Spillway

| Compliance Verification | Design | Actual | Compliant<br>Yes    No | | Comments | |
|---|---|---|---|---|---|---|
| Elevation | N/A | 891.68 | - | - | | |
| Length of spillway (feet) | N/A | 85.0 FT | - | - | | |
