STORMWATER MANAGEMENT FACILITIES OPERATION AND INSPECTION REPORT

Description: SWP27N002 Location Of Pond ACROSS FROM
NO PLANS AVAILABLE N60W15979 KOHLER LN
MENOMONEE FALLS, WI 53051

Kohler Lane Retention Pond – SWP27N002

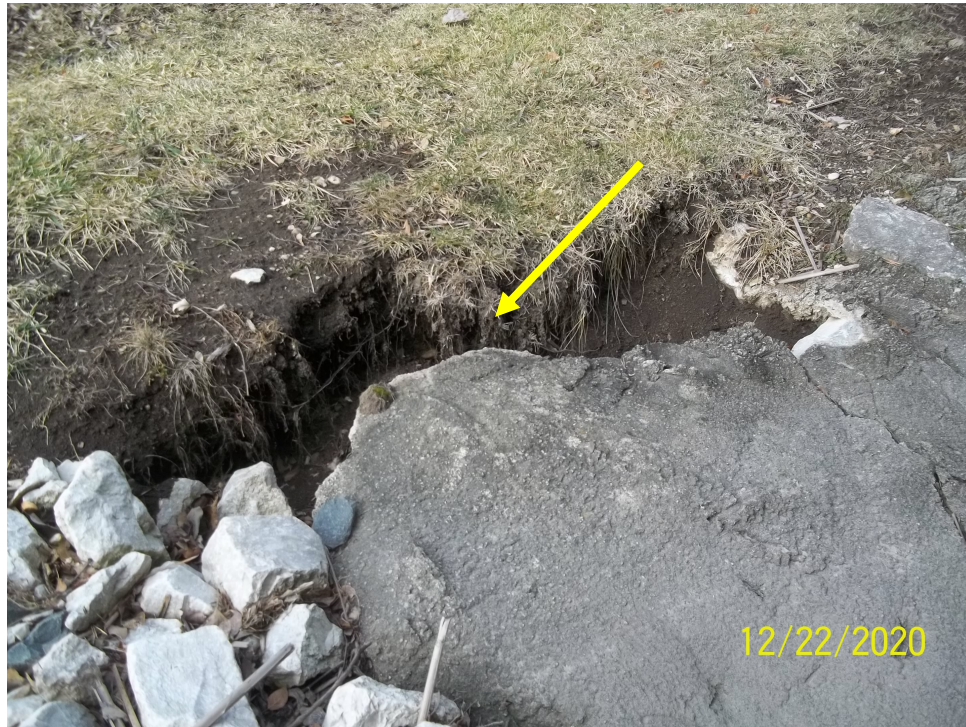
- 1) Storm Water Inlet ST000706
(S side of Kohler Ln between N60W16073 Kohler Ln & N60W15979 Kohler Ln)
Resolve void hazard.

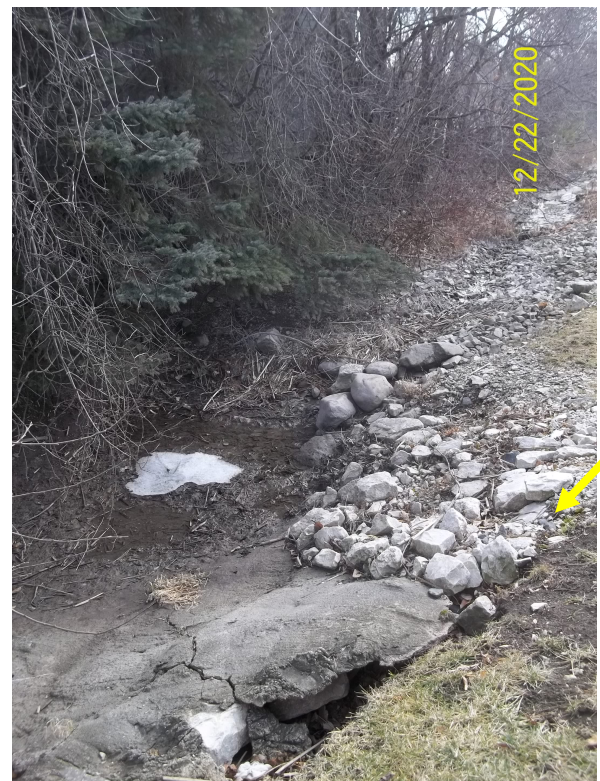
- 2) Storm
Water Inlet
ST000705

Covered by mud.

Clear mud,
confirm storm
sewer not
clogged also.
Work request
submitted
12/23/2020.
