## STORMWATER MANAGEMENT FACILITIES OPERATION AND INSPECTION REPORT

Quarter Section 23 NE Name of Business/Subdivision OAKWOOD PARK/  
Property Tax ID Number 0089962003 Address of Property WINTER FARM POND/  
WINTER HOLLOW SUBD

Location Of Pond SOUTH OF GOOD HOPE RD &  
WEST OF LILLY RD...  
NEAR TERRACE DR & DENNIS  
DROESE DR

# Oakwood Park Retention Pond – SWP23N006

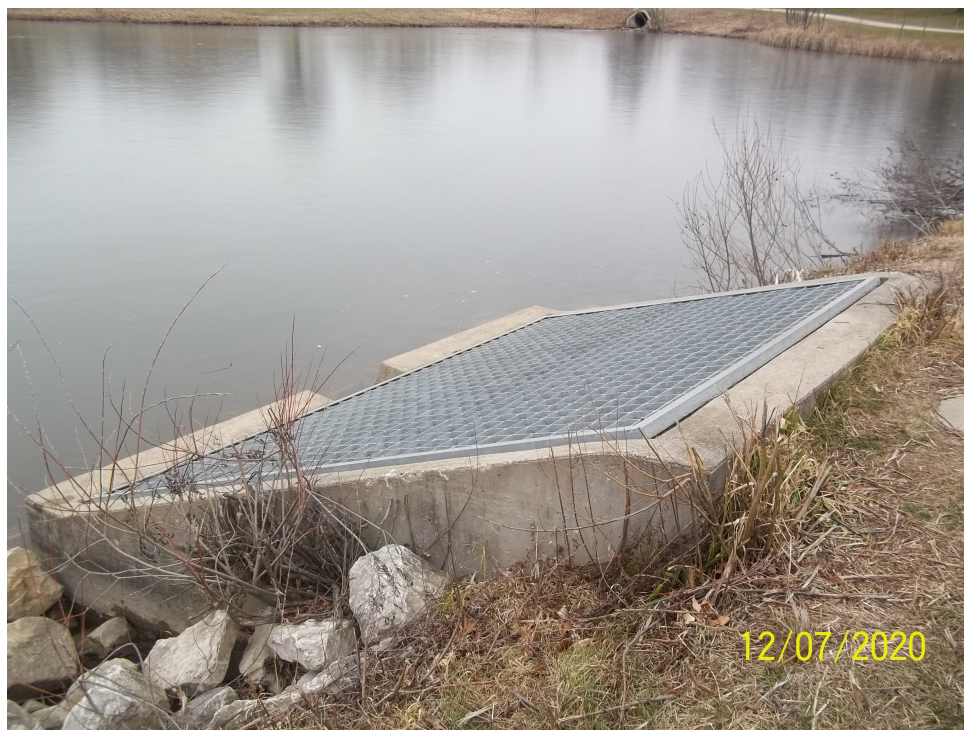
## Overflow Structure ST014026

Compliance Verification	Design	Actual	Compliant Yes    No		Comments	
Lower Discharge Control	(ST014026)					
Opening Diameter (inches)	N/A	SEE NOTE	-	-	V-NOTCH WEIR INTO 48” RCP	
Elevation	774.43	777.39	-	-	BOTTOM OF WIER V-NOTCH	
Other (Description)	N/A					
Opening Type and Size (inches)			-	-		
Elevation			-	-		
Emergency Spillway						
Elevation	784.13	784.50	-	-		
Length of spillway (feet)	50.0 FT	52.3 FT	-	-		
Embankment	Present Yes    No		Comments/Maintenance Requirements			
Unauthorized Plantings, trees, or woody vegetation	-	N				
Animal burrows or slope erosion or hole	-	N				
Storm Sewer Outfalls	Type & Size		Location		Comments	
Outfall 1 (ST011272)	RCP – 18”		SOUTHEAST POND		GOOD CONDITION	
Outfall 2 (ST011259)	RCP – 15”		SOUTH POND		GOOD CONDITION, REMOVE VGTN	
Outfall 3 (ST011273)	RCP – 72”		WEST POND		→END SECTION OFF OF STORM SEWER SEVERAL INCHES	
Outfall 4 (ST011274)	RCP – 72”		NORTHEAST POND

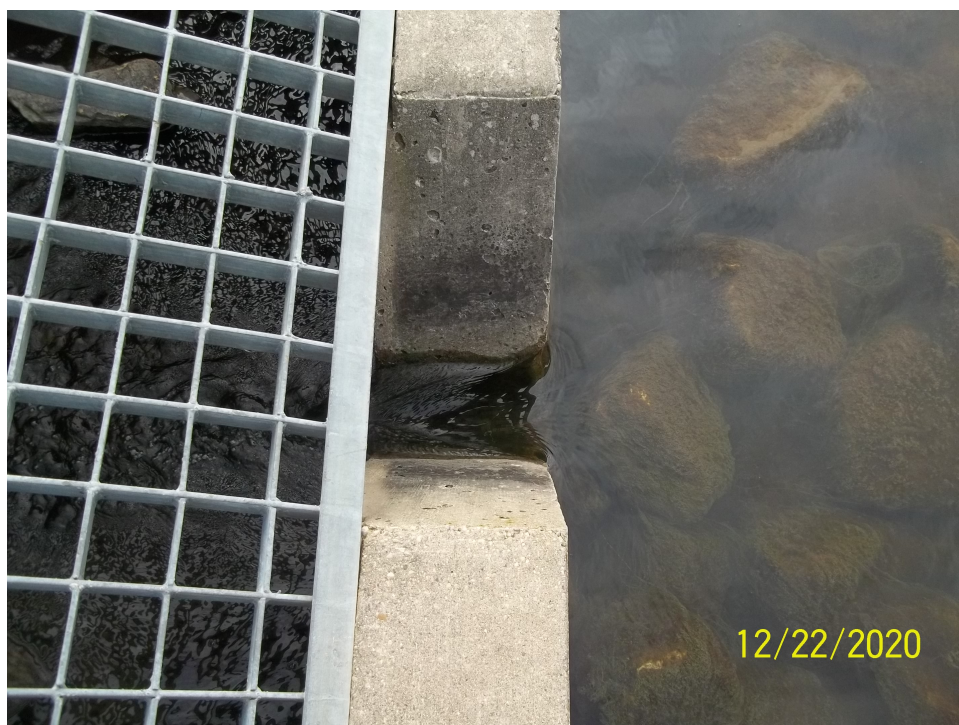
## Weir

Compliance Verification	Design (Non-AsBuilt)	Actual (GPS)	Compliant Yes	No	Comments (Condition of Structure)
<b>Primary Outlet Pipe</b> (ST011270)					Outlet Pipe Material
Opening Diameter (inches)	48" RCP	48" RCP	-	-	48" RCP IN GOOD CONDITION
Upstream Invert	774.43	777.39	-	-	
Downstream Invert	N/A	774.61	-	-	
Length (feet)	114.0 FT	104.9 FT	-	-	
Slope (%)	N/A	2.65%	-	-	
					ELEVATIONS TO VARY SLIGHTLY FROM YEAR TO YEAR DUE TO GPS TECHNOLOGY
<b>Secondary Outlet Pipe</b>	N/A				Outlet Pipe Material
Opening Diameter (inches)			-	-	
Upstream Invert			-	-	
Downstream Invert			-	-	
Length (feet)			-	-	
Slope (%)			-	-	
<b>Riser</b>	N/A				Riser Material
Opening Diameter (inches)		96" X 96" BOX	-	-	RCP @ TOP OF LOWEST ENTRY POINT FOR WATER ABOVE WEIR
Elevation		778.72-781.84	-	-	
<b>Upper Discharge Control</b>	(ST014026)				
Opening Diameter (inches)	N/A	SEE NOTE	-	-	V-NOTCH WEIR INTO 48" RCP
Elevation	776.73	778.72	-	-	TOP OF V-NOTCH

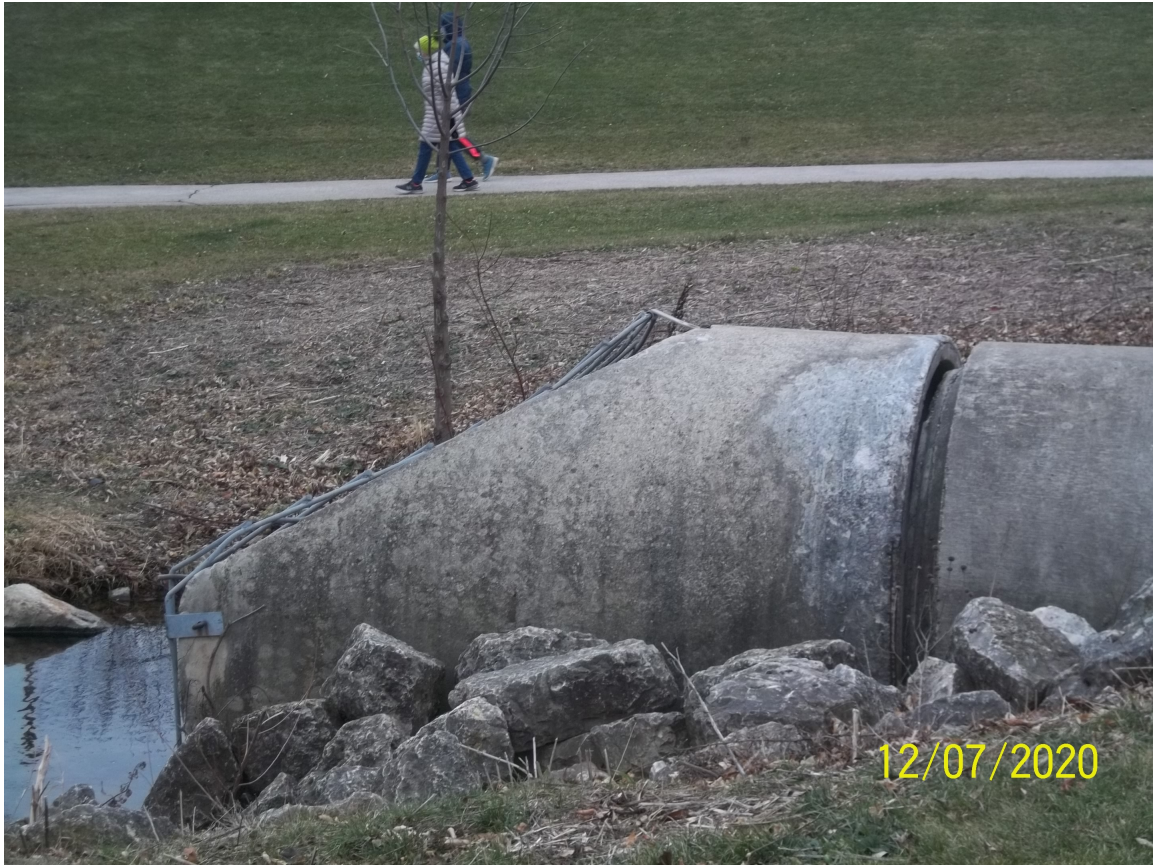
1) Storm Sewer Outlet ST011273

- Gap in Joint (60" Dia)

Repairs Needed (12/8/2020)
