## STORMWATER MANAGEMENT FACILITIES OPERATION AND INSPECTION REPORT

Quarter Section 12 SW Name of Business/Subdivision RIVER'S EDGE PARK POND  
Property Tax ID Number 0047975001 Address of Property \_\_\_\_\_  
\_\_\_\_\_  
\_\_\_\_\_

Description: SWP12S010  
C-97A, C-97M, U-218,  
U-919 – U-922

# River's Edge Park Pond – SWP12S010

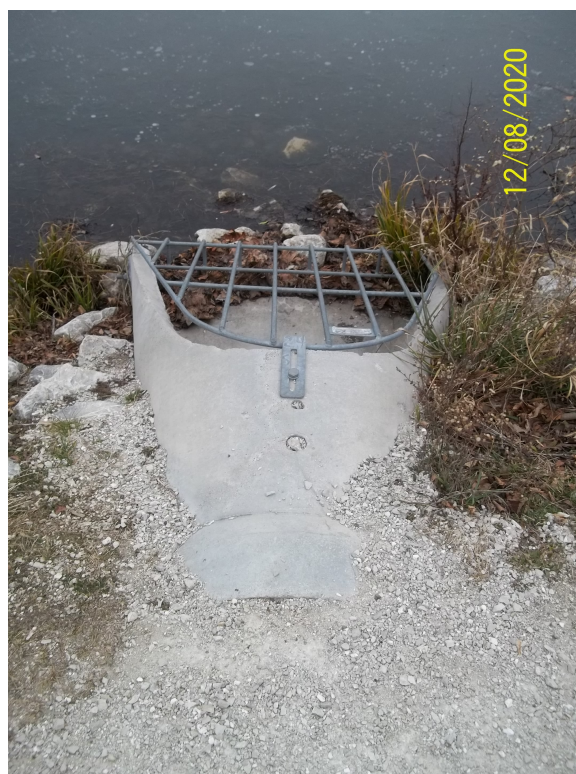
## Outlet ST014266

| Compliance Verification | Design | Actual | Compliant<br>Yes    No | | Comments | |
|---|---|---|---|---|---|---|
| Outfall 1 (ST014266) | 24" RCP | | N BANK OF POND | | GOOD CONDITION | |

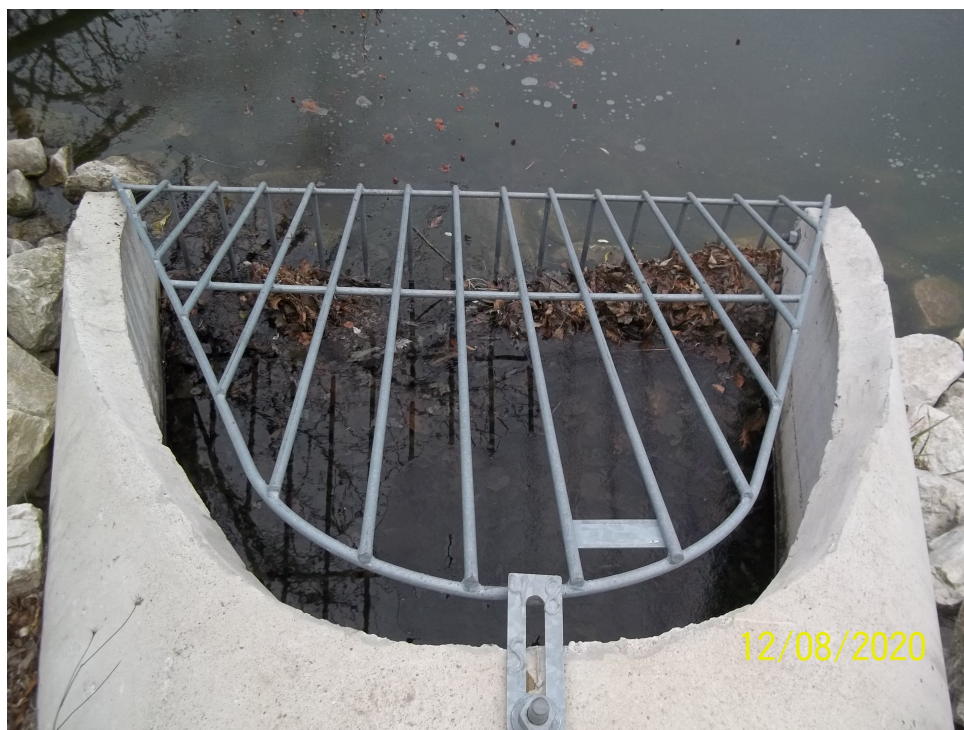
Outlet ST014267

| Compliance Verification | Design | Actual | Compliant<br>Yes    No | | Comments | |
|---|---|---|---|---|---|---|
| Outfall 2 (ST014267) | 48" RCP | | E CENTRAL BANK OF POND | | GOOD CONDITION | |

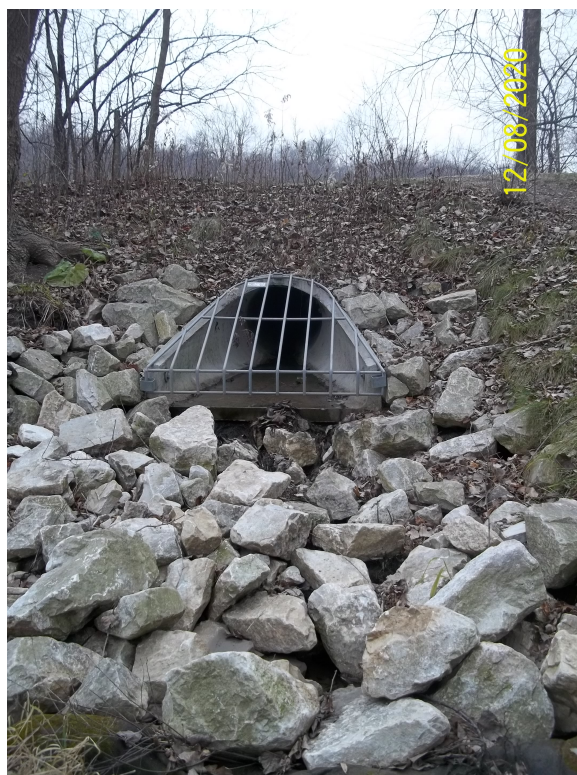
Overflow Outlet ST014269

| Compliance Verification | Design (Non-AsBuilt) | Actual (GPS) | Compliant Yes | No | Comments (Condition of Structure) |
|---|---|---|---|---|---|
| Opening Diameter (inches) | 24" RCP | 24" RCP | Y | - | SEE PICTURES FOR CONTROL STRUCTURE<br><br>ELEVATIONS TO VARY SLIGHTLY FROM YEAR TO YEAR DUE TO GPS TECHNOLOGY |
| Downstream Invert (ST14269) | 747.07 | 747.16 | Y | - | |
