STORMWATER MANAGEMENT FACILITIES OPERATION AND INSPECTION REPORT

Quarter Section 15 NE Name of Business/Subdivision HUNTER'S RIDGE ESTATES
 Property Tax ID Number 0057158 Address of Property _____

Hunter's Ridge Estates (Pilgrim Rd & Countryside)
Retention Pond - SWP15N005

Inspector Name : CHRISTOPHER M GARIEPY
 Inspection Date: 11/7/2013

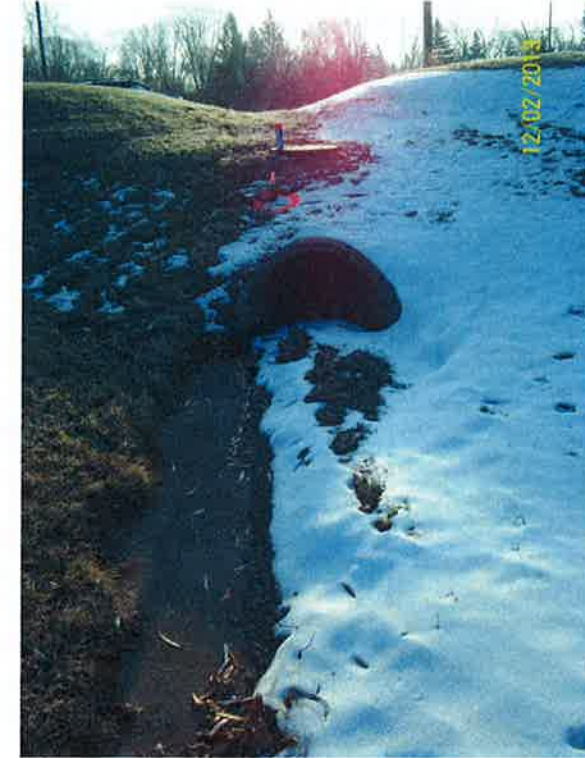
IN15N005, YB15N024, & Emergency Spillway

Compliance Verification	Design (Non-AsBuilt)	Actual (GPS)	Compliant		Comments (Condition of Structure)
			Yes	No	
Primary Outlet Pipe (IN15N005)					Outlet Pipe Material
Opening Diameter (inches)	18" RCP	18" RCP	-	-	18" RCP IN GOOD CONDITION, REPAIR GAP/SMALL SINK HOLE @ JOINT
Upstream Invert	837.50	837.62	-	-	
Downstream Invert	837.50	837.00	-	-	
Length (feet)	54.0 FT	56.2 FT	-	-	
Slope (%)	0.0024',	0.0110',	-	-	
					ELEVATIONS TO VARY SLIGHTLY FROM YEAR TO YEAR DUE TO GPS TECHNOLOGY
Secondary Outlet Pipe	N/A				Outlet Pipe Material
Opening Diameter (inches) (IN15N006)	15" RCP	15" RCP	-	-	15" RCP IN GOOD CONDITION
Upstream Invert	837.50	837.59	-	-	
Downstream Invert	837.50	837.20	-	-	
Length (feet)	6.0 FT	6.3 FT	-	-	
Slope (%)	0.0000',	0.0622',	-	-	
Riser	N/A				Riser Material
Opening Diameter (inches)					
Elevation					
Upper Discharge Control	N/A				
Opening Diameter (inches)					
Elevation

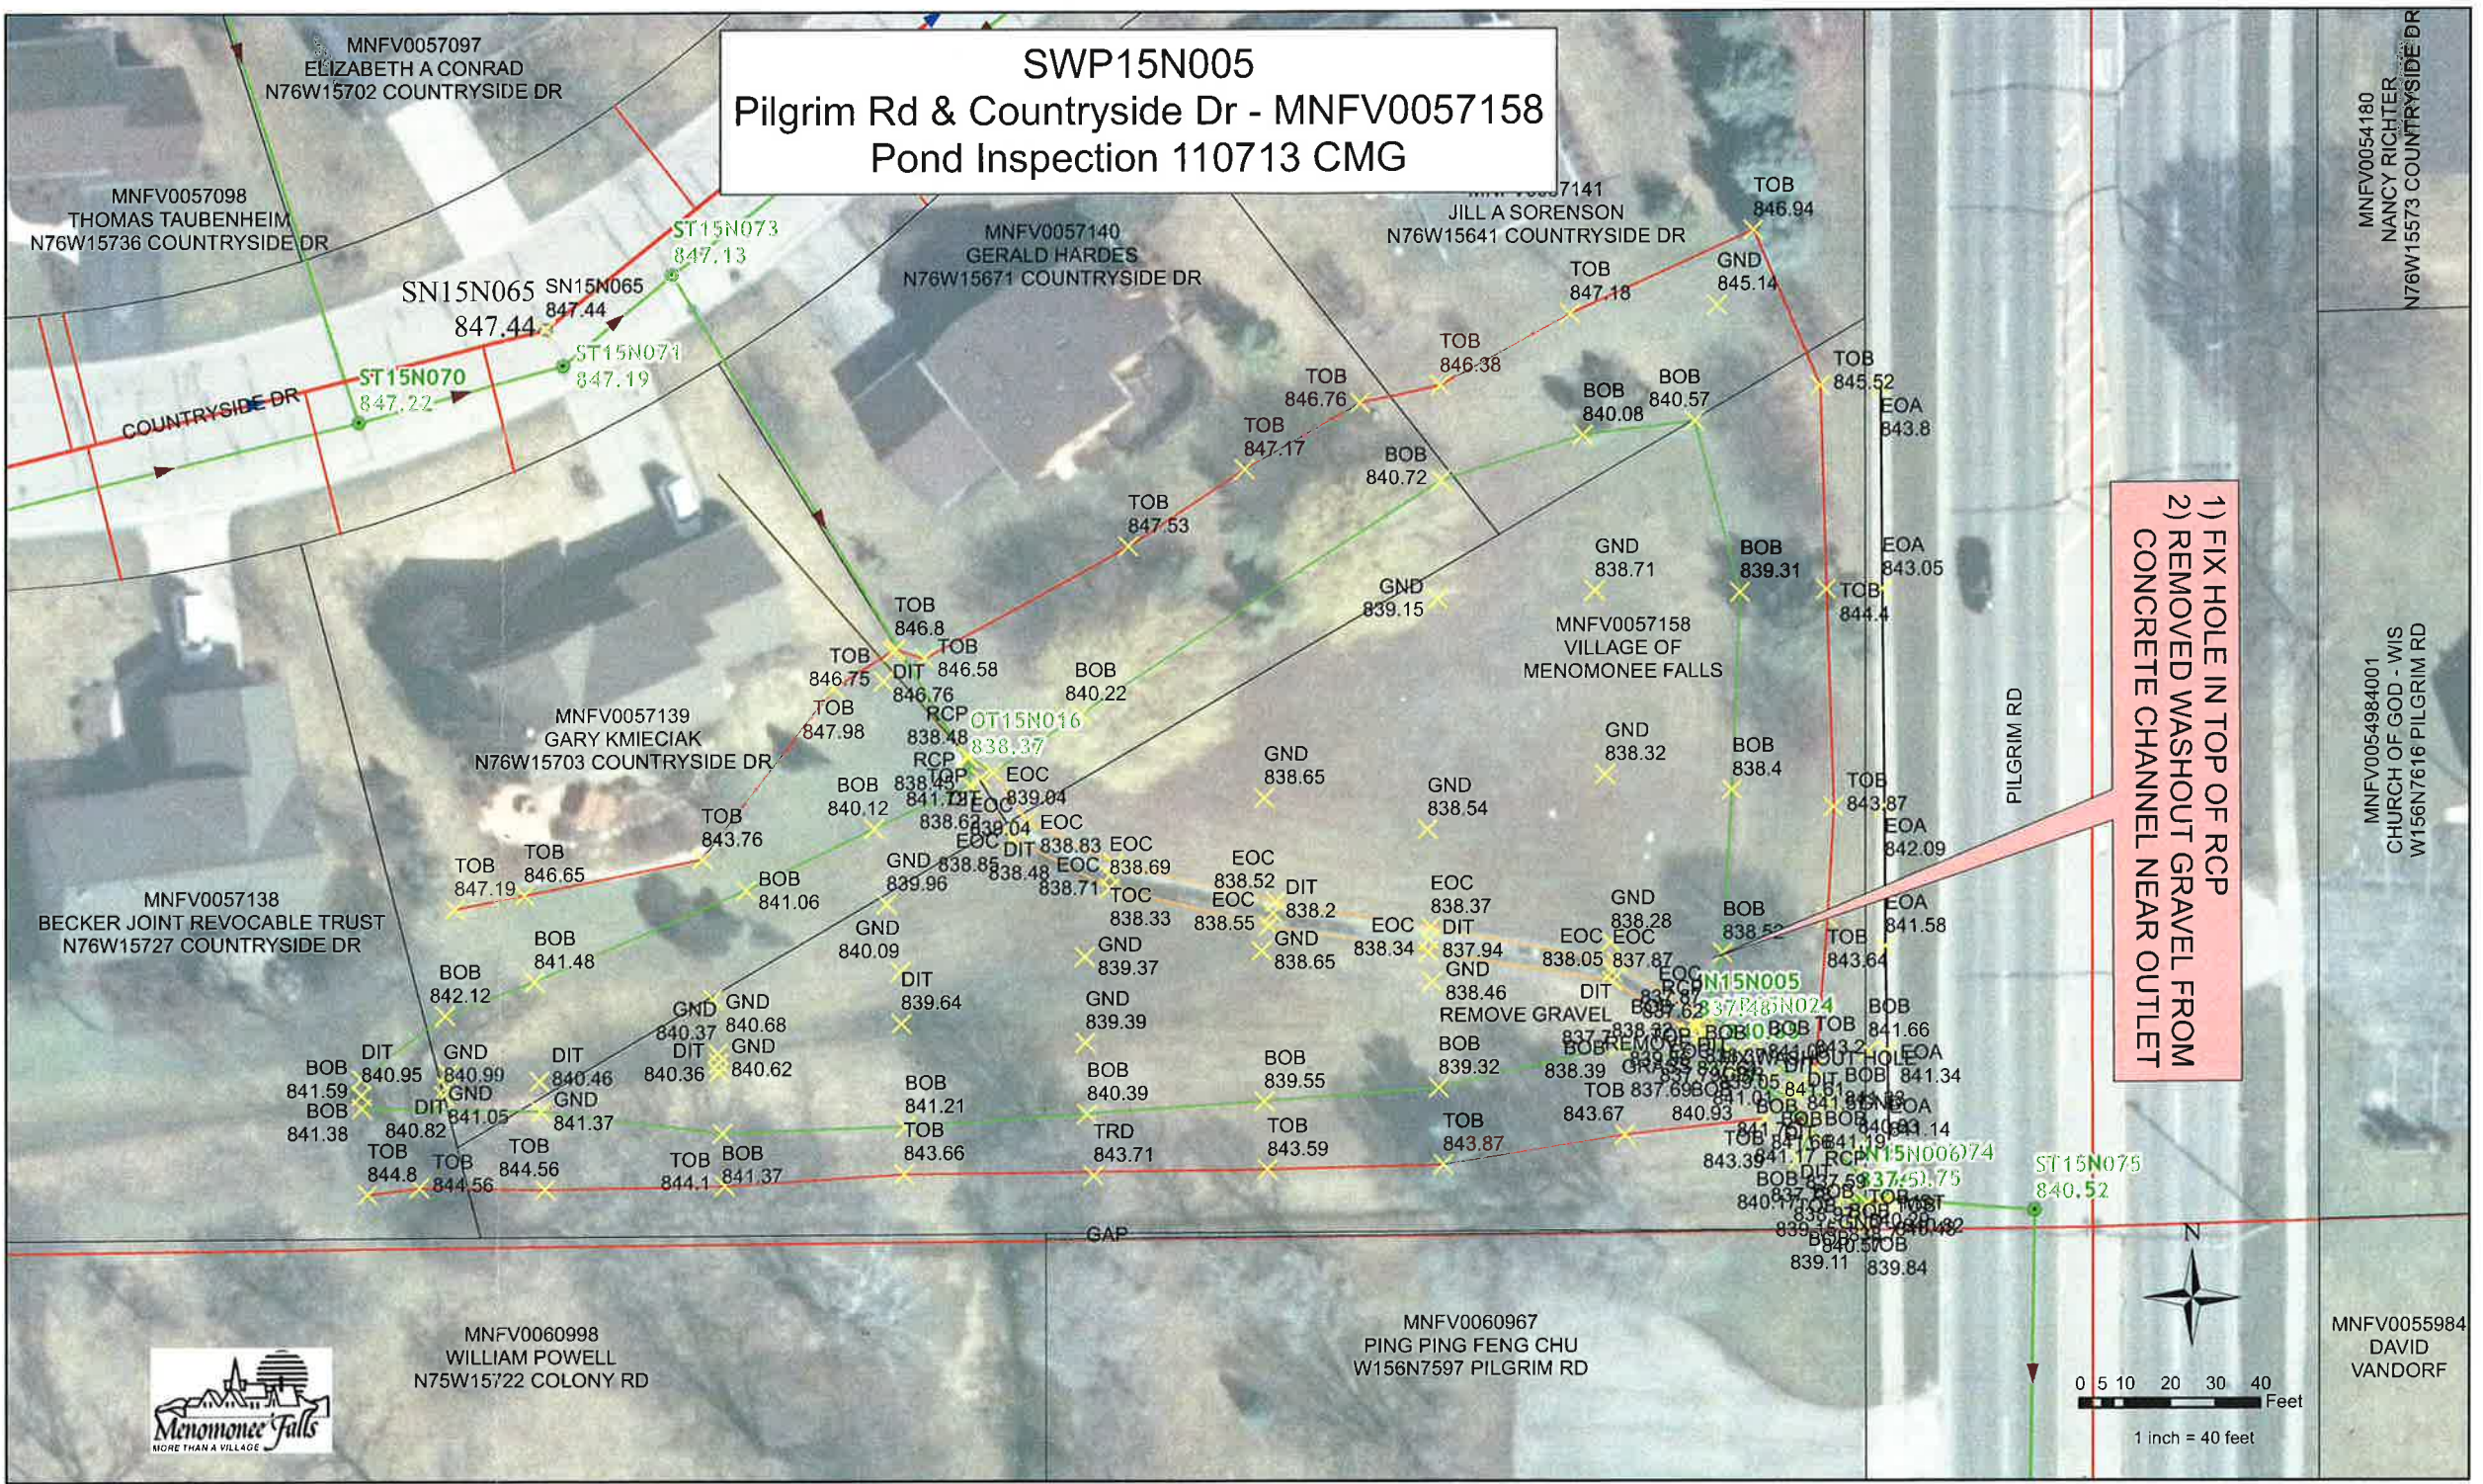
SWP15N005
Pilgrim Rd & Countryside Dr - MNFV0057158
Pond Inspection 110713 CMG

CONTOUR LINES

GAP

1) FIX HOLE IN TOP OF RCP
 2) REMOVED WASHOUT GRAVEL FROM
 CONCRETE CHANNEL NEAR OUTLET
