## STORMWATER MANAGEMENT FACILITIES OPERATION AND INSPECTION REPORT

Quarter Section 26 NE Name of Business/Subdivision MILL RIDGE NO. 5 SUBD  
Property Tax ID Number 0101158 Address of Property (INDEX NO. 01.15)

Location Of Pond WEST OF LILLY RD  
NORTH OF MANHARDT DR

Description: SWP26N002  
P-0144

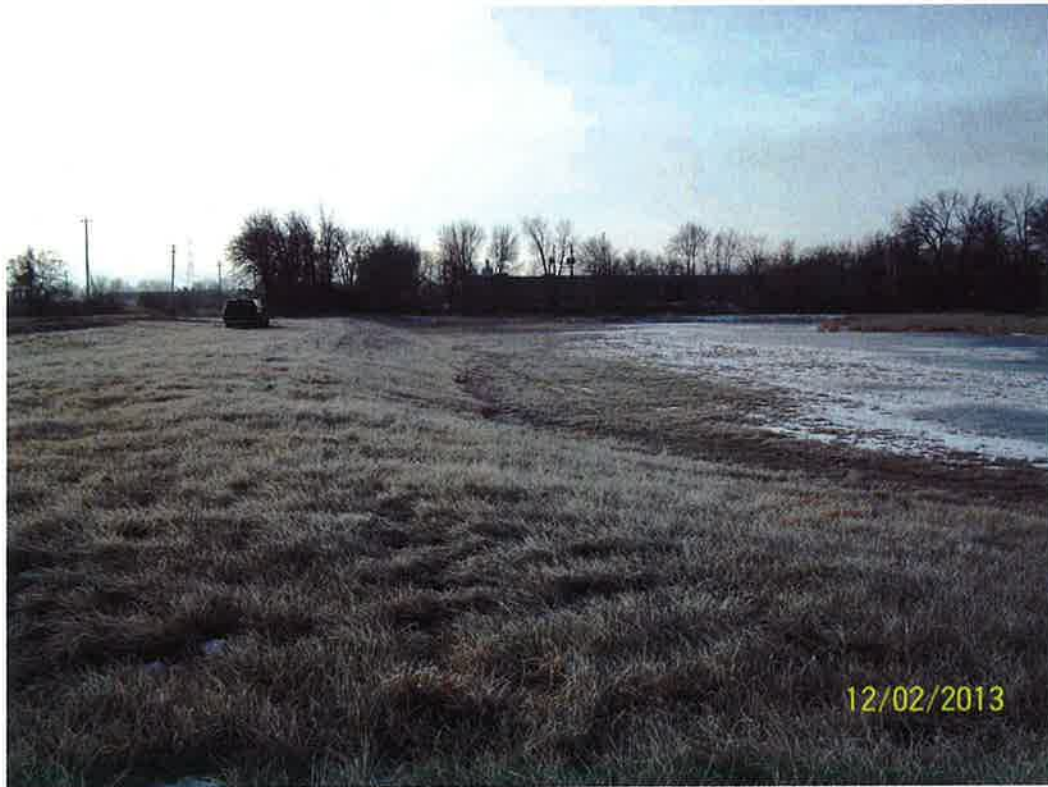
Mill Ridge No. 5 (Lilly Rd)  
Retention Pond – SWP26N002  
Overview

Four (4) 12" Culverts Service Pond  
Through Westerly Bank into stream.

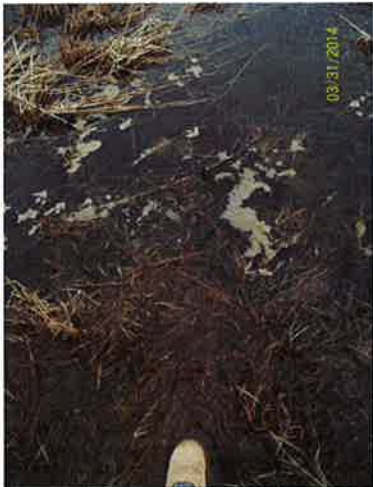
ST012544

| Compliance Verification | Design<br>(Non-AsBuilt) | Actual<br>(GPS) | Compliant<br>Yes No | Comments<br>(Condition of Structure) |
|---|---|---|---|---|
| Opening Diameter<br>(inches) | 12" CMP | 12" CMP | | 12" CMP IN GOOD CONDITION<br><br>ELEVATIONS TO VARY SLIGHTLY<br>FROM YEAR TO YEAR DUE TO GPS<br>TECHNOLOGY |

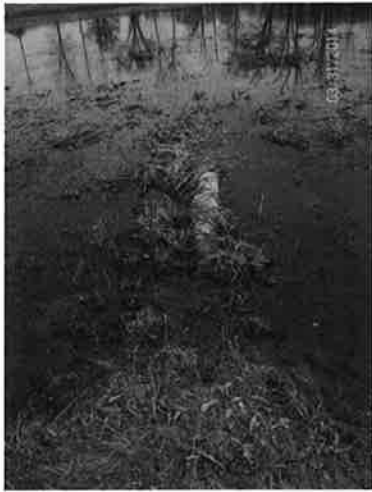
ST012500

| Compliance Verification | Design<br>(Non-AsBuilt) | Actual<br>(GPS) | Compliant<br>Yes No | Comments<br>(Condition of Structure) |
|---|---|---|---|---|
| Opening Diameter (inches) | 12" CMP | 12" CMP | | 12" CMP IN GOOD CONDITION |

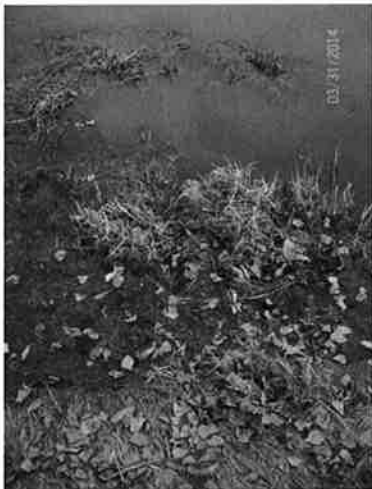
ST012501

| Compliance Verification | Design<br>(Non-AsBuilt) | Actual<br>(GPS) | Compliant<br>Yes No | Comments<br>(Condition of Structure) |
|---|---|---|---|---|
| Opening Diameter (inches) | 12" CMP | 12" CMP | | 12" CMP IN GOOD CONDITION |

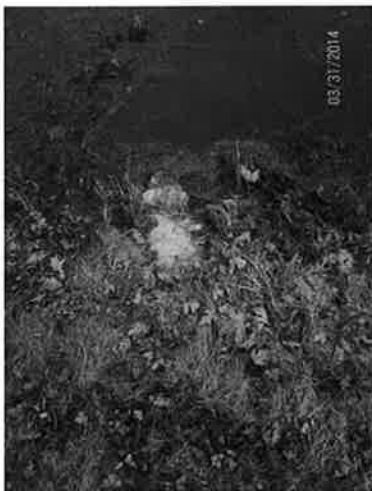
ST012503

| Compliance Verification | Design<br>(Non-AsBuilt) | Actual<br>(GPS) | Compliant<br>Yes No | | Comments<br>(Condition of Structure) |
|---|---|---|---|--|---|
| Opening Diameter (inches) | 12" CMP | 12" CMP | | | <b>***REPAIR NEEDED***</b><br><br>12" CMP CRUSHED AT POND SIDE OF BERM |

- 1) Fix crushed northerly most culvert (ST012503)
- 2) Place Markers at each Culver pipe to prevent crushing.

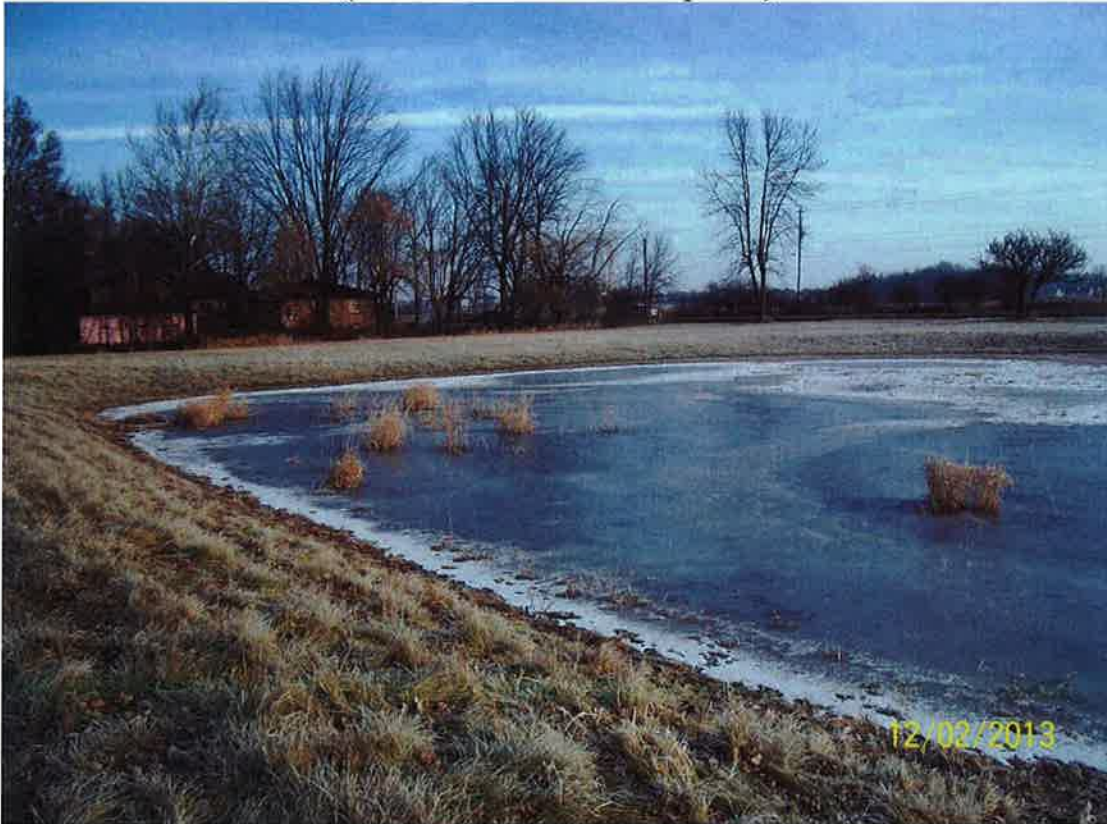
SPILLWAY  
(North end of retention pond.)

| Compliance Verification | Design<br>(Non-AsBuilt) | Actual<br>(GPS) | Compliant<br>Yes No | | Comments<br>(Condition of Structure) |
|---|---|---|---|--|---|
| Elevation | 773.00 | 771.97 | | | |
| Length of spillway<br>(feet) | 45.0 FT | 79.1 FT | | | |

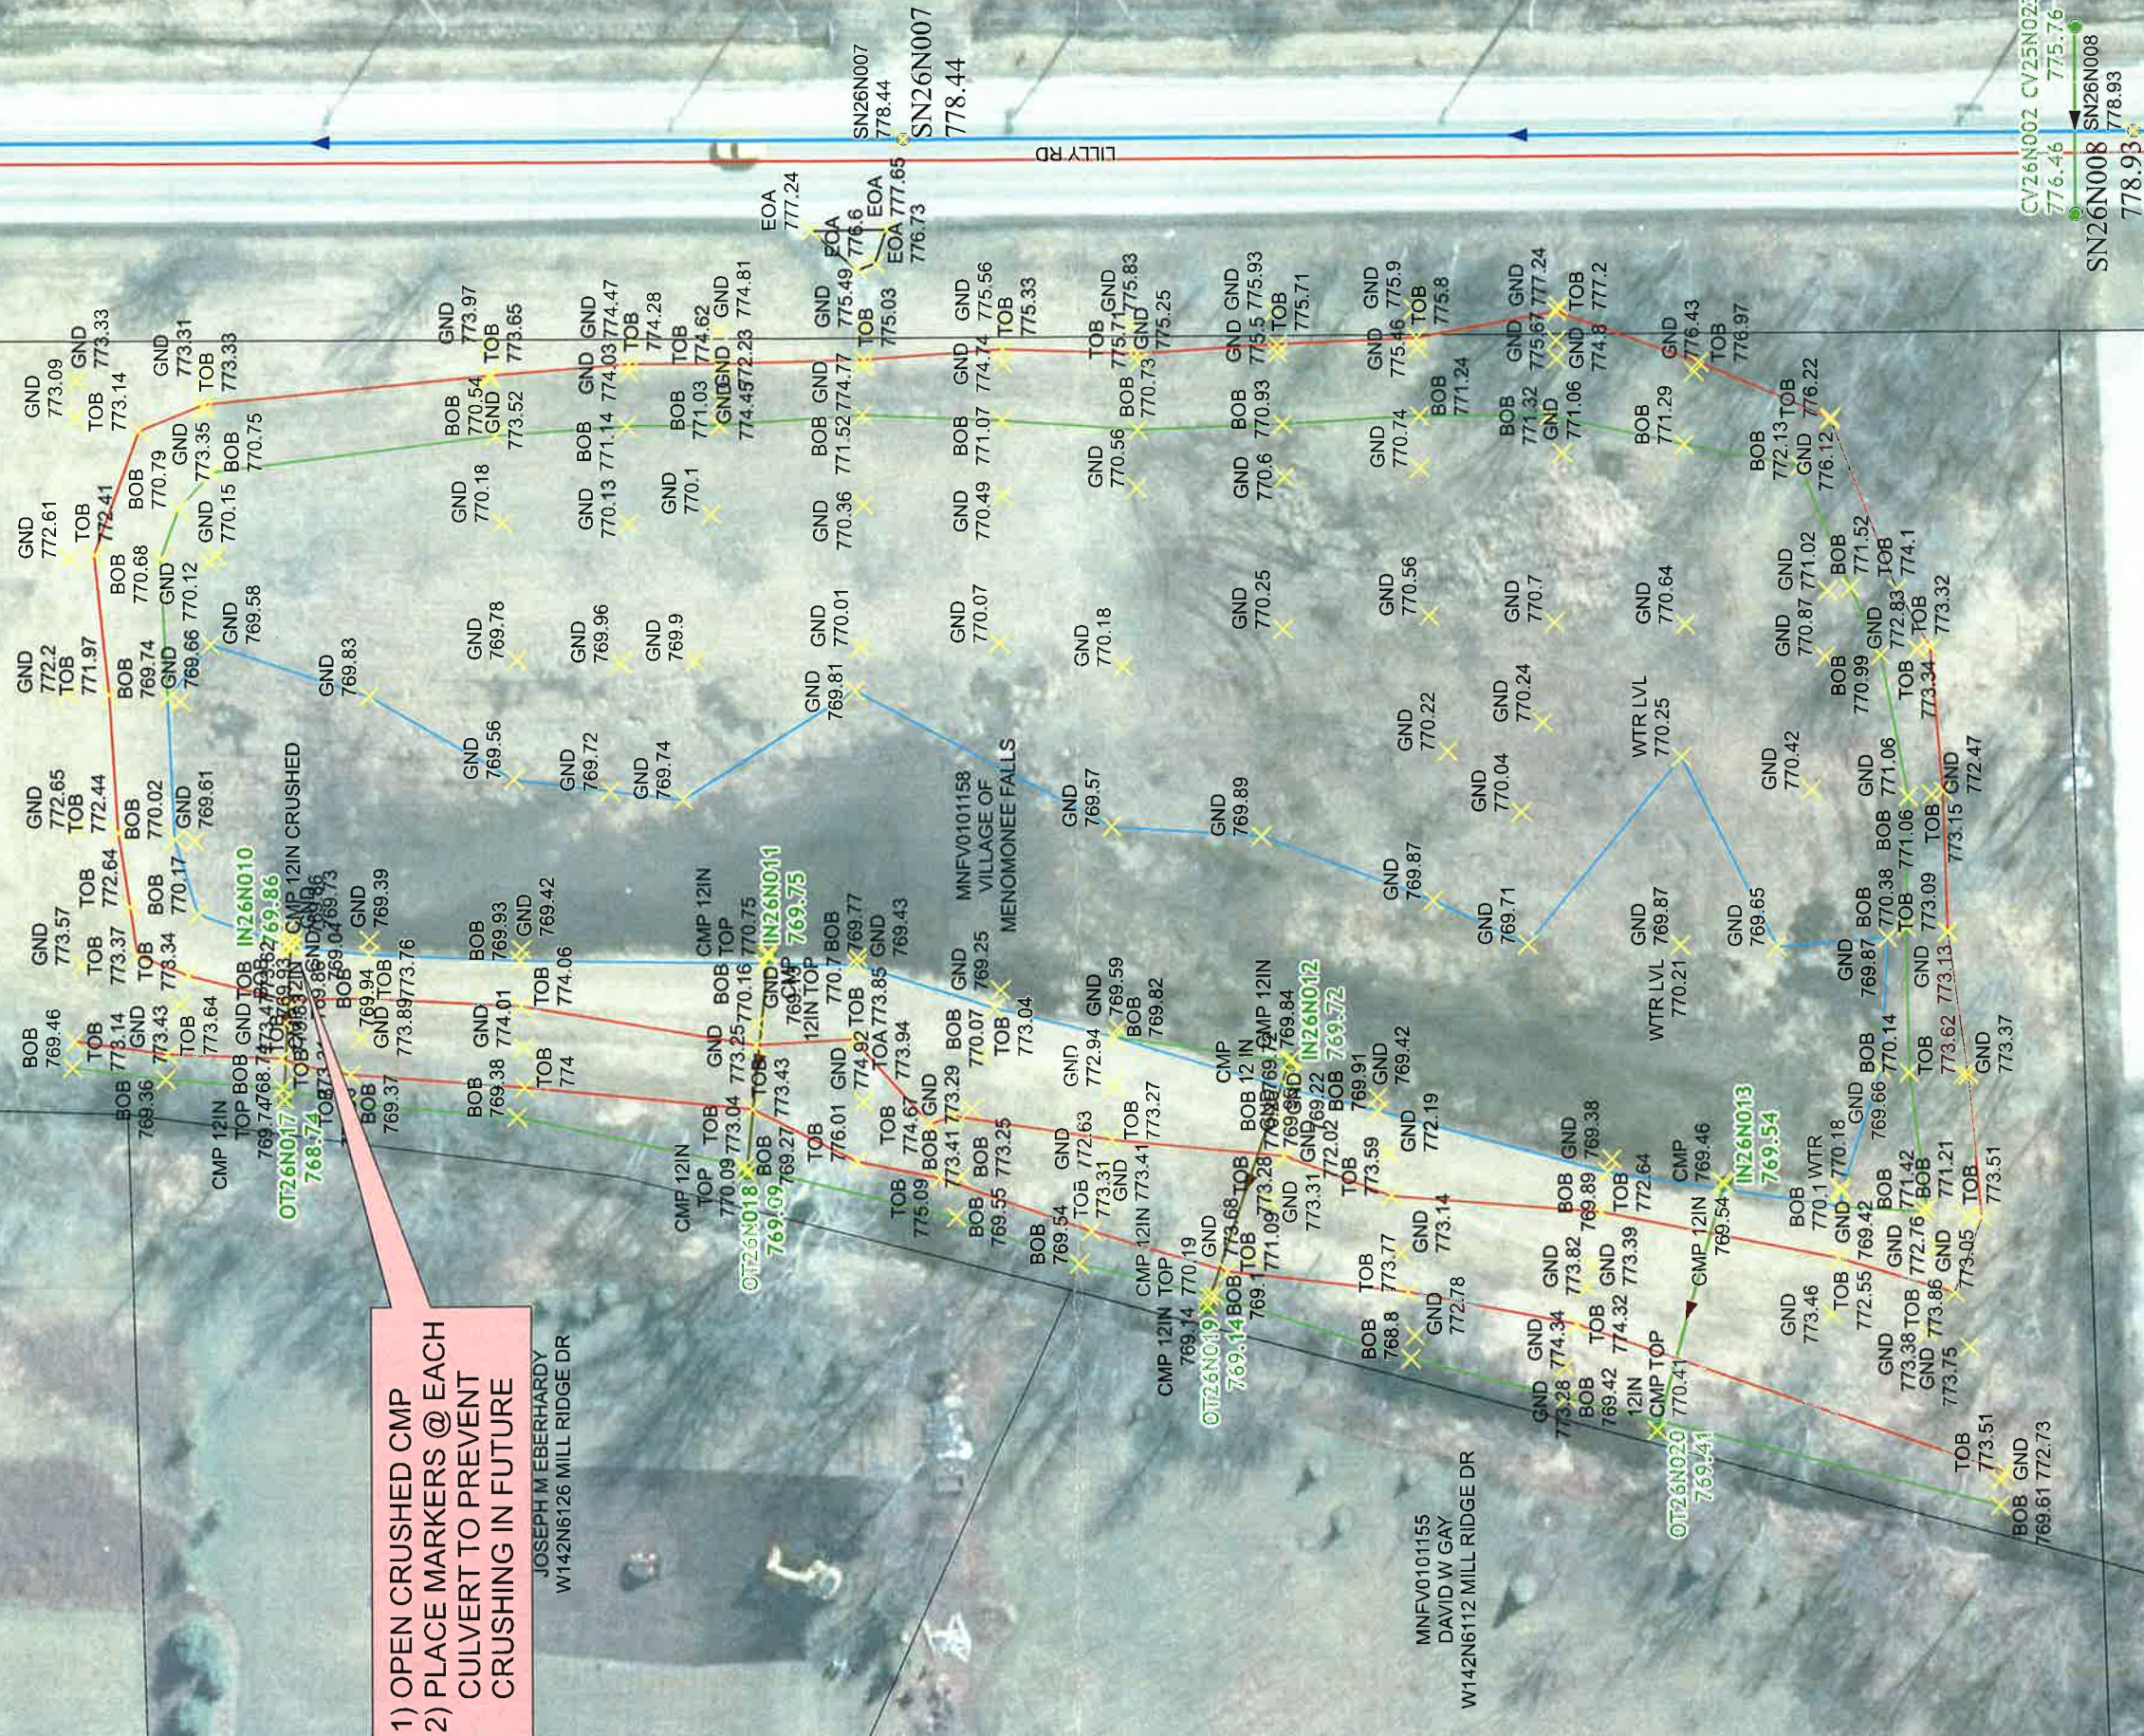
**SWP26N002**  
**Mill Ridge #5 - Lilly Rd - MNFV0101158**  
**Pond Inspection 111513 CMG**

MISSED CULVERT IN 11/15/13 DATA COLLECTION.  
SHOOT CULVERT ELEVATIONS

- 1) OPEN CRUSHED CMP
- 2) PLACE MARKERS @ EACH CULVERT TO PREVENT CRUSHING IN FUTURE
