STORMWATER MANAGEMENT FACILITIES OPERATION AND INSPECTION REPORT

SW 1/4 Sec 33 Name of Business/Subdivision Cranes Crossing
0131038 Address of Property N48 W18200 Lisbon Road

Pond ID: SWP 33s004

CRANES CROSSING

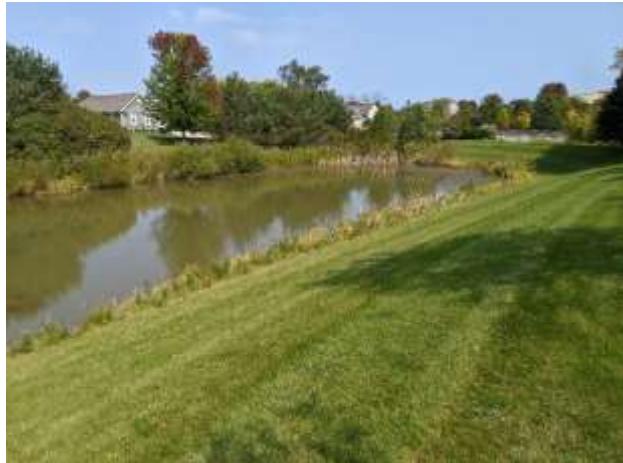
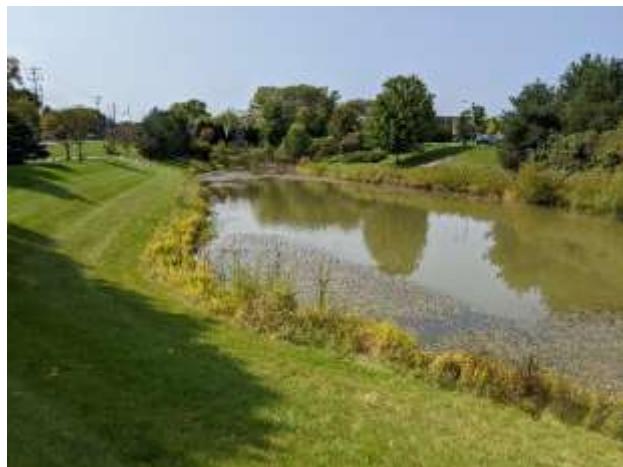
Sketch Outlet or Attach to Document

Compliance Verification	Design	Actual	Compliant Yes	No	Comments (Condition of Structure)
Primary Outlet Pipe					
Opening Diameter (inches)	18"	18"	X		RCP
Upstream Invert	876.75	876.89	X		
Downstream Invert	876.45	876.17	X		
Length (feet)	193.63	167.7	X		
Slope (%)	0.284	0.429	X		
Secondary Outlet Pipe	(If Applicable)				
Opening Diameter (inches)					Not Applicable (NA)
Upstream Invert					
Downstream Invert					
Length (feet)					
Slope (%)					
Riser	(If Applicable)				
Opening Diameter (inches)	48"	48"	X		Precast Reinforced concrete
Elevation	878.70	879.06	X		
Upper Discharge Control	(If Applicable)				
Opening Diameter (inches)					NA
Elevation

Compliance Verification	Design	Actual	Compliant Yes	No	Comments
Lower Discharge Control	(If Applicable)				
Opening Diameter (inches)	24"x15"	24"x17"	X		Debris screen over rectangular opening
Elevation	877.00	877.02	X		
Other (Description)					
Opening Type and Size (inches)	2-4" dia.	2-4" dia.	X		Two orifices
Elevation	877.00	877.02	X		
Emergency Spillway					
Elevation	884.29	883.4±		X	
Length of spillway (feet)	10.0	15±		X	
Embankment	Present Yes		Comments/Maintenance Requirements		
Unauthorized Plantings, trees, or woody vegetation		X	Mowed lawn. Remove large trees near northwest inlet and woody vegetation near northeast corner of pond.		
Animal burrows or slope erosion		X			
Storm Sewer Outfalls	Type & Size		Location		Comments
Outfall 1	30" RCP		East side		From Pond P2E, good condition
Outfall 2	12" RCP		North side		Good condition
Outfall 3	24" RCP		Northwest corner		Good condition
Outfall 4	21" CMP		Northeast corner		Good condition

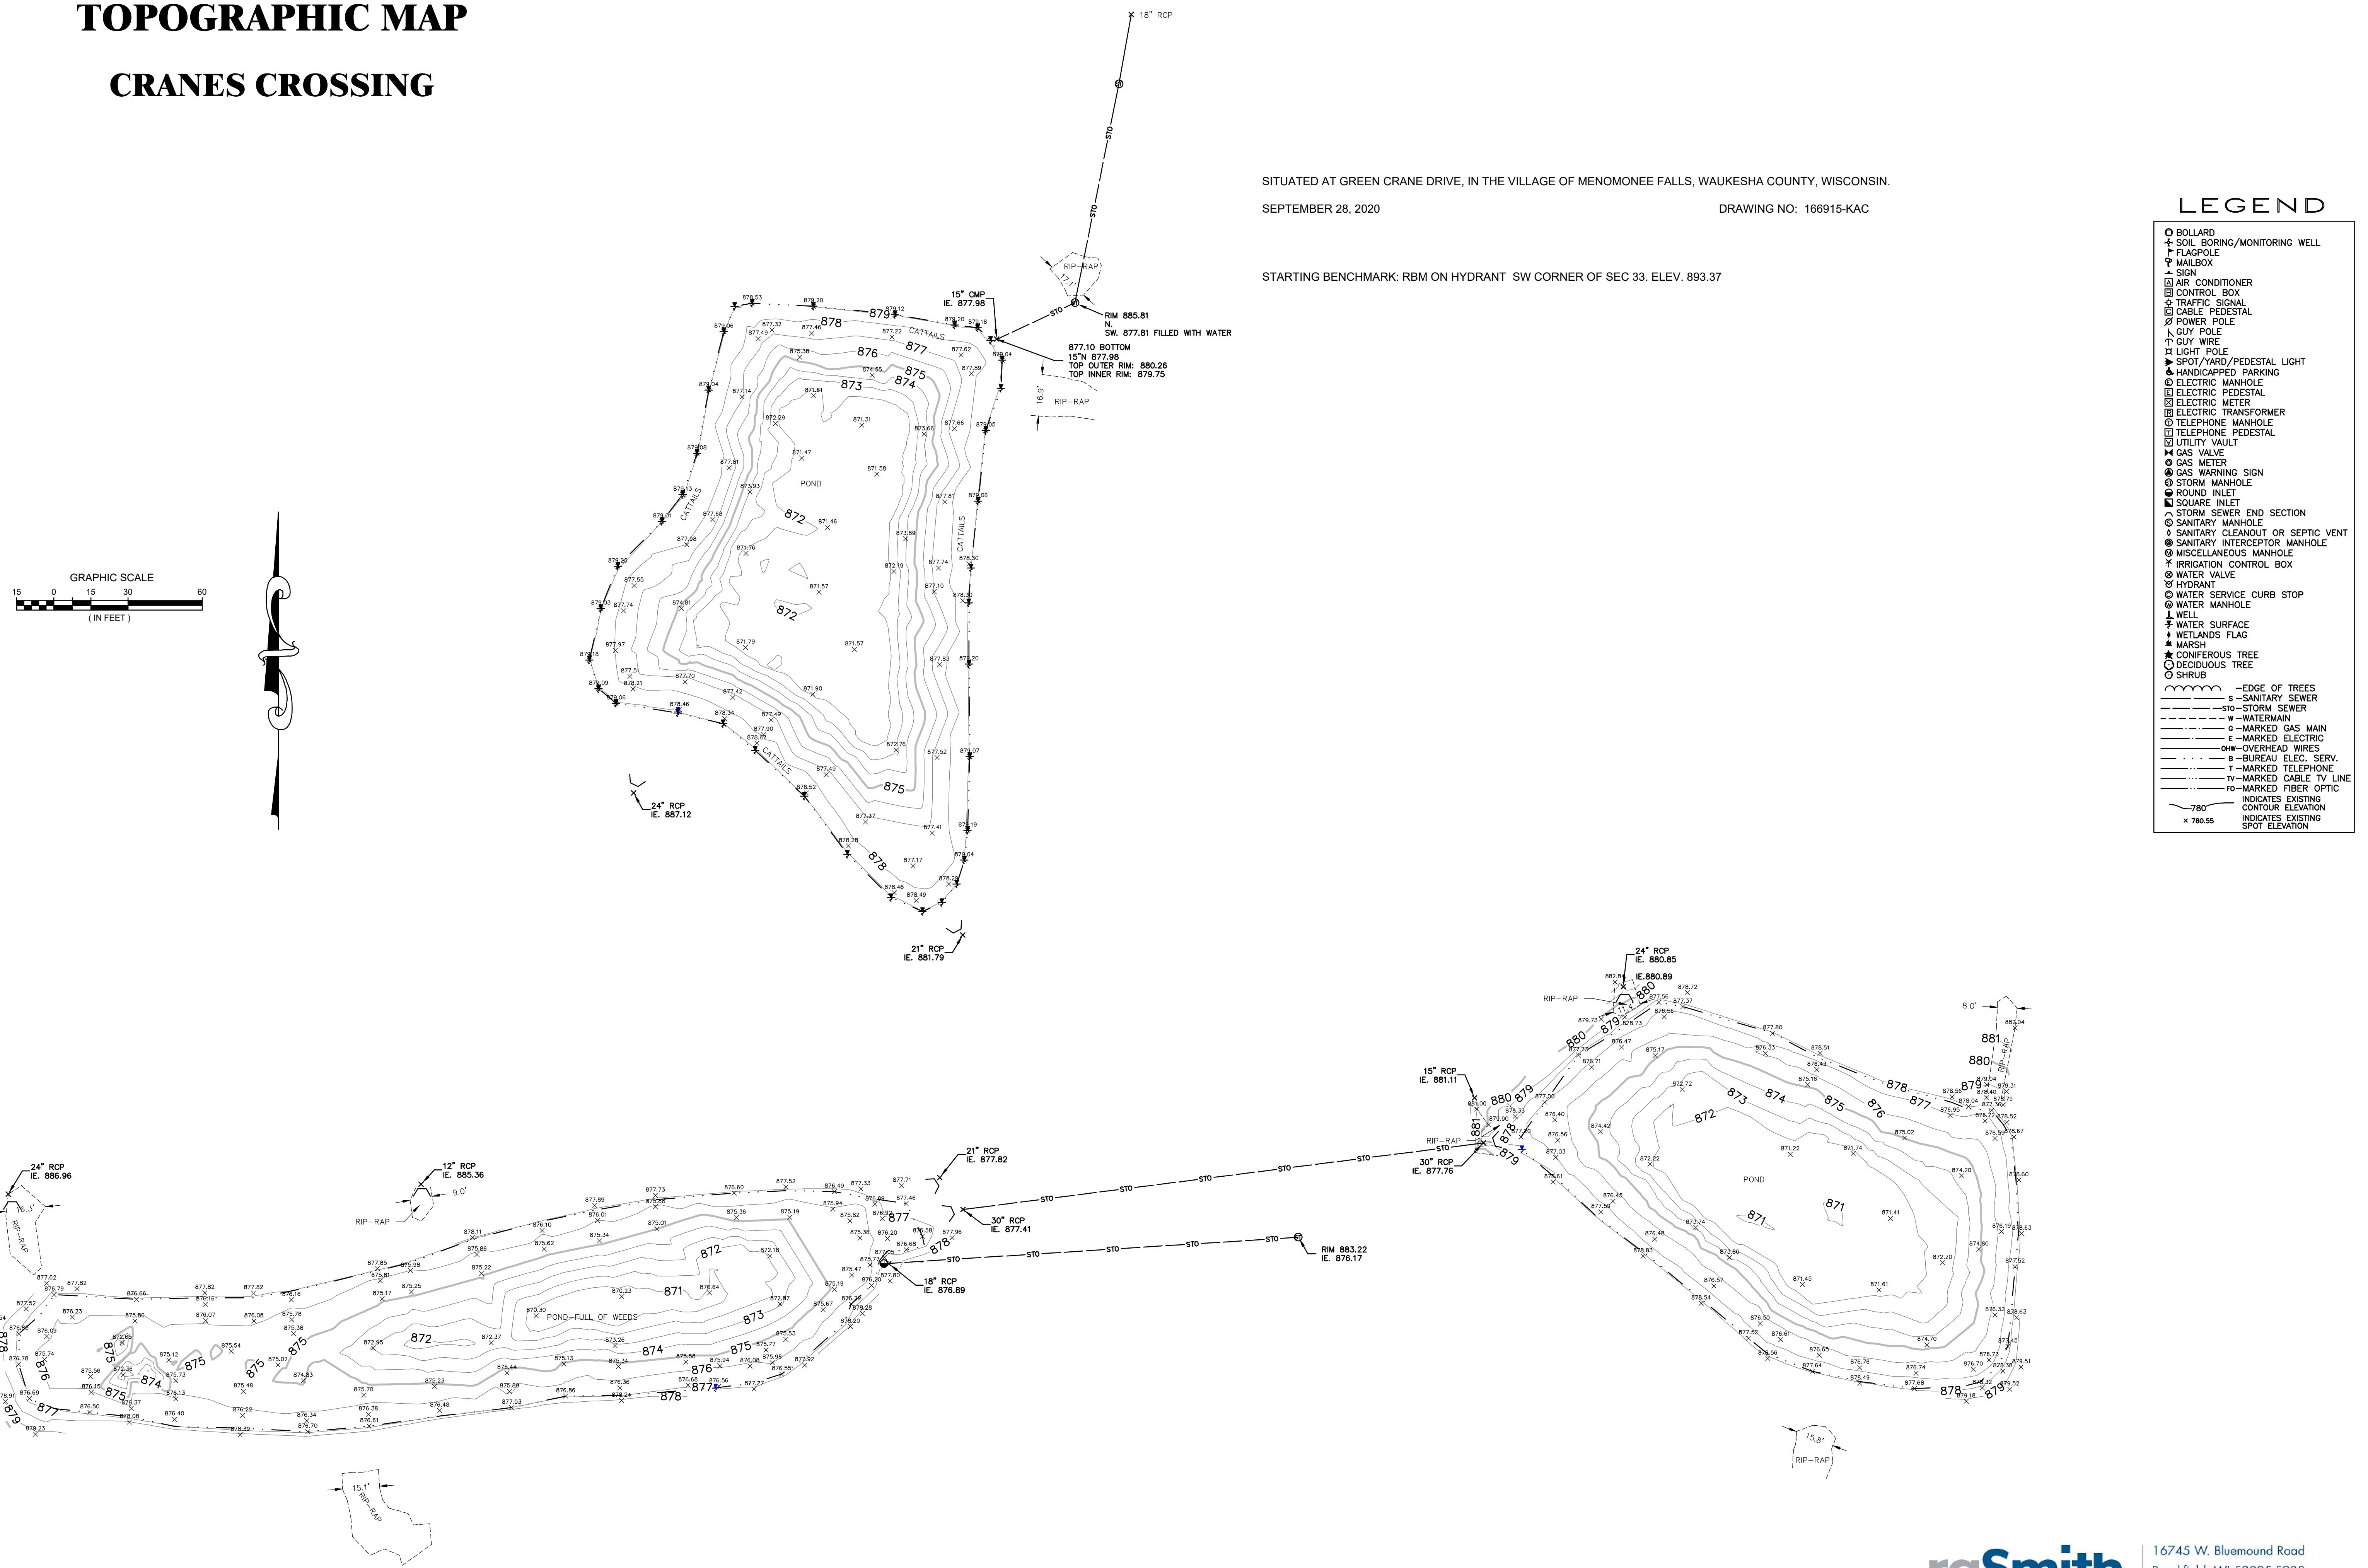
TOPOGRAPHIC MAP

Storage Properties	Design	Actual	Compliant Yes	Not Applicable No	Equipment Used
Normal Water Elevation (Wet Ponds)	877.00	877.02	X		Total station & GPS
Design High Water Elevation	884.29	883.4	X		
Area at Normal Water Elevation (Ac) (Wet Ponds)	0.4316	0.499	X		
Area at Design High Water Elevation (Ac)	1.0560	0.921	X		
Active Storage Available (Ac-Ft)*	3.9856	3.51	X		
Lowest Elevation at Top of Embankment (If Applicable)	885.2	883.3		X	
Average Elevation at Top of Embankment (If Applicable)	885.22	884.5		X	
Maximum Bottom Elevation	870.0	870.23	X		
Average Pond Bottom Elevation	870.7	872.0	X		
Pond Bottom Area (Ac)	0.0361	0.053	X		
Maximum Pond Depth	7.00	6.7	X		
Average Pond Depth	6.3	5.0	X		
Average Permanent Pool Depth (Wet Ponds)	6.3	5.0	X		HyDrone-Remote Control Survey Boat Platform
