STORMWATER MANAGEMENT FACILITIES OPERATION AND INSPECTION REPORT

SE 1/4 SEC 22 Name of Business/Subdivision FOX MEADOW
Address of Property _____

SWP22S002

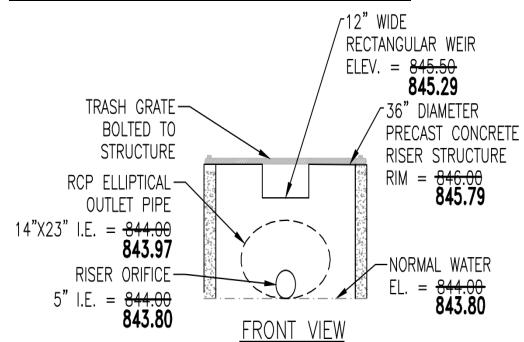
Figure 1: Outlet Structure As-Built

Compliance Verification	Design	Actual	Compliant Yes	No	Comments (Condition of Structure)
Primary Outlet Pipe					Outlet Pipe Material
Opening Diameter (inches)	14x23	14x23	X		Reinforced concrete pipe
Upstream Invert	844.00	843.97	X		Good Condition
Downstream Invert	843.80	843.88	X		
Length (feet)	32.7	32.7	X		
Slope (%)	0.60	0.28	X		
Secondary Outlet Pipe	(If Applicable)				Outlet Pipe Material
Opening Diameter (inches)	NA				NA
Upstream Invert	NA				
Downstream Invert	NA				
Length (feet)	NA				
Slope (%)	NA				
Riser	(If Applicable)				Riser Material
Opening Diameter (inches)	36	36	X		Precast concrete structure
Elevation	846.00	845.79	X		Good Condition
Upper Discharge Control	(If Applicable)				
Opening Diameter (inches)	12	12	X		Concrete weir
Elevation	845.50	845.37	X		Good Condition

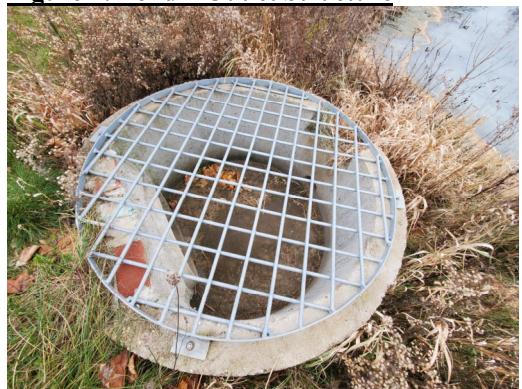
Figure 2: Pond 1 Outlet Structure

Compliance Verification	Design	Actual	Compliant Yes No		Comments	
Lower Discharge Control	(If Applicable)					
Opening Diameter (inches)	5	5	X		Concrete orifice Good Condition	
Elevation	844.00	843.80	X			
Other (Description)						
Opening Type and Size (inches)	NA	NA				
Elevation	NA	NA				
Emergency Spillway						
Elevation	847.65	847.65	X		Good Condition	
Length of spillway (feet)	15	15	X		Good Condition	
Embankment	Present Yes No		Comments/Maintenance Requirements			
Unauthorized Plantings, trees, or woody vegetation		X	One animal burrow observed along northwest bank. Recommend filling animal burrow.			
Animal burrows or slope erosion	X					
Storm Sewer Outfalls	Type & Size		Location		Comments	
Outfall 1	12" RCP FES		W bank		Good Condition	
Outfall 2	15" RCP FES		SE corner		Good Condition	
Outfall 3						
Storage Properties	Design	Actual	Compliant Yes No	Not Applicable	Equipment Used	
Normal Water Elevation (Wet Ponds)	844.00	843.63	X		Trimble Total Station & GPS
