Village of Menomonee Falls
 W156N8480 Pilgrim Rd
 Menomonee Falls WI 53051
 (262) 532-4200

**Stormwater Management Facilities
 Operation and Inspection Report
 Porous Pavement**

ALPS Pharmacy
 W133N5138 Campbell Dr.
 Menomonee Falls, WI

Location of Device: Southwest parking area

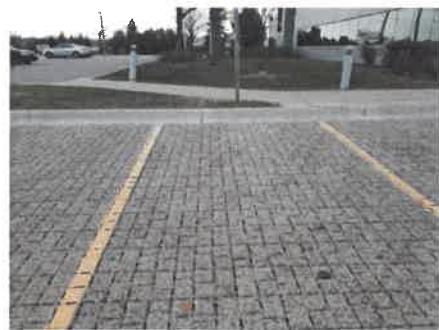
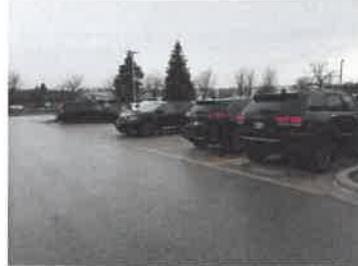
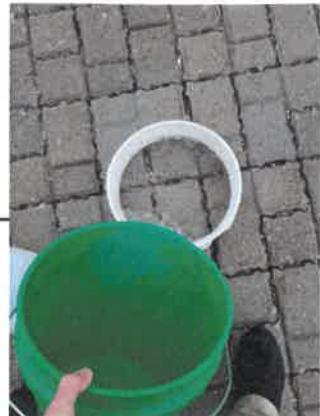
Porous pavement areas drain into existing storm sewer system in Campbell Drive.

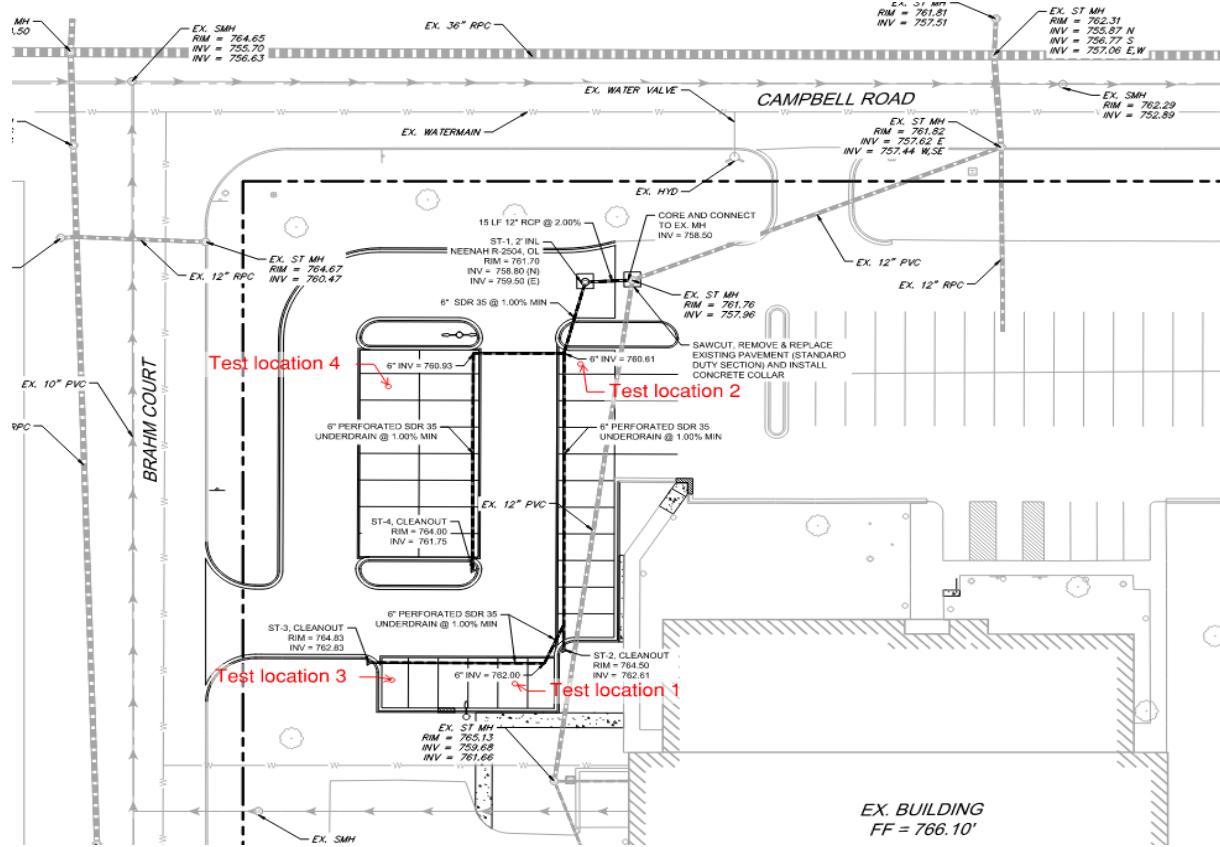
Location of Tests:

ASTM C 1701 Infiltration Rate of Pervious Concrete

Test #	1 Gallon Infiltration Time (seconds)	Infiltration rate	5 Gallon Infiltration Time (seconds)	Infiltration rate
1	16.0	459 in/hr	33.0	1,113 in/hr
2	17.0	432 in/hr	28.0	1,312 in/hr
3	18.0	408 in/hr	30.0	1,225 in/hr
4	20.0	367 in/hr	33.0	1,113 in/hr

Average 1 gallon infiltration rate 416 in/hr

Average 5 gallon infiltration rate 1,191 in/hr
