**Stormwater Management Facilities  
Operation and Inspection Report  
Porous Pavement**

ALPS Pharmacy  
W133N5138 Campbell Dr.  
Menomonee Falls, WI

Location of Device: Southwest parking area

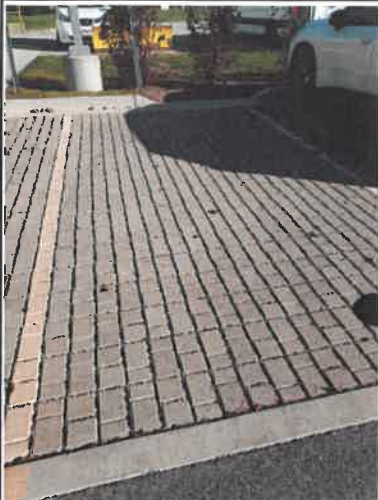
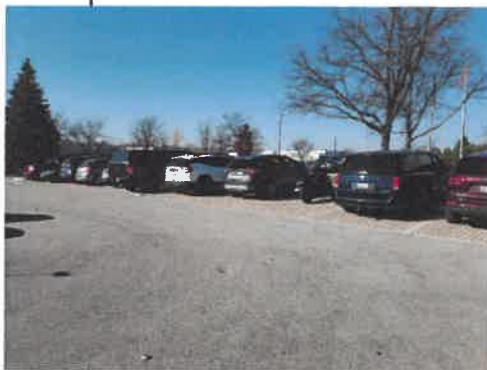
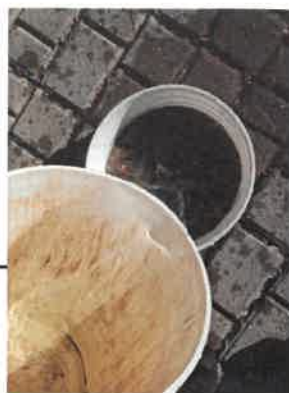
Porous pavement areas drain into existing storm sewer system in Campbell Drive.

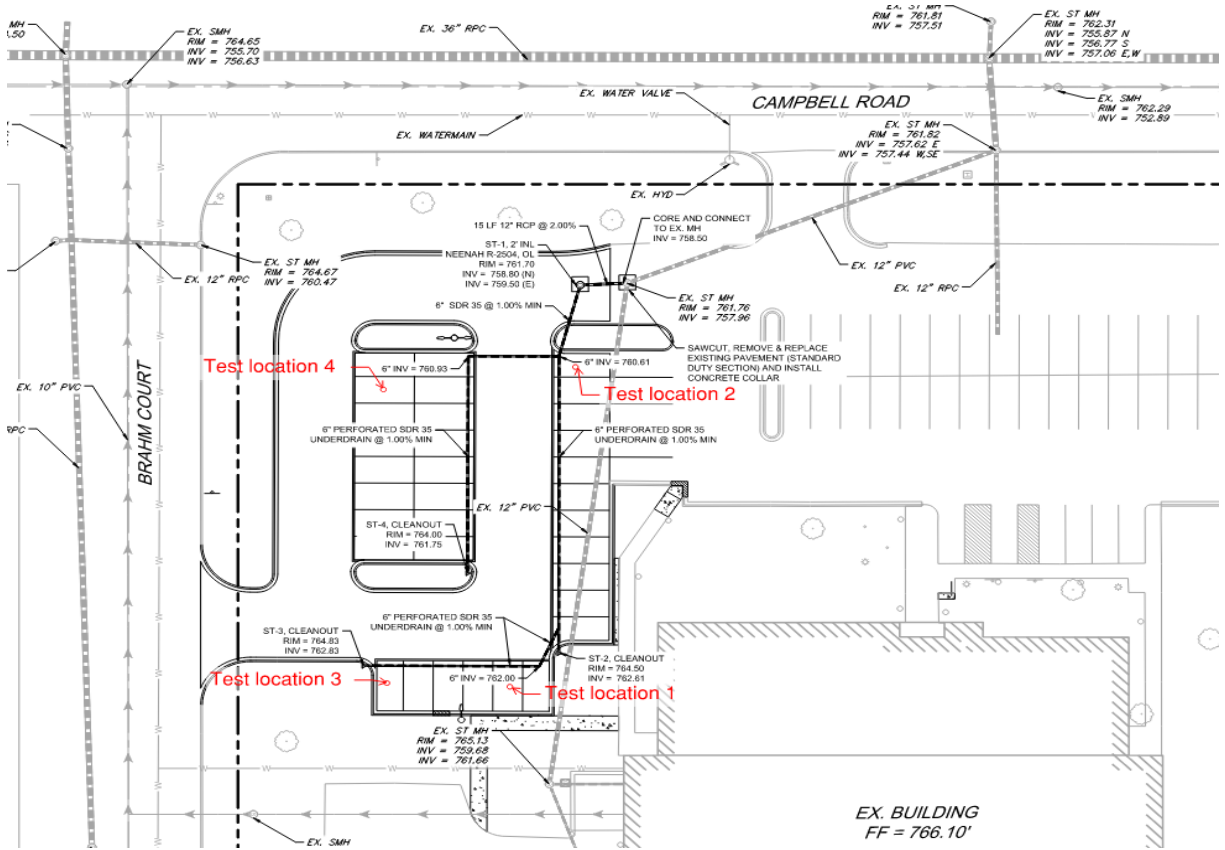
### Location of Tests:

| Test # | 1 Gallon Infiltration Time (seconds) | Infiltration rate | 5 Gallon Infiltration Time (seconds) | Infiltration rate |
| 1 | 14.0 | 524 in/hr | 41.0 | 896 in/hr |
| 2 | 13.0 | 565 in/hr | 38.0 | 967 in/hr |
| 3 | 17.0 | 432 in/hr | 36.0 | 1,021 in/hr |
| 4 | 18.0 | 408 in/hr | 39.0 | 942 in/hr |

| <b>Average 1 gallon infiltration rate</b> | <b>482 in/hr</b> |

| <b>Average 5 gallon infiltration rate</b> | <b>956 in/hr</b> |
