RE: Good Will Facility  
Storm Water Pond Inspection

STORMWATER MANAGEMENT FACILITIES  
OPERATION AND INSPECTION REPORT

Storm Water Basin  
Existing Conditions

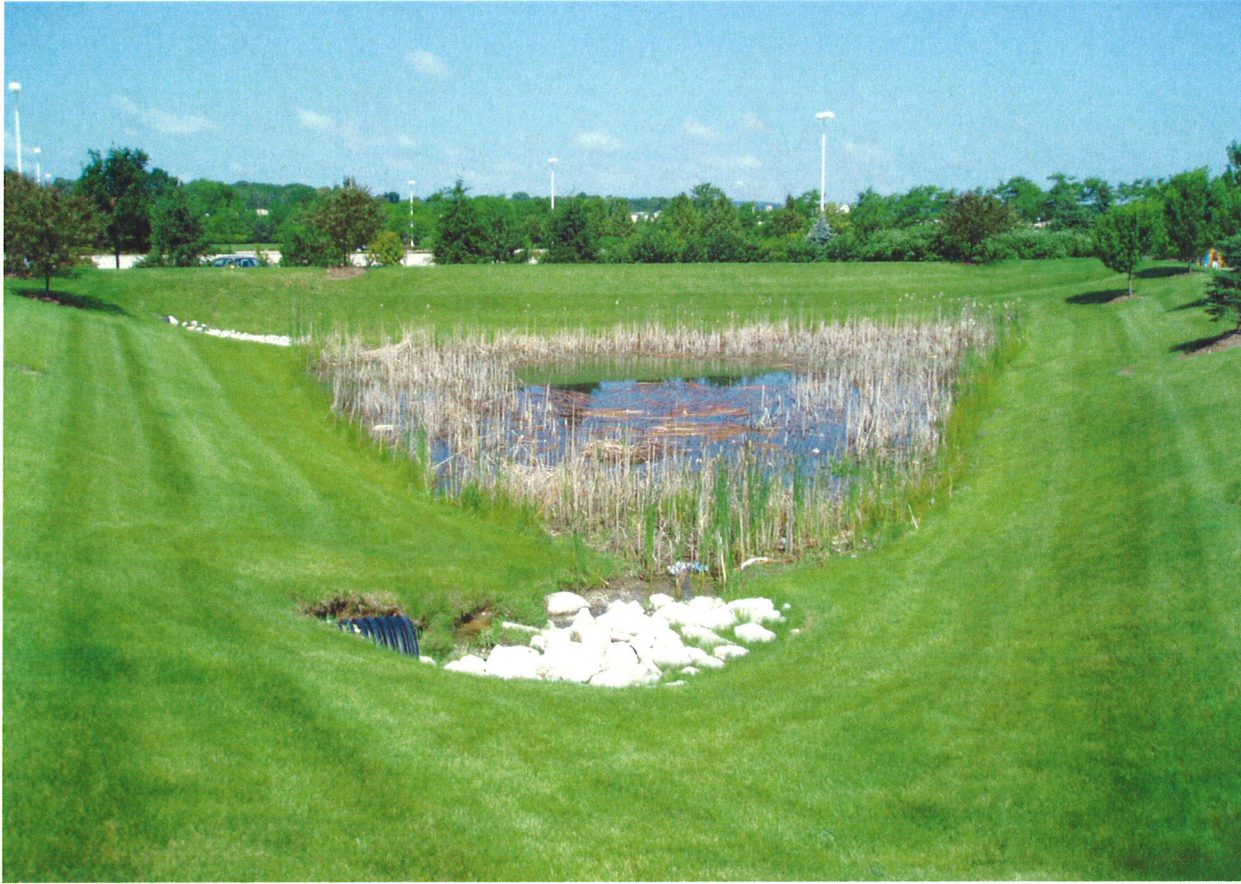
Pond Overview

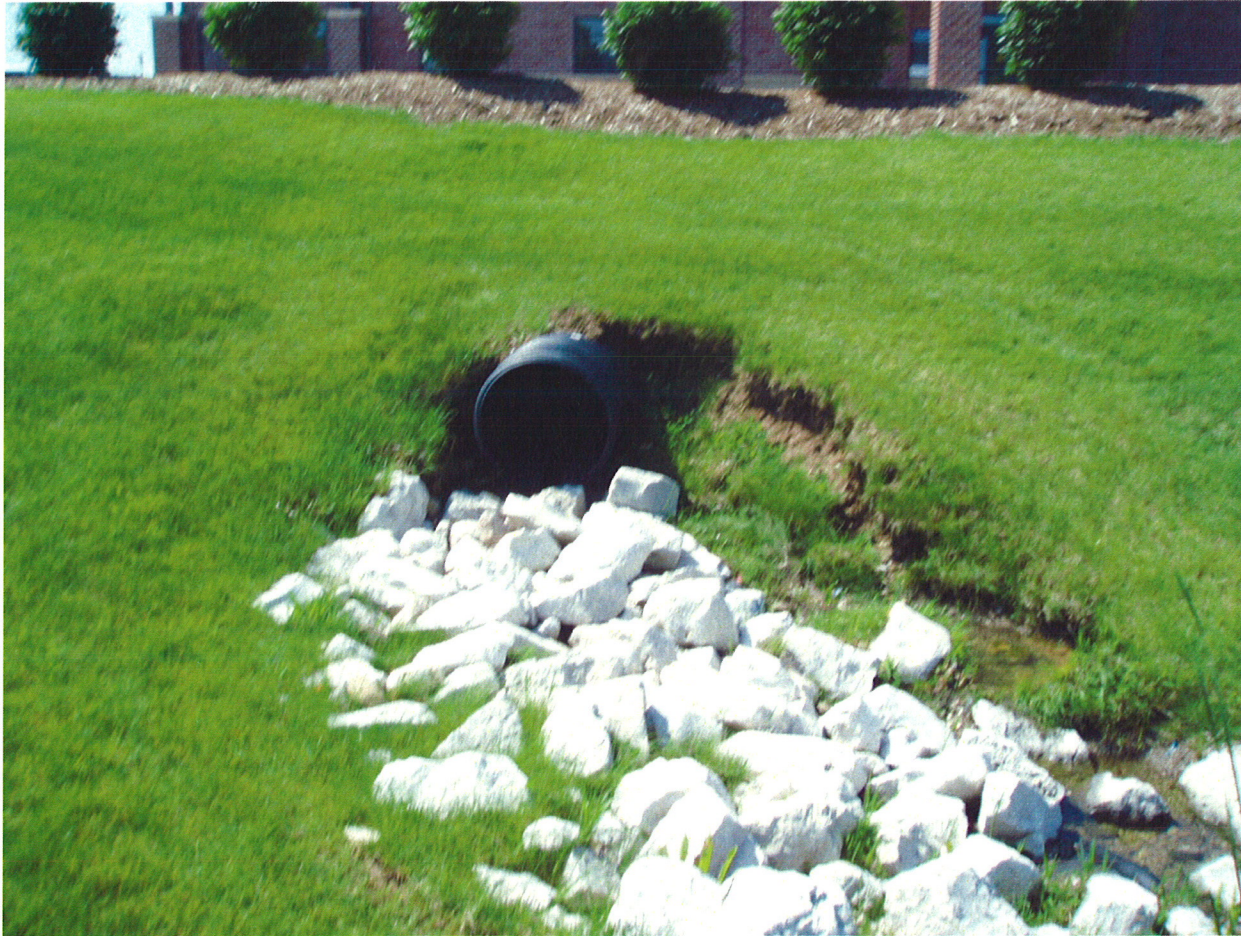
| Compliance Verification | Design | Actual | Compliant<br>Yes No | | Comments | |
|---|---|---|---|--|---|---|
| Animal burrows or slope erosion | | | X | | EROSION AT SE INLET SEE PHOTO | |

Erosion around southeast inlet pipe.

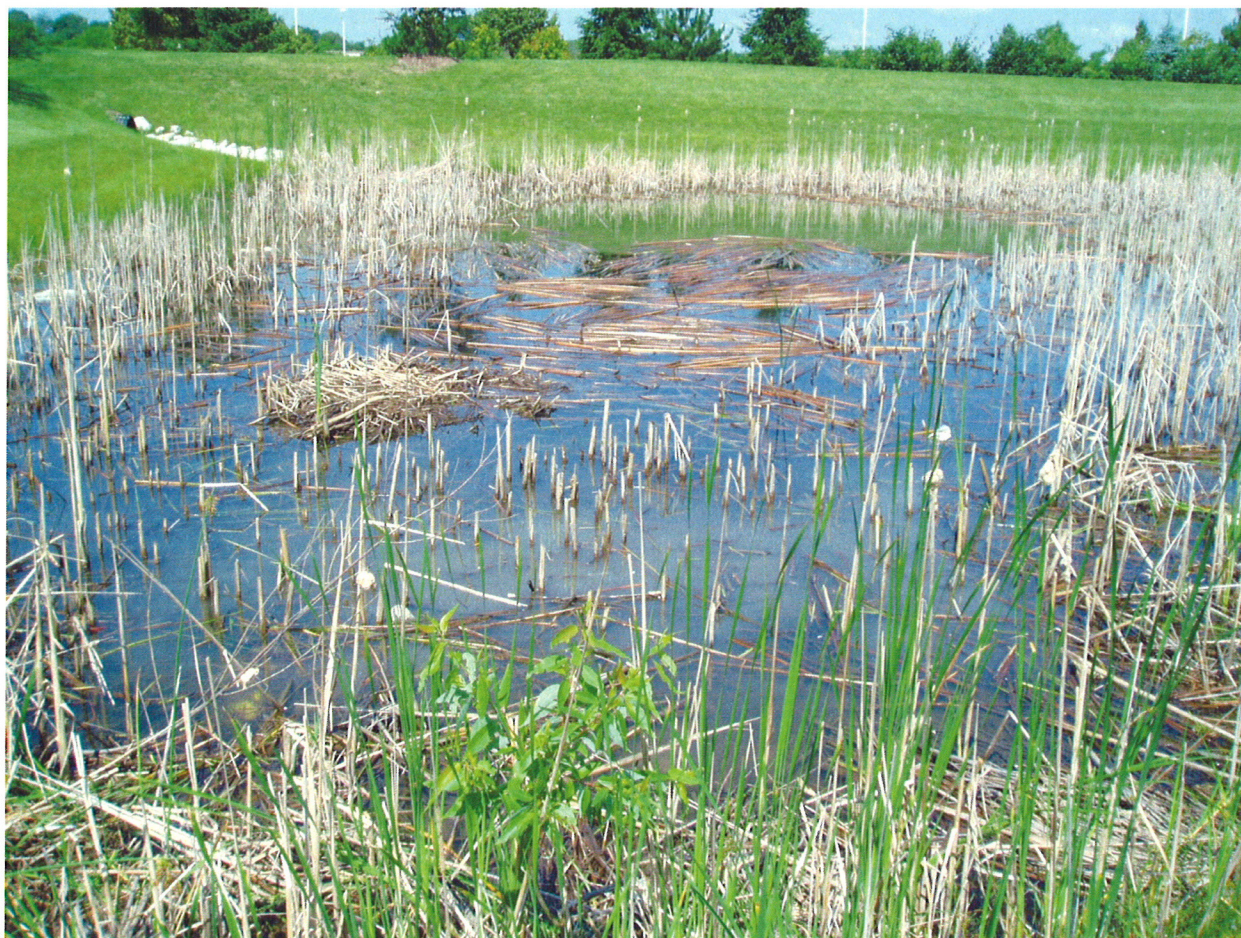
| Compliance Verification | Design | Actual | Compliant<br>Yes No | | Comments | |
|---|---|---|---|--|---|---|
| Unauthorized plantings, trees, or woody vegetation | | | X | | POND CONTAINS LARGE-2 CEE AMOUNT OF VEGETATION PHOTO | |

Vegetation

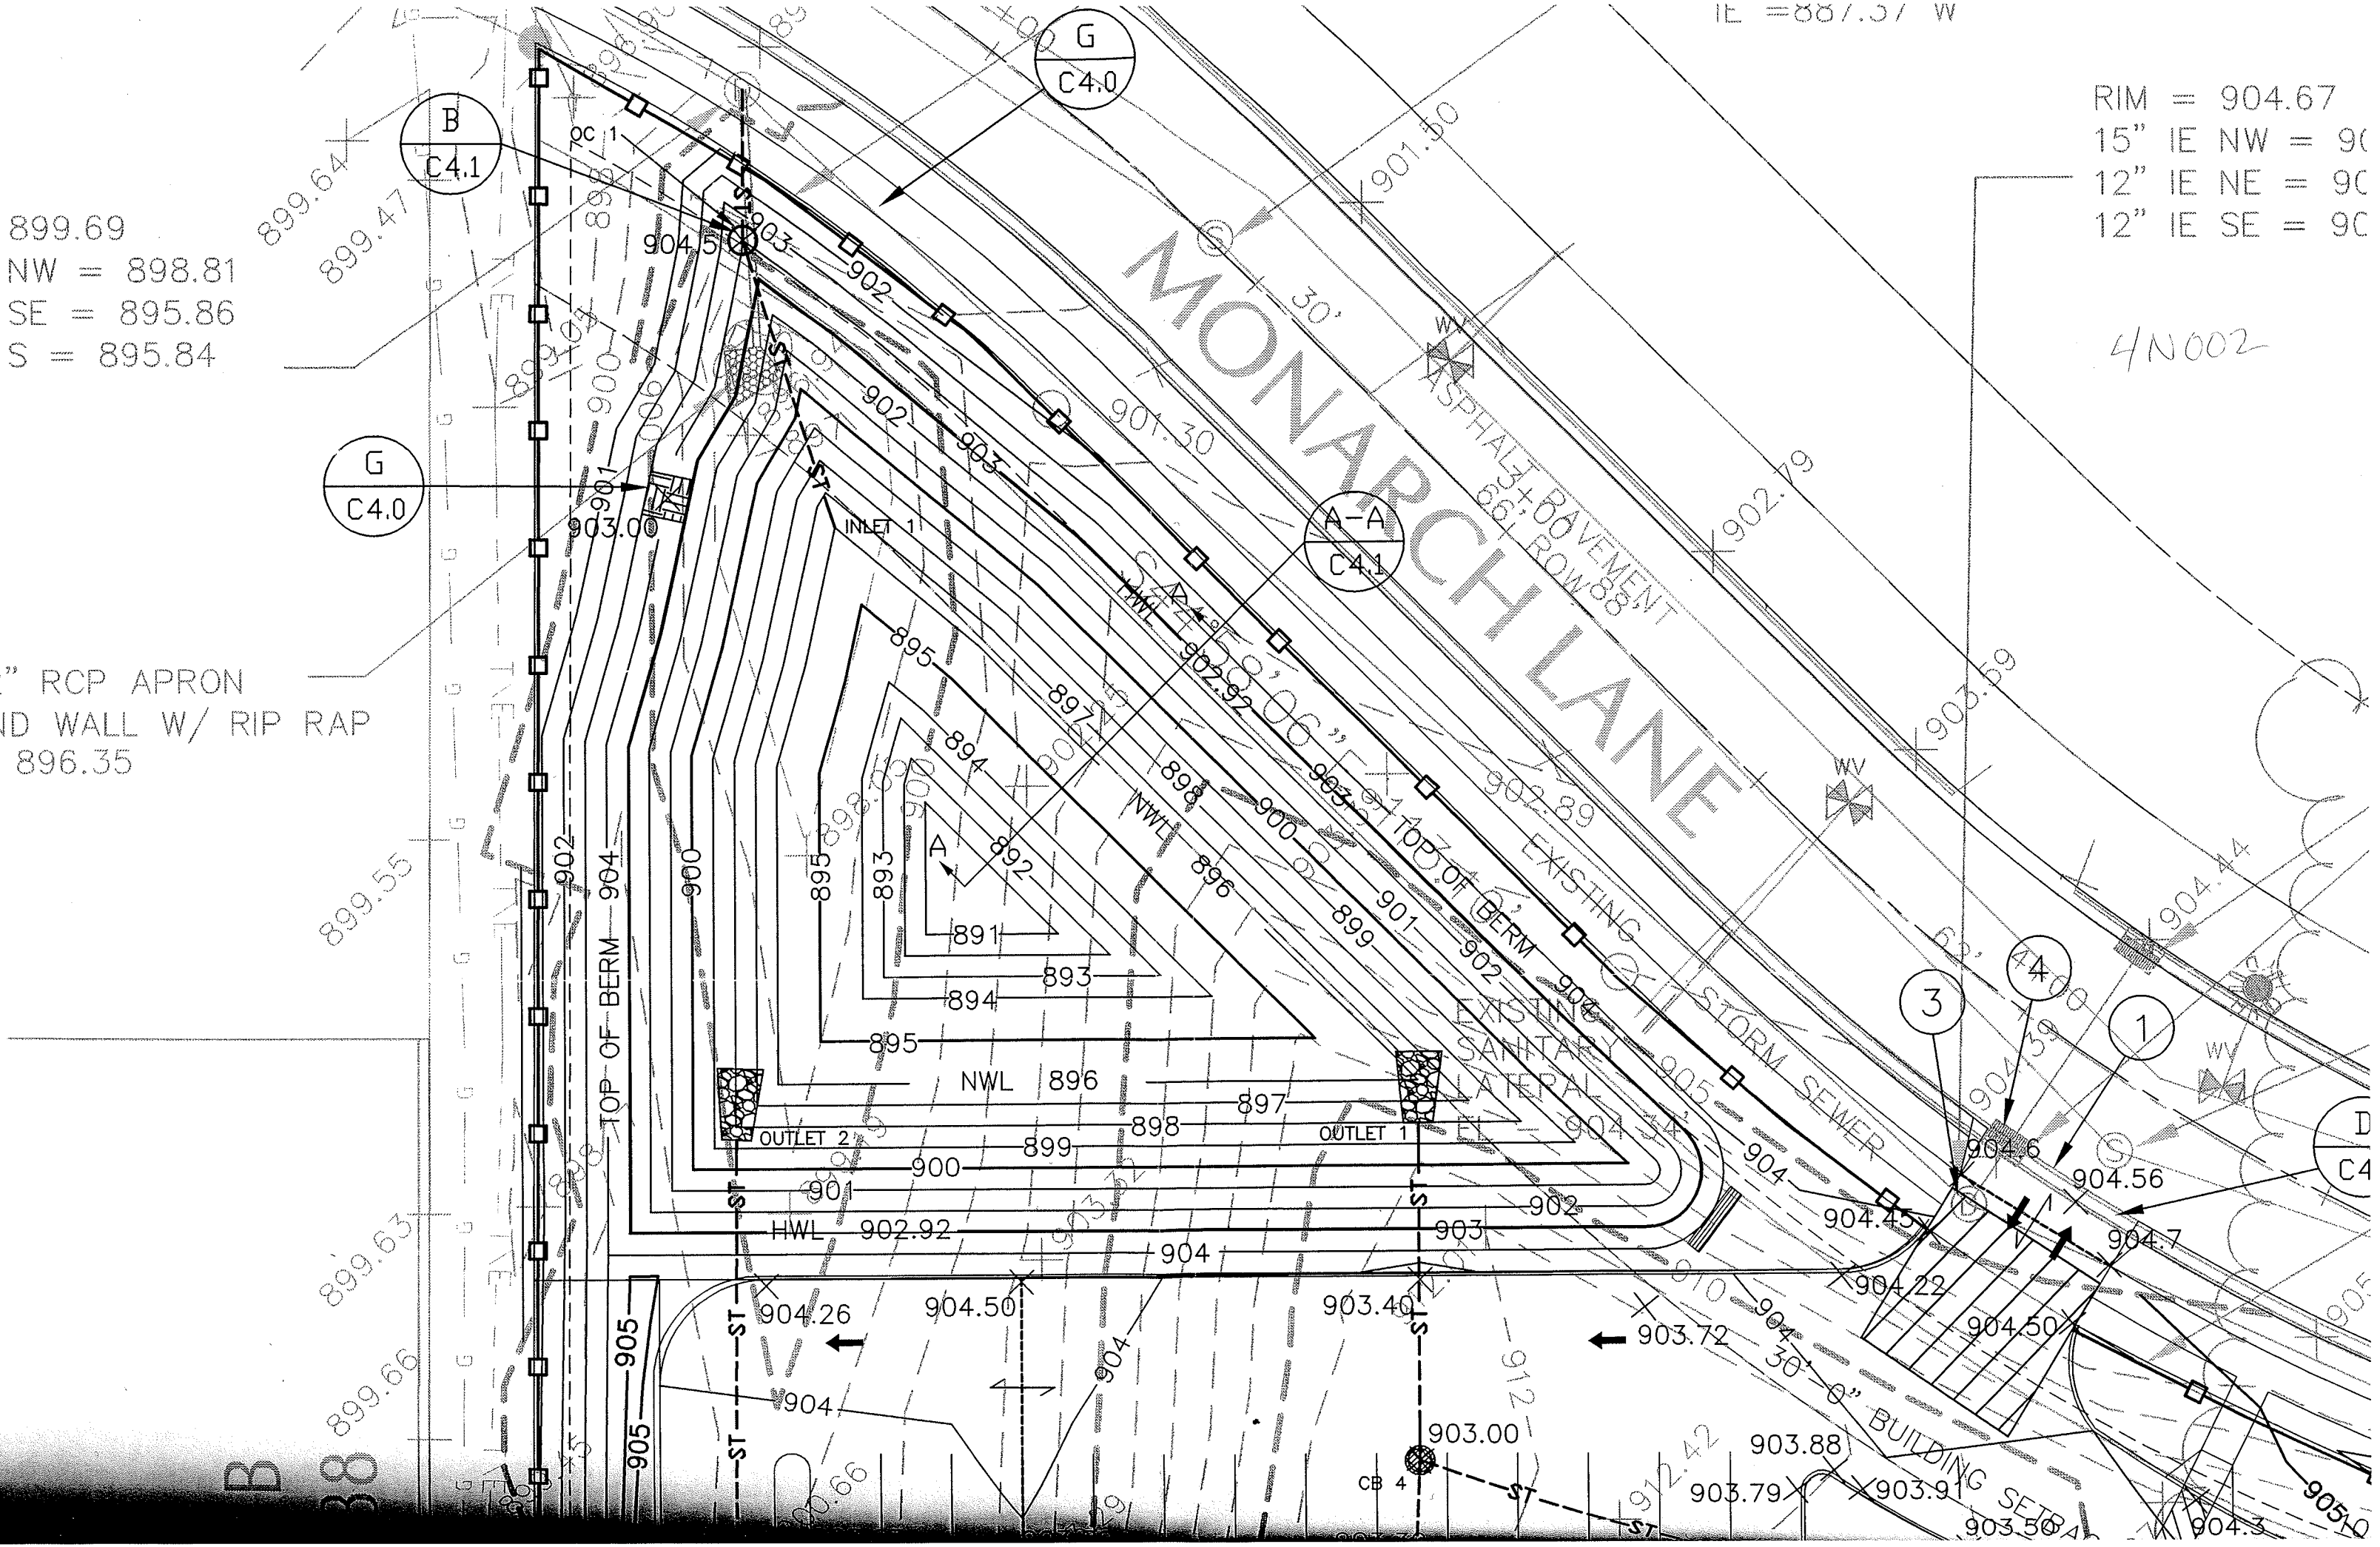
FIGURE 1

MANHOLE RIM=904.08 (904.50)  
N. 24" HDPE I.E.=895.93 (896.00)  
S. 24" HDPE I.E.=896.00 (896.00)

OUTLET  
24" HDPE  
I.E.=896.02 (896.00)

Contours shown represent existing  
conditions June 24, 2010

Water elev June 24, 2010 - 896.3
