# STORMWATER MANAGEMENT FACILITIES OPERATION AND INSPECTION REPORT

Quarter Section SE 4 Name of Business/Subdivision Christman Crossing  
Property Tax ID Number MNFV0016280 Address of Property W177 N8848 St. Thomas Dr.  
Menomonee Falls, WI

#### SITE PHOTOGRAPHS

Christman Crossing Subdivision  
Dry Pond  
Menomonee Falls, WI

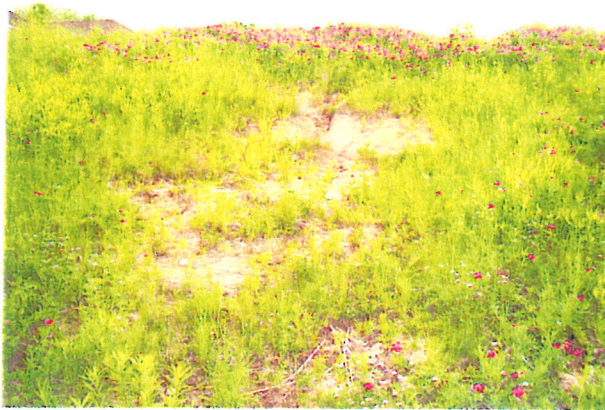
1. Photograph shows erosion observed along the northwestern portion of the pond. Lesser erosion observed along south west slope of pond and in east section of section. Minor erosion or vegetation overgrowth in area of weir.

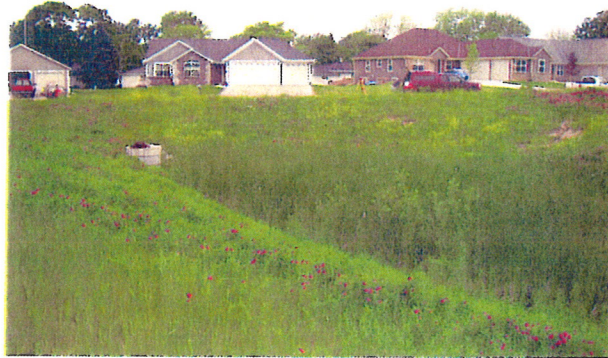
2. Photograph taken from southeast corner of top of pond, facing to the west. Photo shows outlet structure on left side of photo and erosion on right side of photo. Cattails in the bottom of pond.

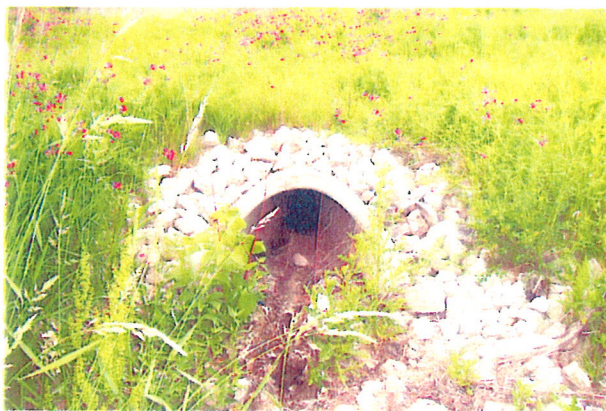
3. Photograph shows inlet structure observed along the central portion of the western slope of the pond. Some soil deposits and debris at end of structure.
