**STORMWATER MANAGEMENT FACILITIES
 OPERATION AND INSPECTION REPORT
 POUROUS PAVEMENT**

Quarter Section SW 1/4 Sec 26 Name of Business/Subdivision Pilgrim Spring Marketplace
 Property Tax ID Number 0103-983 Address of Property N56 W15560 Silver Spring Drive

Location of Device North Parking Area in front of Building B
 Year Constructed 2008 Last Certification Q3/2009

PILGRIM SPRING MARKETPLACE
POROUS PAVEMENT INSPECTION
JULY 15, 2010 AT 8:30 AM

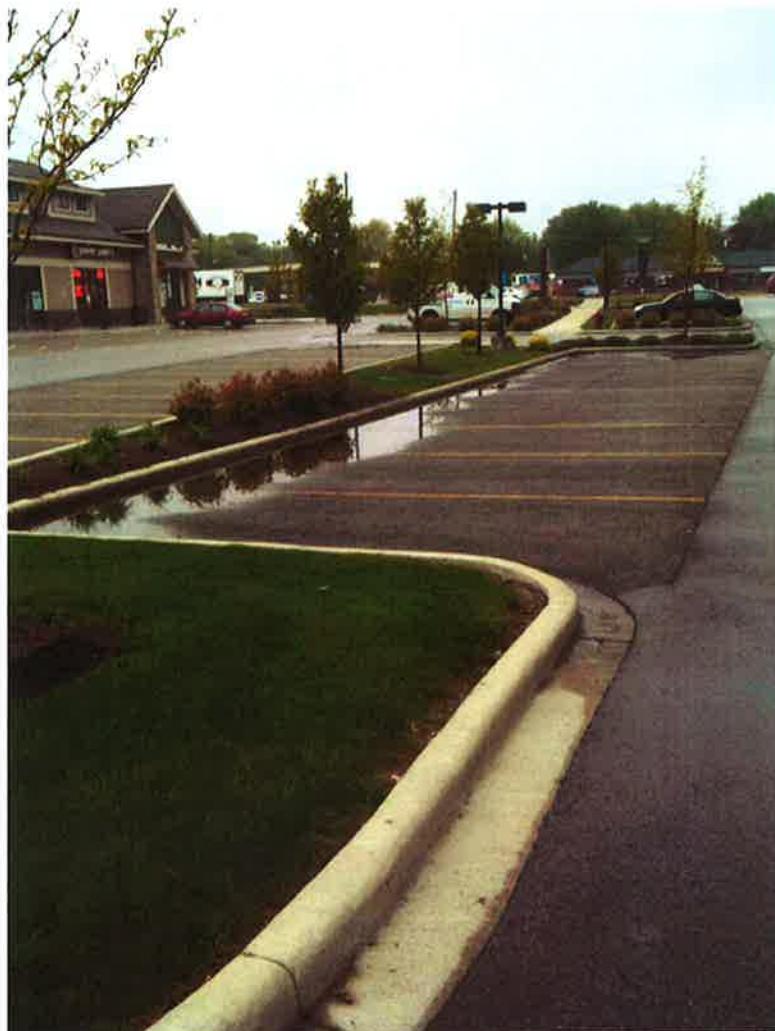
Taken standing from northeast corner of north porous pavement parking area looking west prior to cleaning.

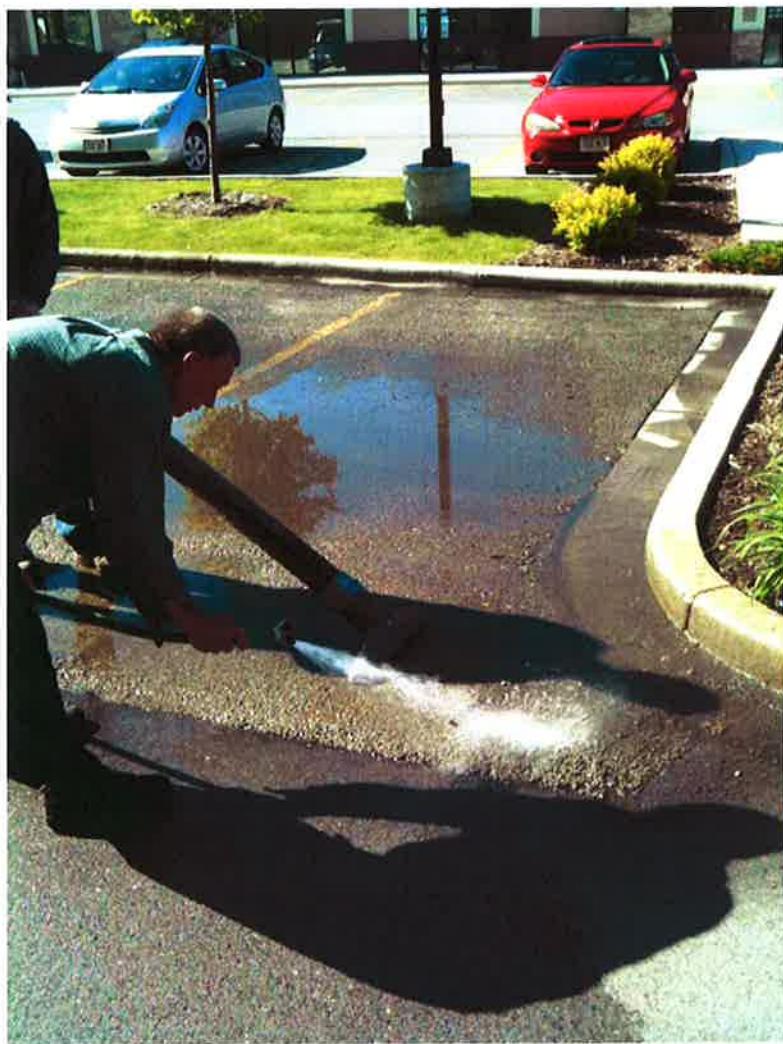
Photo of cleaning effort to remove surface debris and improve the drain down times for the northeast porous pavement parking area.

Corrective Action Needed	Due Date
Continue investigating best cleaning methods to reduce drain down times for convenience of retail tenants.	October 2010

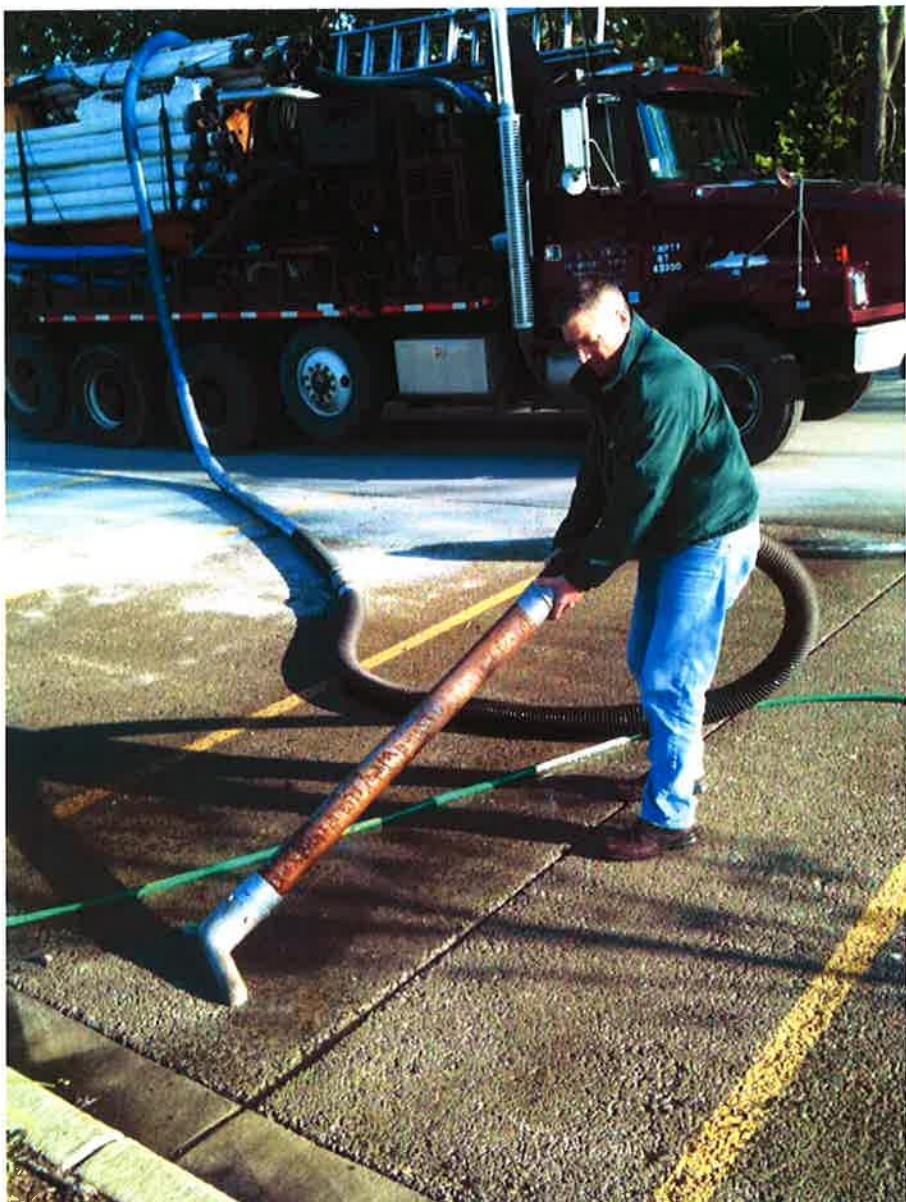
Cleaning included flushing the debris to the surface with a garden hose and removing the water and debris from the surface with an industrial vacuum truck.
