**STORMWATER MANAGEMENT FACILITIES
 OPERATION AND INSPECTION REPORT
 POUROUS PAVEMENT**

Quarter Section SW 1/4 Sec 26 Name of Business/Subdivision Pilgrim Spring Marketplace
 Property Tax ID Number 0103-983 Address of Property N56 W15560 Silver Spring Drive

PILGRIM SPRING MARKETPLACE
POROUS PAVEMENT INSPECTION
JULY 15, 2010 AT 8:30 AM

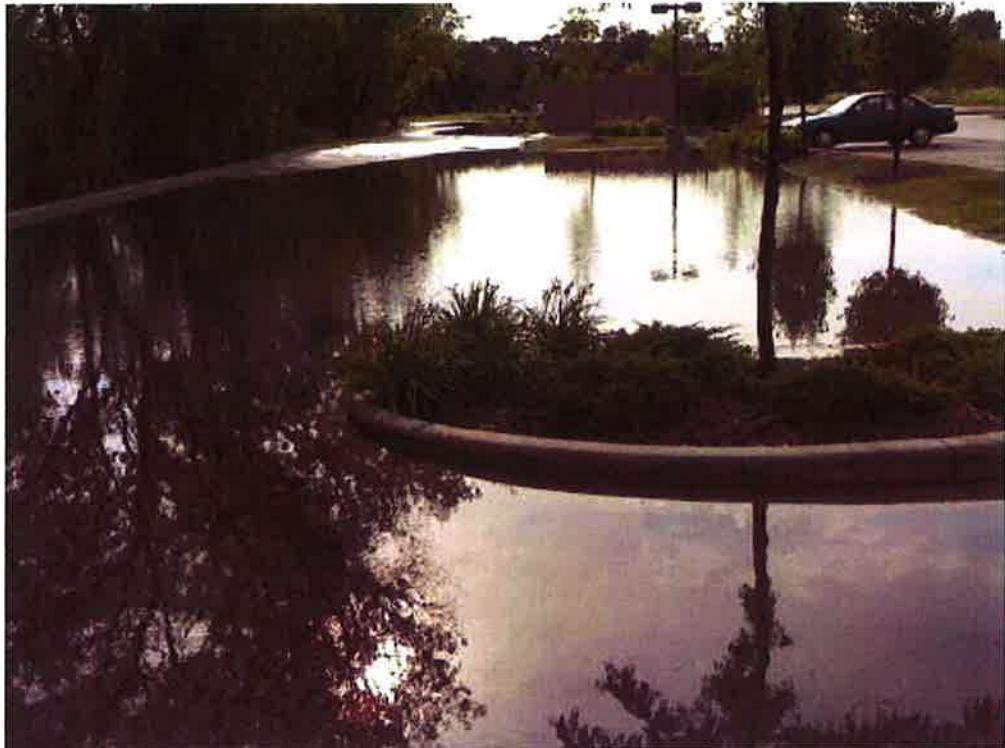
Standing on the northwest corner of the parking lot looking east toward outfall structure. Ponding is limited to the northeast porous pavement parking area.

Corrective Action Needed	Due Date
Continue investigating best cleaning methods to reduce drain down times for convenience of retail tenants.	October 2010
Continue efforts to verify porous concrete mix quality.	October 2010

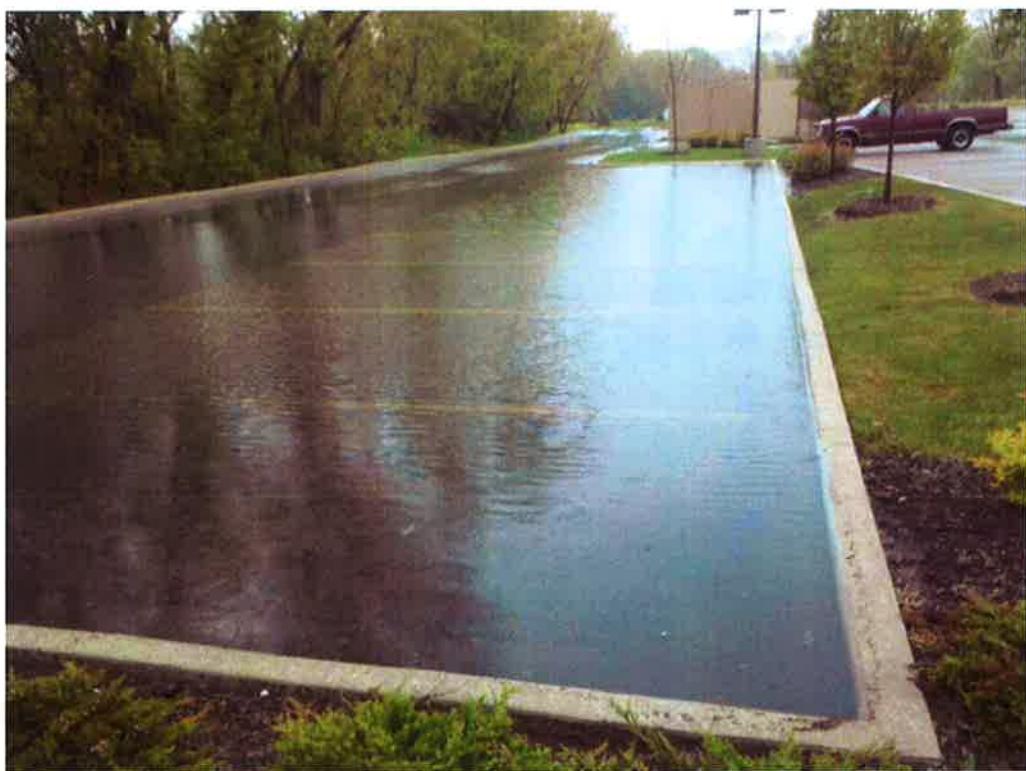
Taken standing on northeast porous pavement parking area looking east.

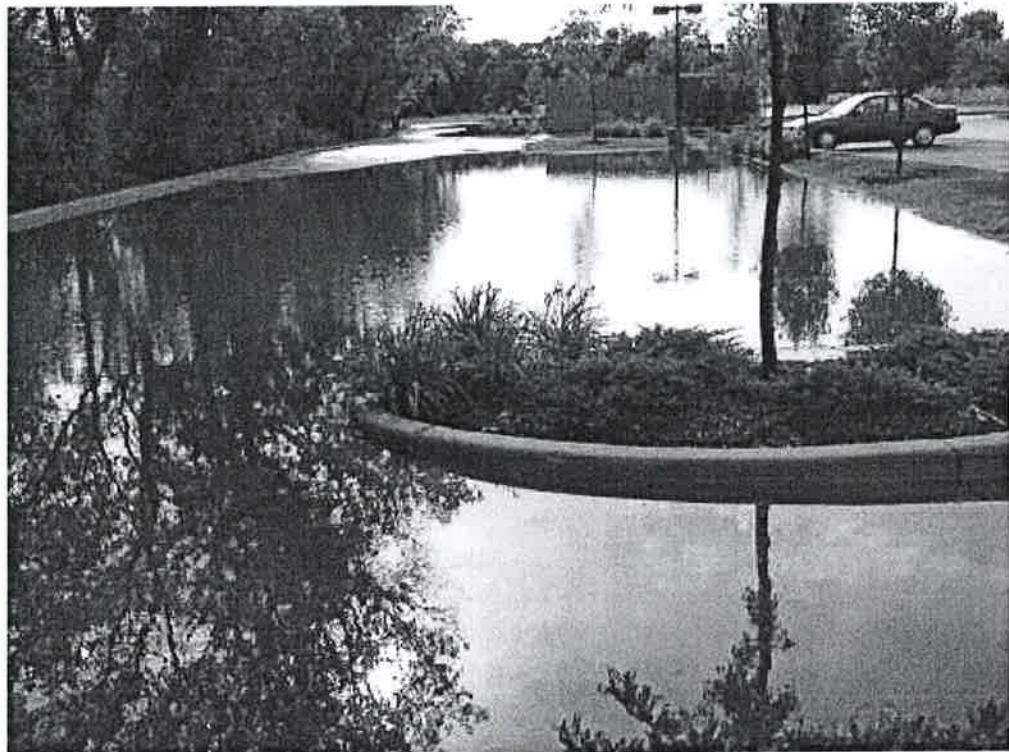
Standing on the northwest corner of the parking lot looking east toward outfall structure. Ponding is limited to the northeast porous pavement parking area.

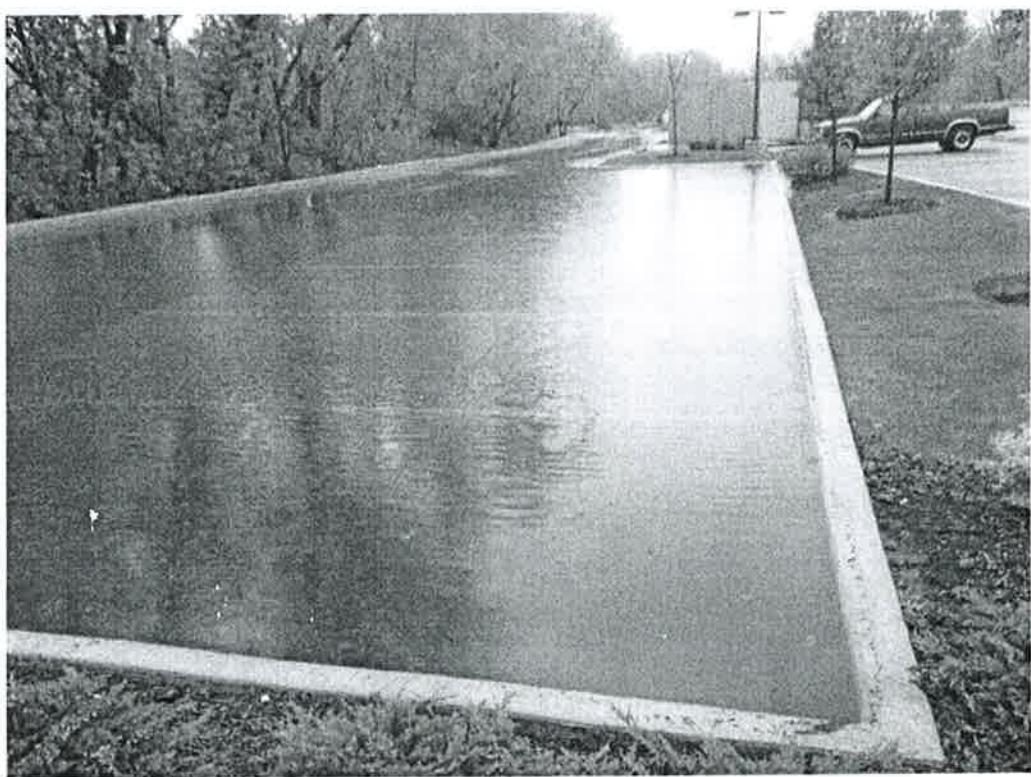
Taken standing on northeast porous pavement parking area looking east.
