STORMWATER MANAGEMENT FACILITIES OPERATION AND INSPECTION REPORT

SE 1/4 Sec 13 Name of Business/Subdivision 401 Woodland Prime
MNF005299 Address of Property W126 N7449 Flint Drive
2014 Menomonee Falls, WI 53051

| Pond ID: | SWP13s015 | | |

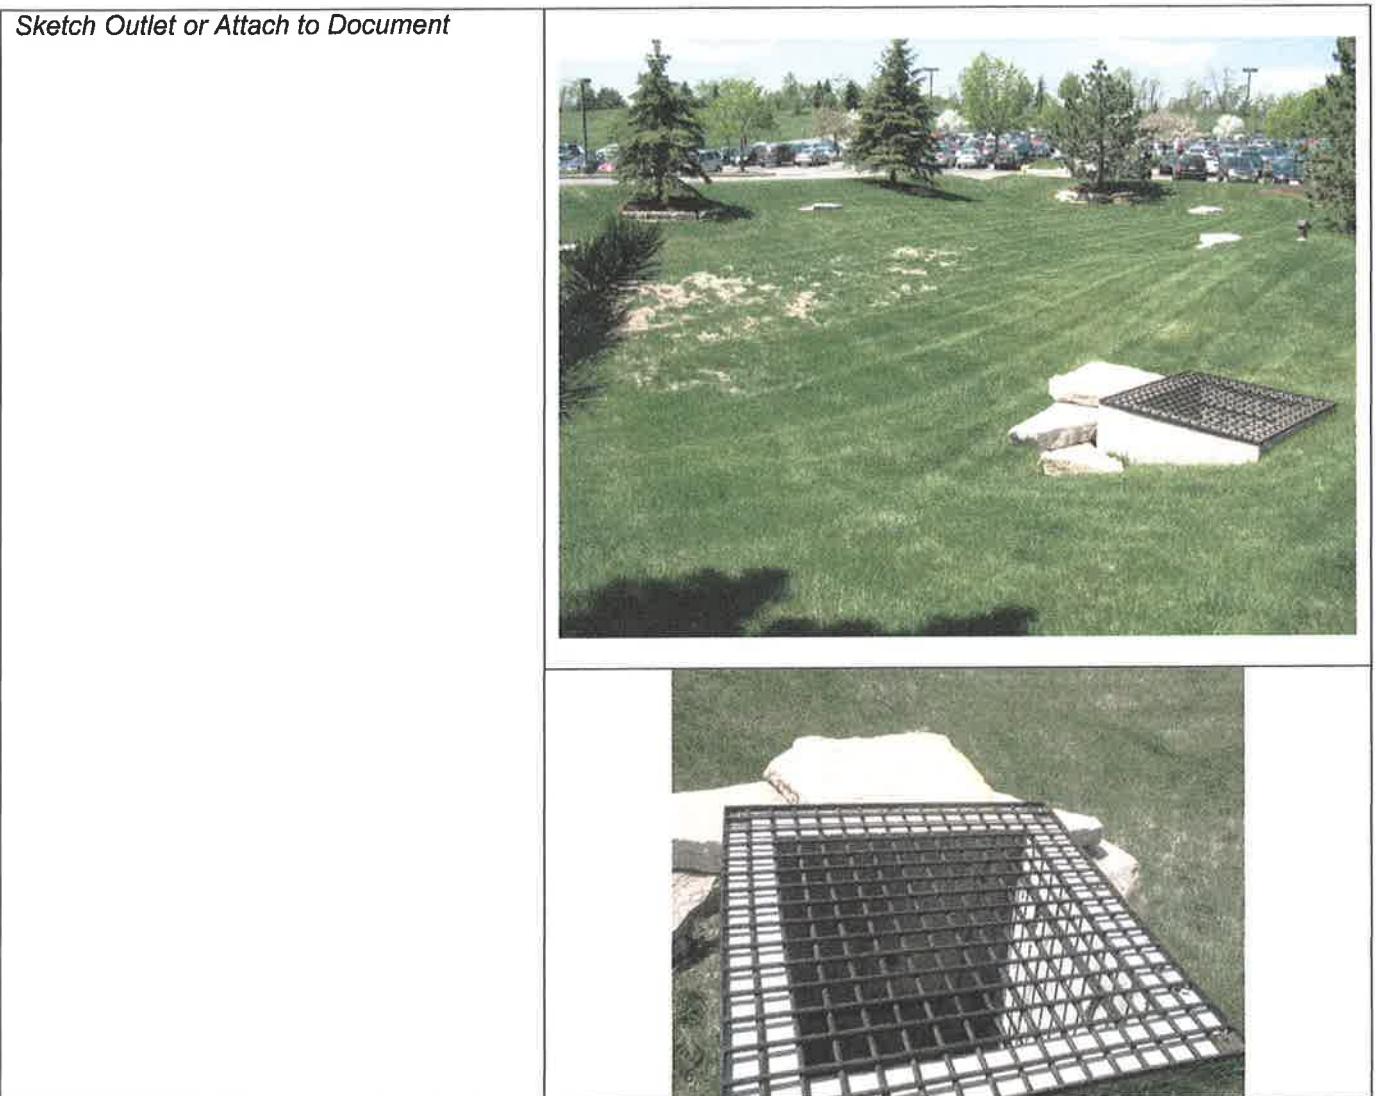
Sketch Outlet or Attach to Document

| Compliance Verification | Design | Actual | Compliant Yes | No | Comments (Condition of Structure) |
|---|---|---|---|---|---|
| Opening Diameter (inches) | 18 | 18 | <input checked="" type="checkbox"/> | <input type="checkbox"/> | Outlet Pipe Material Outlet pipe is located inside of concrete riser structure. Pipe is 18" Corrugated HDPE, and appears to be in good condition. |
| Opening Diameter (inches) | Not specified | 48"x 48" square | | | Riser Material Top opening of concrete riser |
| Opening Diameter (inches) | 3 | 3 | <input checked="" type="checkbox"/> | <input type="checkbox"/> | *The concrete is uneven on the inside of the structure. The surveyor measured the invert at 778.85. I measured down from the top of concrete at exactly 36", therefore 779.00 |

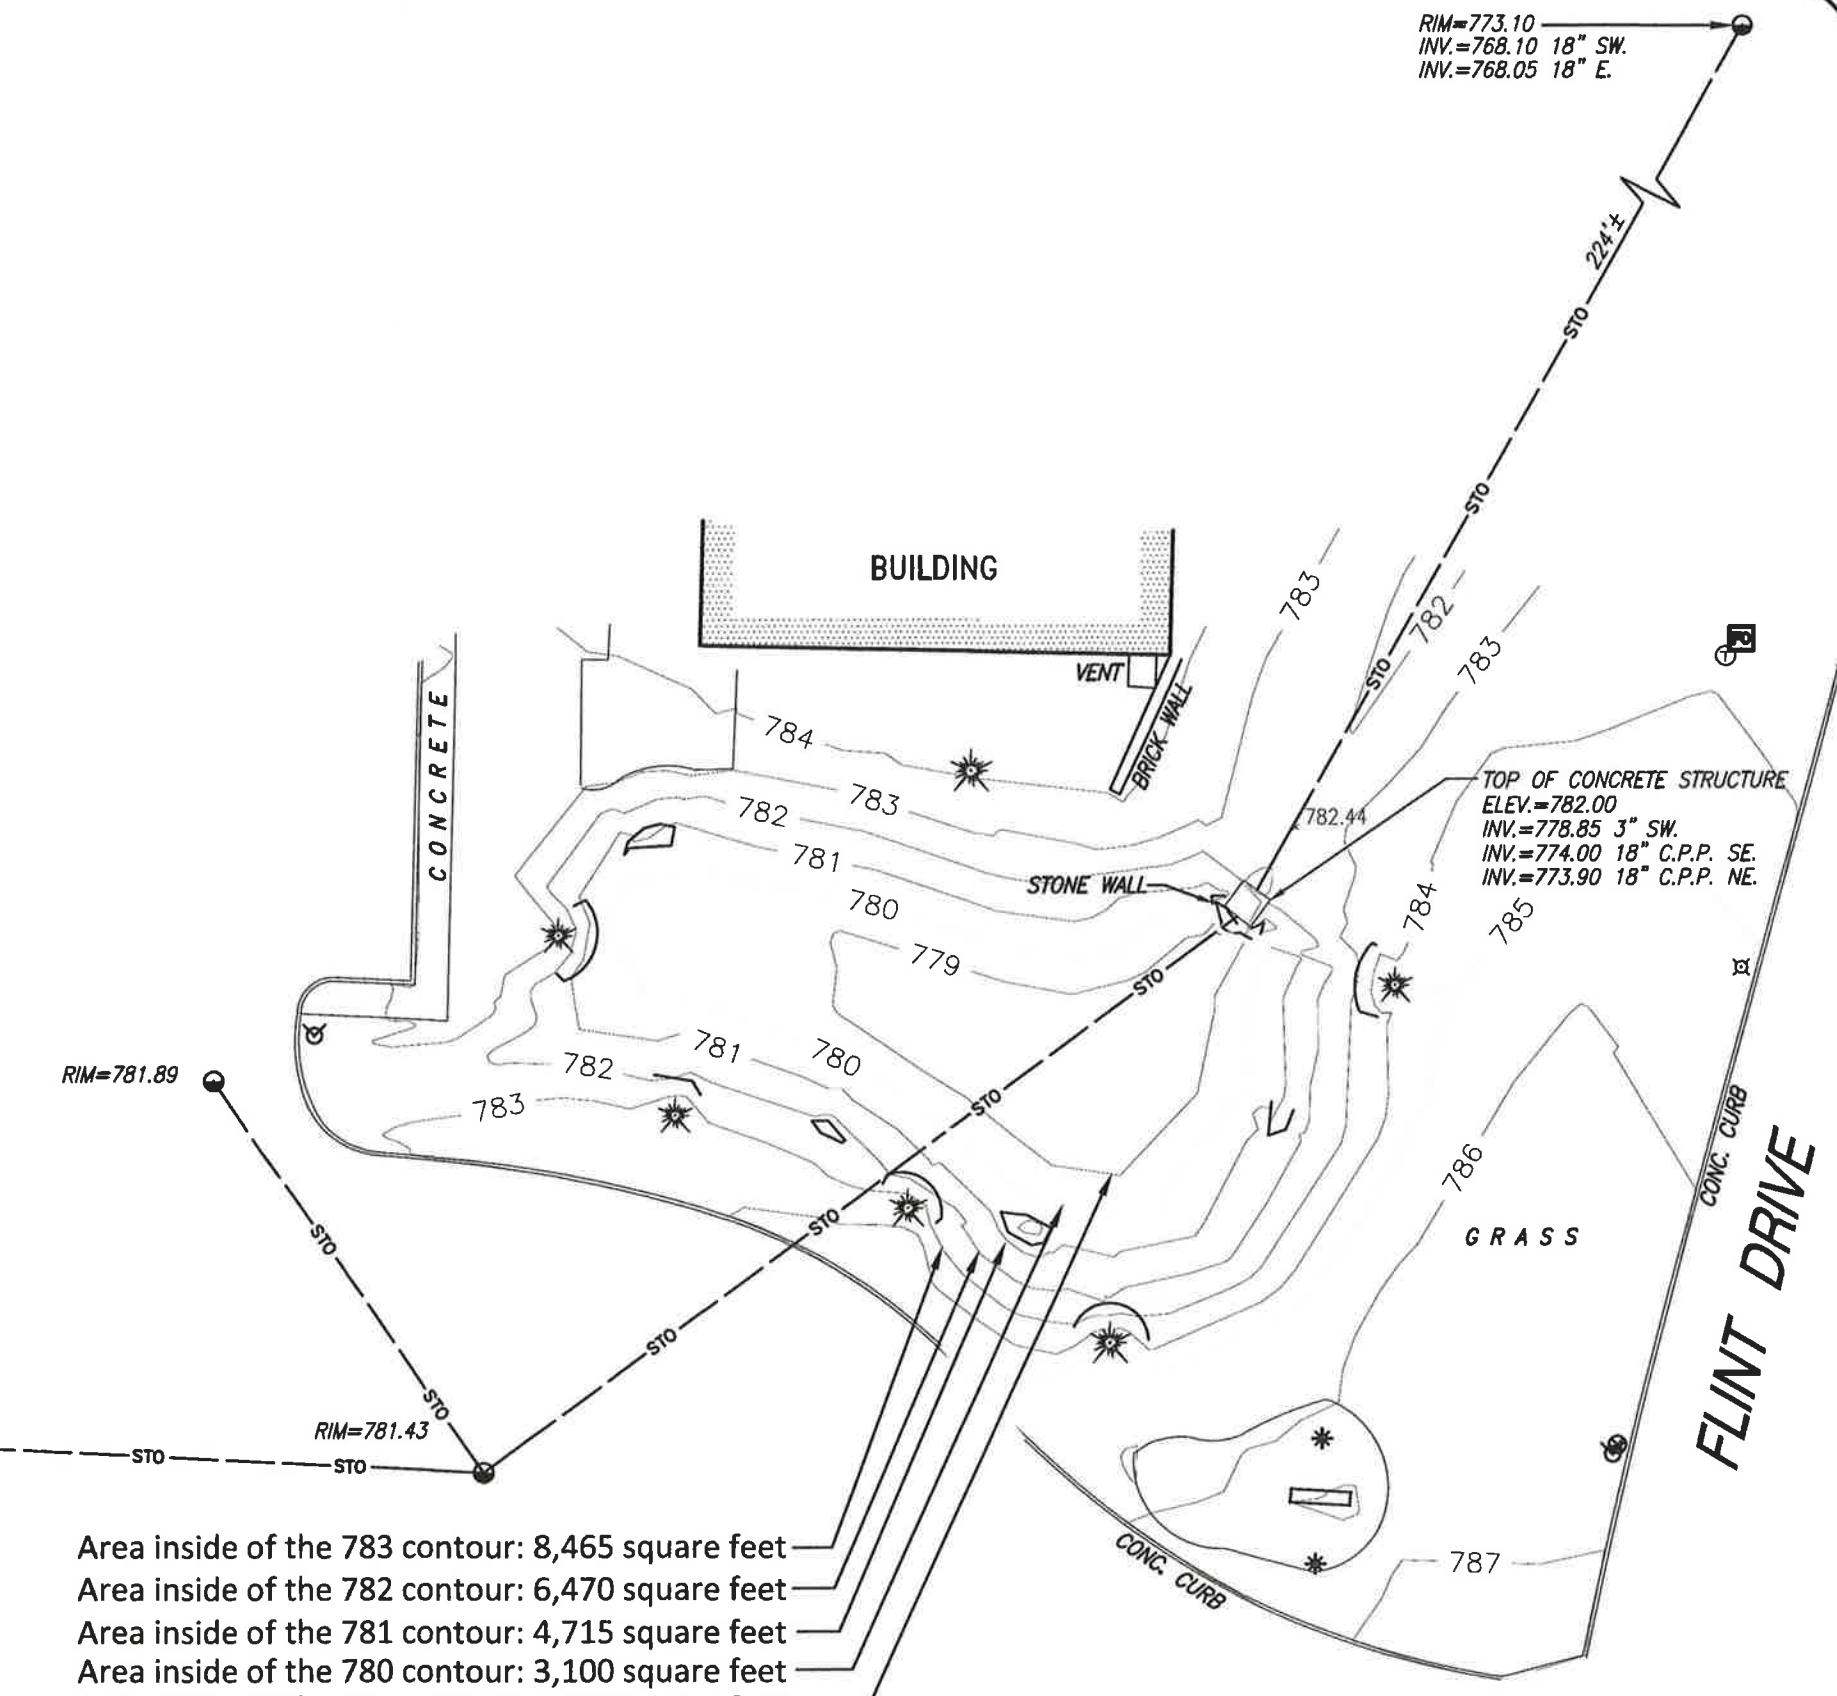
EXHIBIT

RIM=786.49

STO RIM=782.51

Area inside of the 783 contour: 8,465 square feet
 Area inside of the 782 contour: 6,470 square feet
 Area inside of the 781 contour: 4,715 square feet
 Area inside of the 780 contour: 3,100 square feet
 Area inside of the 779 contour: 1,425 square feet
