**STORMWATER MANAGEMENT FACILITIES
 OPERATION AND INSPECTION REPORT
 POUROUS PAVEMENT**

Quarter Section SW 1/4 Sec 26 Name of Business/Subdivision Shecterle Commercial Properties 6
 Property Tax ID Number 0103-983 Address of Property PO Box 1205
Brookfield, WI 53005

Location of Device North parking area in front of Building A & future Building B
 Year Constructed 2008 Last Certification Q3 2013

**Pilgrim Spring Market Place
POUROUS PAVEMENT – Photo Log**

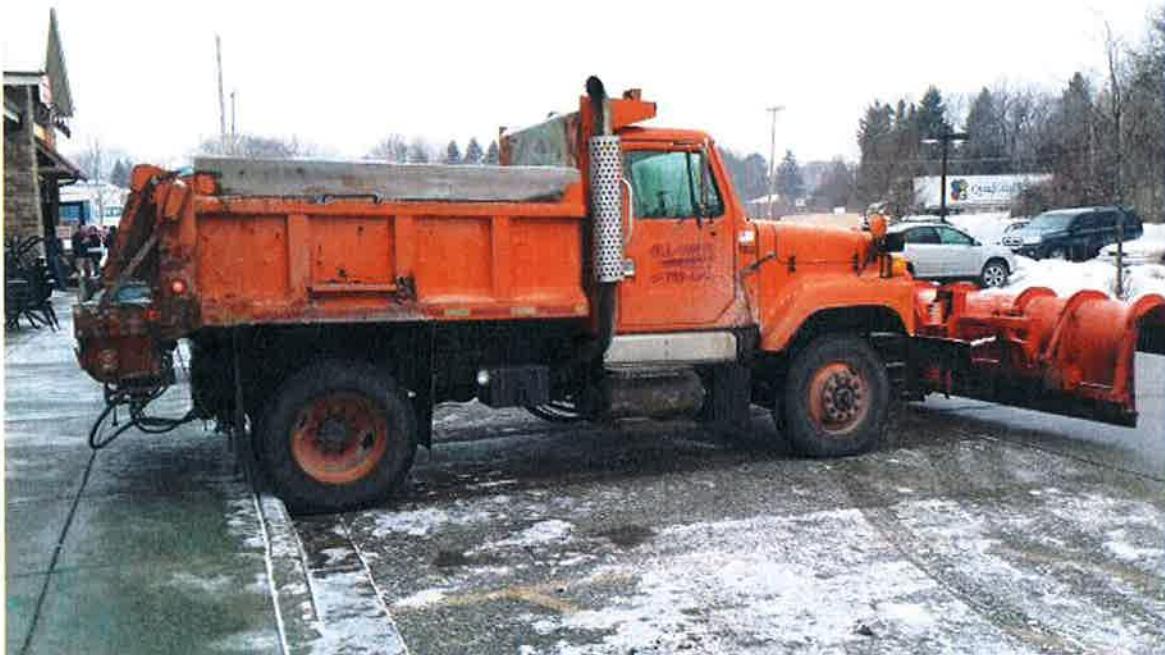
Photo #1: Snow removal equipment with salt only and plastic plow blade.

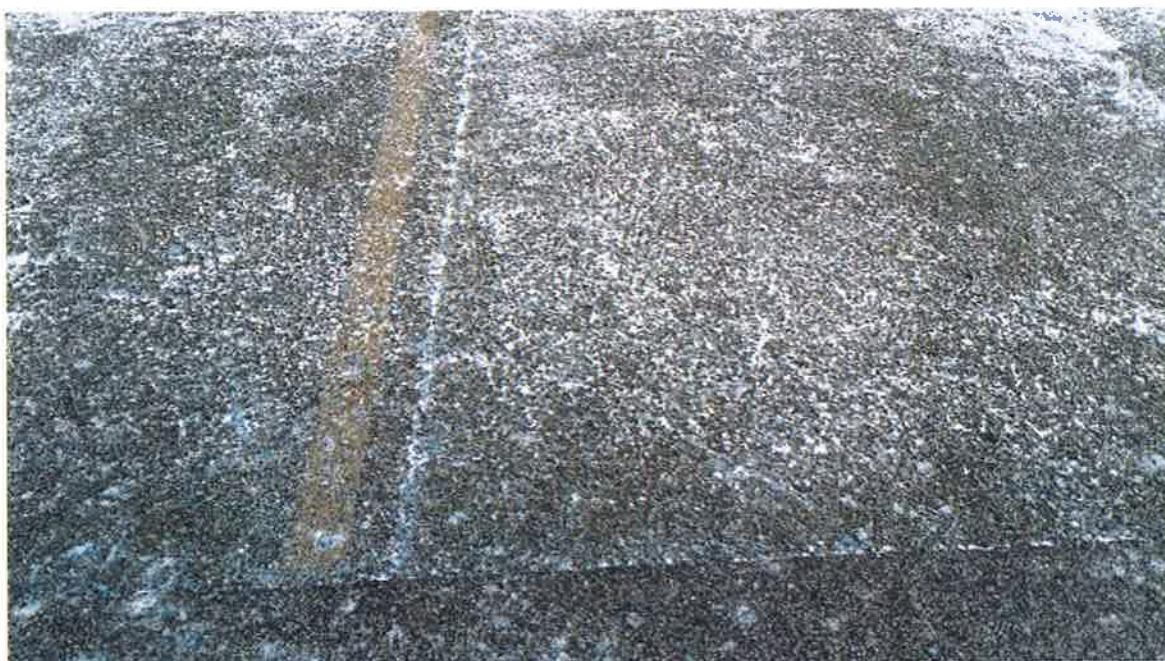
Photo #2: Porous pavement in north parking field of west building. No visible signs of wear from snow removal operations.

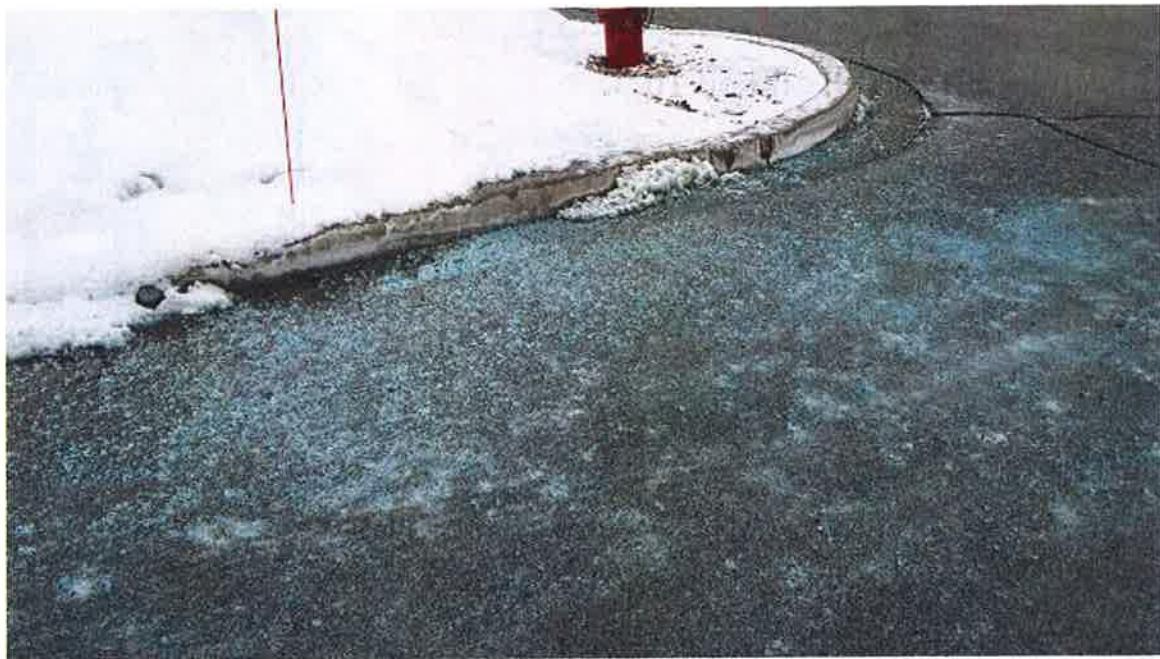
Photo #3: Salt accumulation at low areas in parking field.

Corrective Action Needed	Due Date
Sweep excess salt from pavement prior to major snow melt.	03/01/2014
Clean outfall end section of plant debris.	04/01/2014

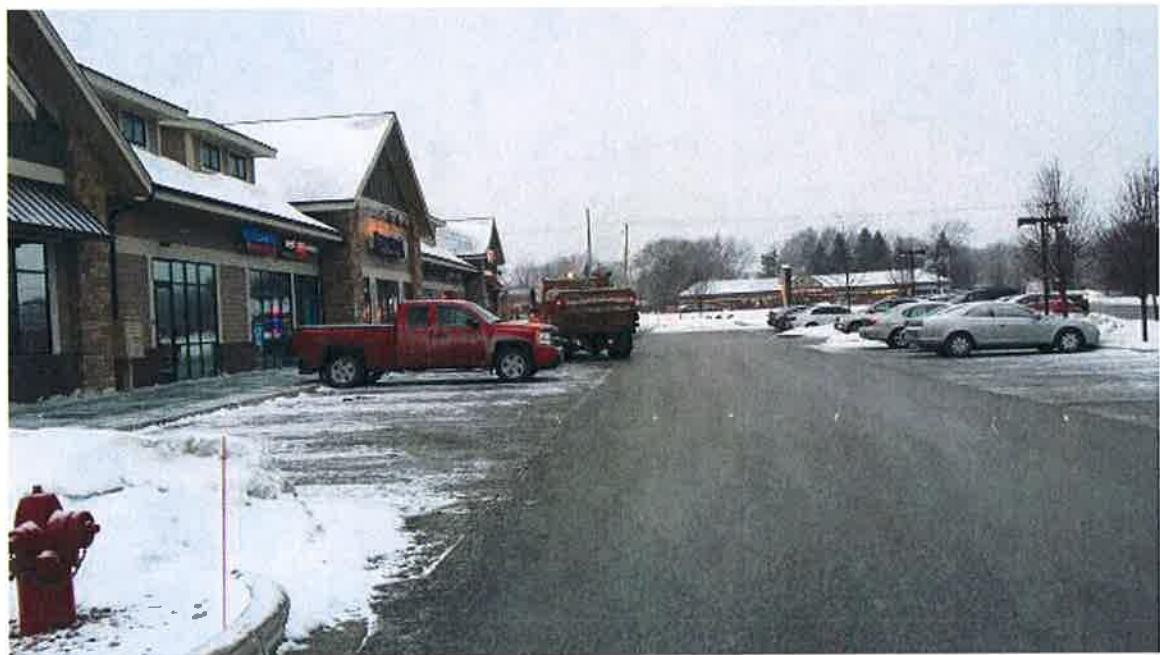
Photo #4: Results of snow removal and salting operations following a +1" snow event.
