STORMWATER MANAGEMENT FACILITIES OPERATION AND INSPECTION REPORT

Pond ID: SWP24N006

PROJECT:
**NORTHFIELD MANOR
 POND CERTIFICATION**
 VILLAGE OF MENOMONEE FALLS, WI

SHEET TITLE:
**SWP24N006
 POND OUTLET
 DETAIL**

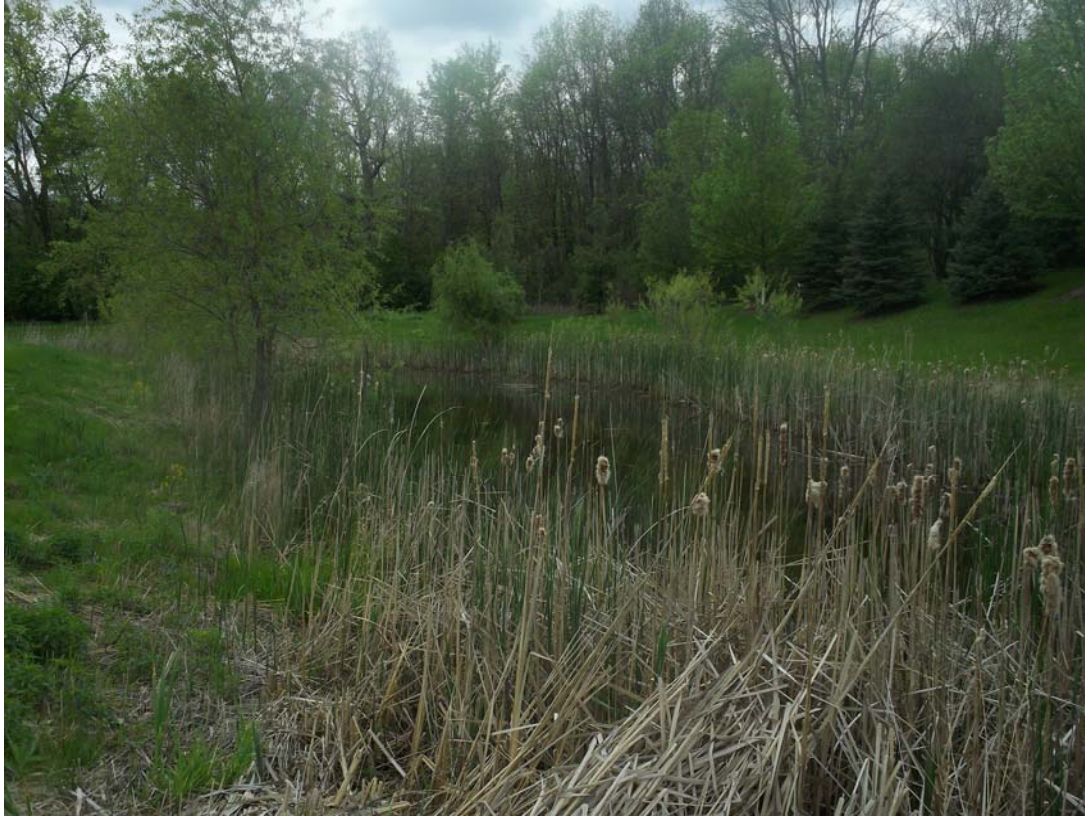
Figure 1: At north portion of pond; looking southwesterly

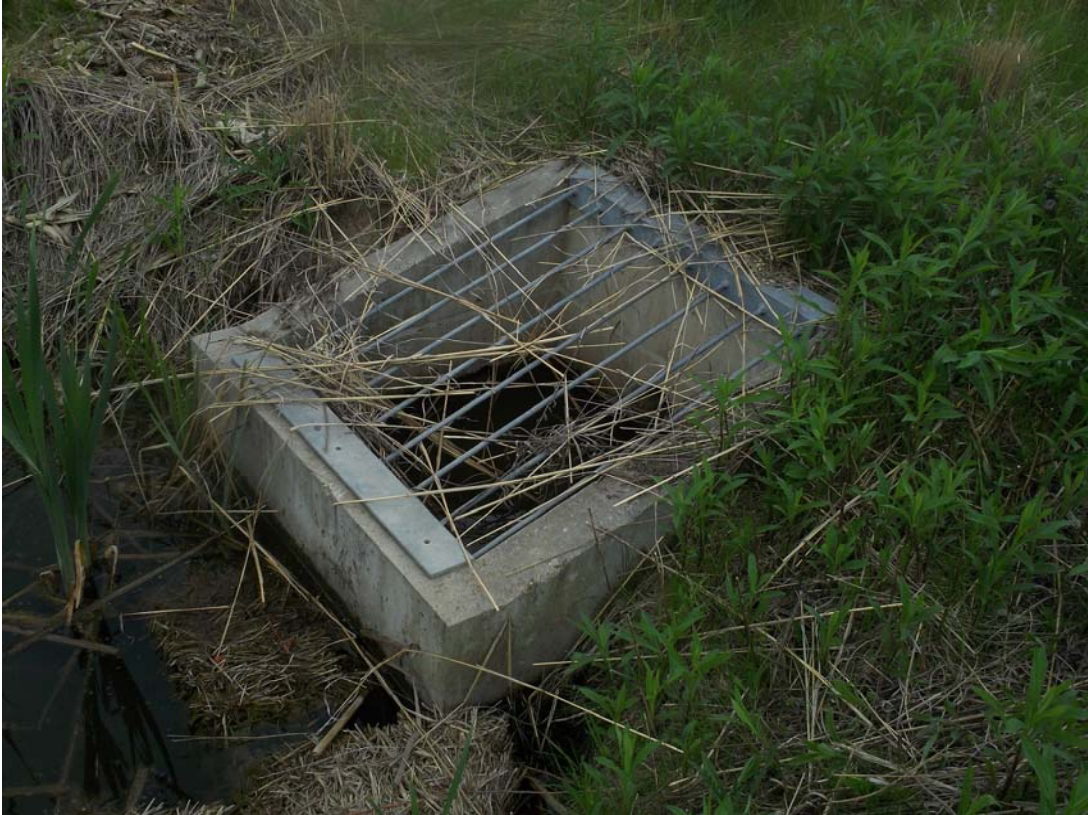
| Compliance Verification | Design | Actual | Compliant | | Comments (Condition of Structure) |
|---|---|---|---|---|---|
| Opening Diameter (inches) | 12" | 12" | | | Concrete HEAVY VEGETATION AND DEBRIS SURROUNDING |

Figure 3: At southeast portion of pond; looking northerly (pond outlet structure)

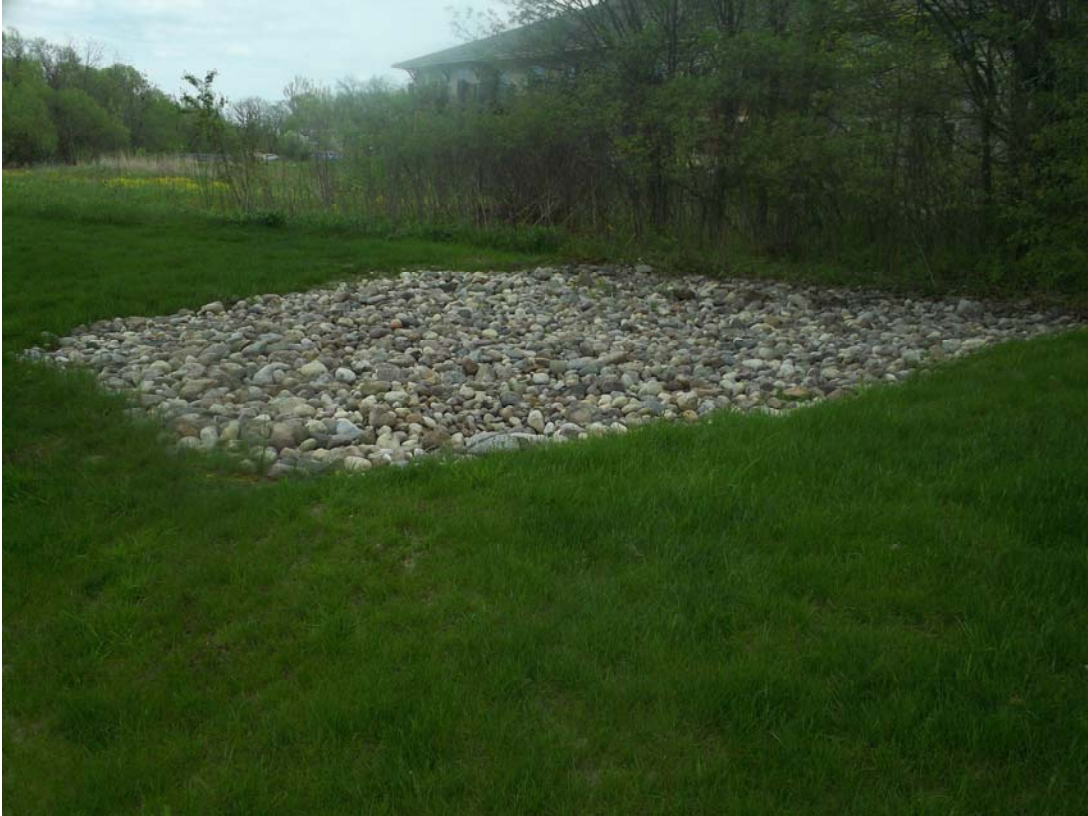
| Compliance Verification | Design | Actual | Compliant Yes No | | Comments | |
|--|---|---|---|--|---|---|
| Elevation | 793.50 | 793.07 | | | | |
| Length of spillway (feet) | 20.0' | 19.5' | | | | |

Figure 4: At southeast portion of pond; looking southeasterly (emergency spillway)

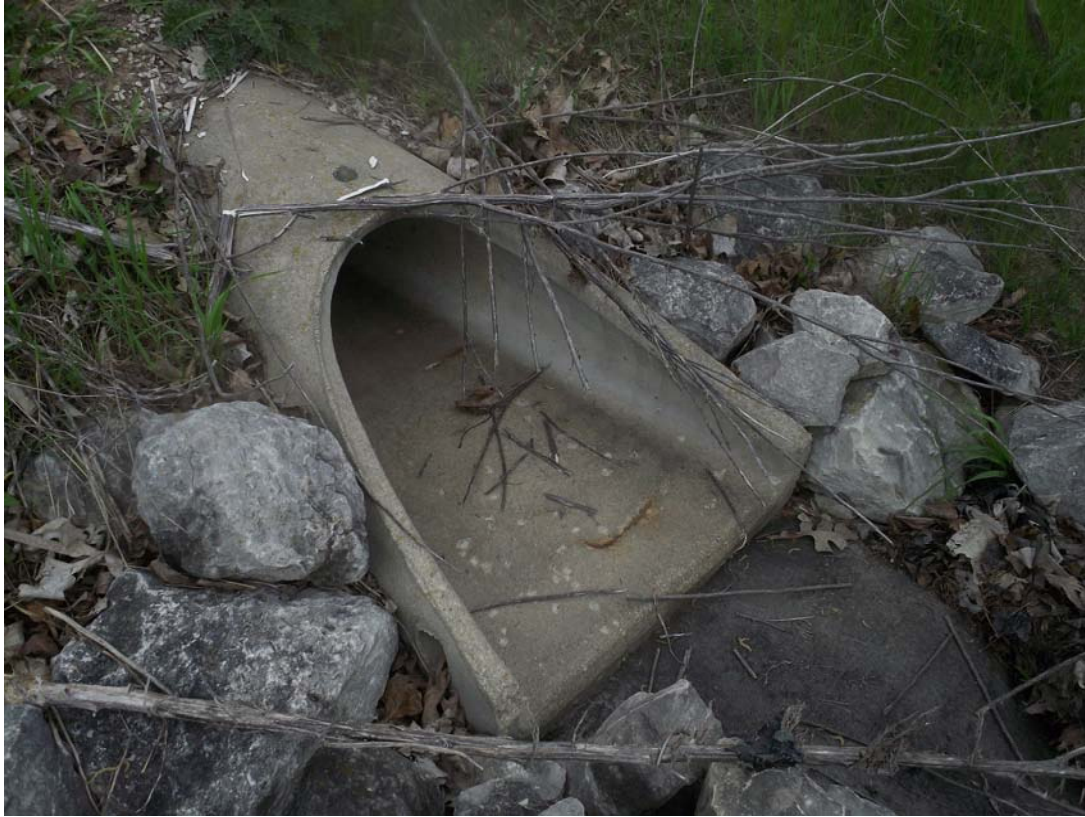
Figure 5: At north portion of pond; looking northwesterly (storm outfall)
