STORMWATER MANAGEMENT FACILITIES OPERATION AND INSPECTION REPORT

Quarter Section 34 SW Name of Business/Subdivision RUSSEL CT WETLAND/POND
Property Tax ID Number 0135996002 Address of Property _____

Russell Ct Wetland – SWP34S002

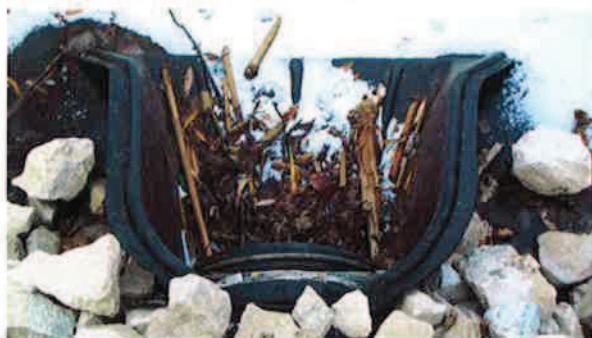
Inlet IN34S027

Compliance Verification	Design (Non- AsBuilt)	Actual (GPS)	Compliant Yes	Non-Compliant No	Comments (Condition of Structure)
Primary Outlet Pipe					Outlet Pipe Material
Opening Diameter (inches)	N/A	12" PVC	-	-	12" PVC IN GOOD CONDITION
Upstream Invert (IN34S027)	N/A	877.99	-	-	
Downstream Invert (OT34S019)	N/A	876.72	-	-	
Length (feet)	N/A	138.3 FT	-	-	
Slope (%)	N/A	0.0087%,	-	-	ELEVATIONS TO VARY SLIGHTLY FROM YEAR TO YEAR DUE TO GPS TECHNOLOGY
Secondary Outlet Pipe	N/A				Outlet Pipe Material
Opening Diameter (inches)			-	-	
Upstream Invert			-	-	
Downstream Invert			-	-	
Length (feet)			-	-	
Slope (%)			-	-	
Riser	N/A				Riser Material
Opening Diameter (inches)			-	-	
Elevation			-	-	
Upper Discharge Control	N/A				
Opening Diameter (inches)			-	-	
Elevation			-	-

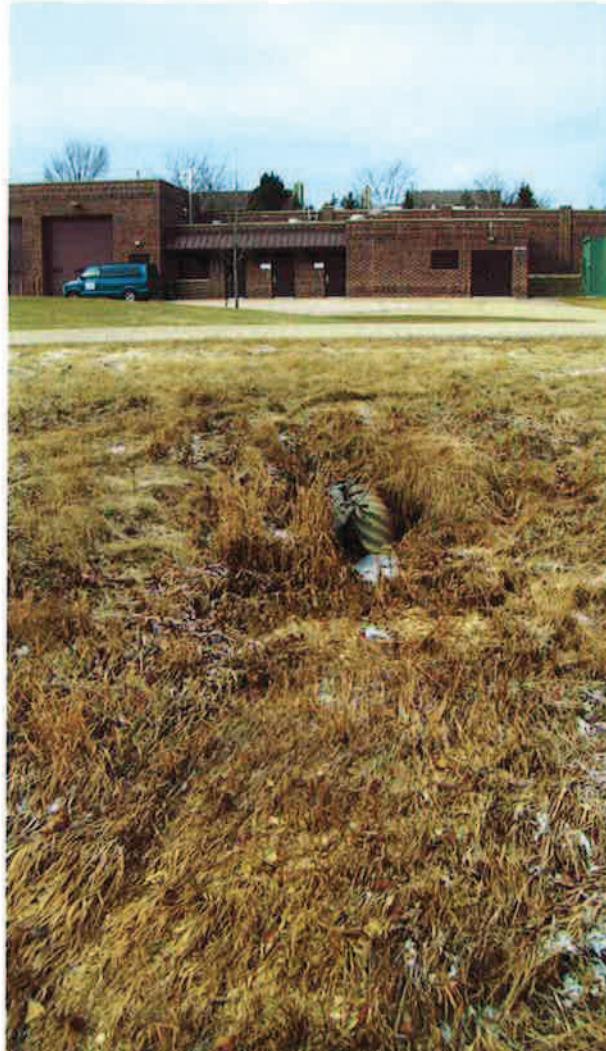
Outlet OT34S018

- CMP end damaged some restriction of flow.

Repairs Needed (12/2010)

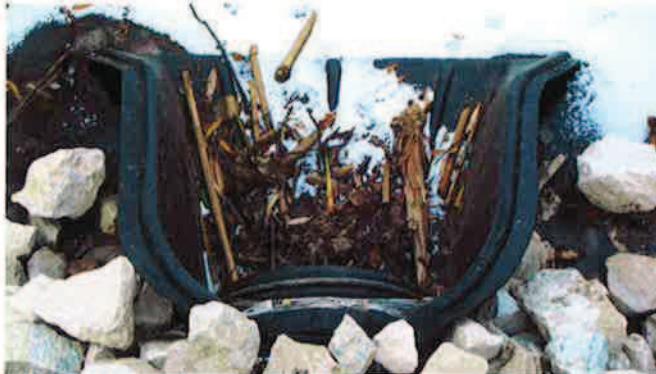
IN34S027

- This style of PVC piping not typically seen on Village of Menomonee Falls Property.
 - Was this pipe approved by the village?
 - Does it meet requirements?

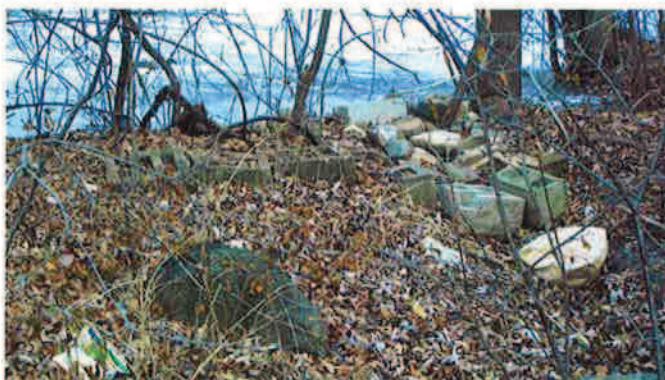
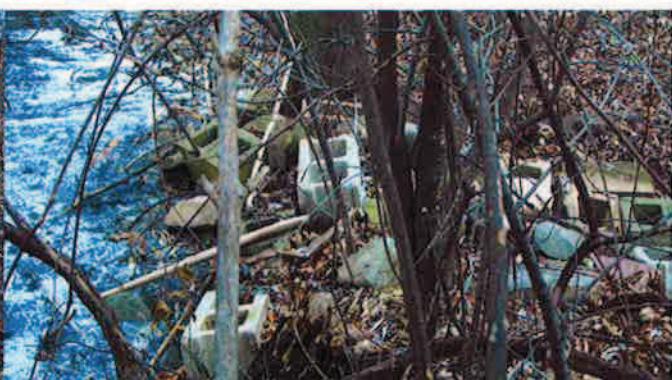
- Does the Village of Menomonee Falls have any concerns regarding the blocking of this ditch on the south side of the pond?
