STORMWATER MANAGEMENT FACILITIES OPERATION AND INSPECTION REPORT

Quarter Section 14 NW Name of Business/Subdivision DEERFIELD SUBDIVISION
 Property Tax ID Number 0054271 Address of Property W152 N7900 COUNTRYSIDE LN
MENOMONEE FALLS, WI 53051

Description: SWP14N003

Deerfield Subdivision Retention Pond – SWP14N003

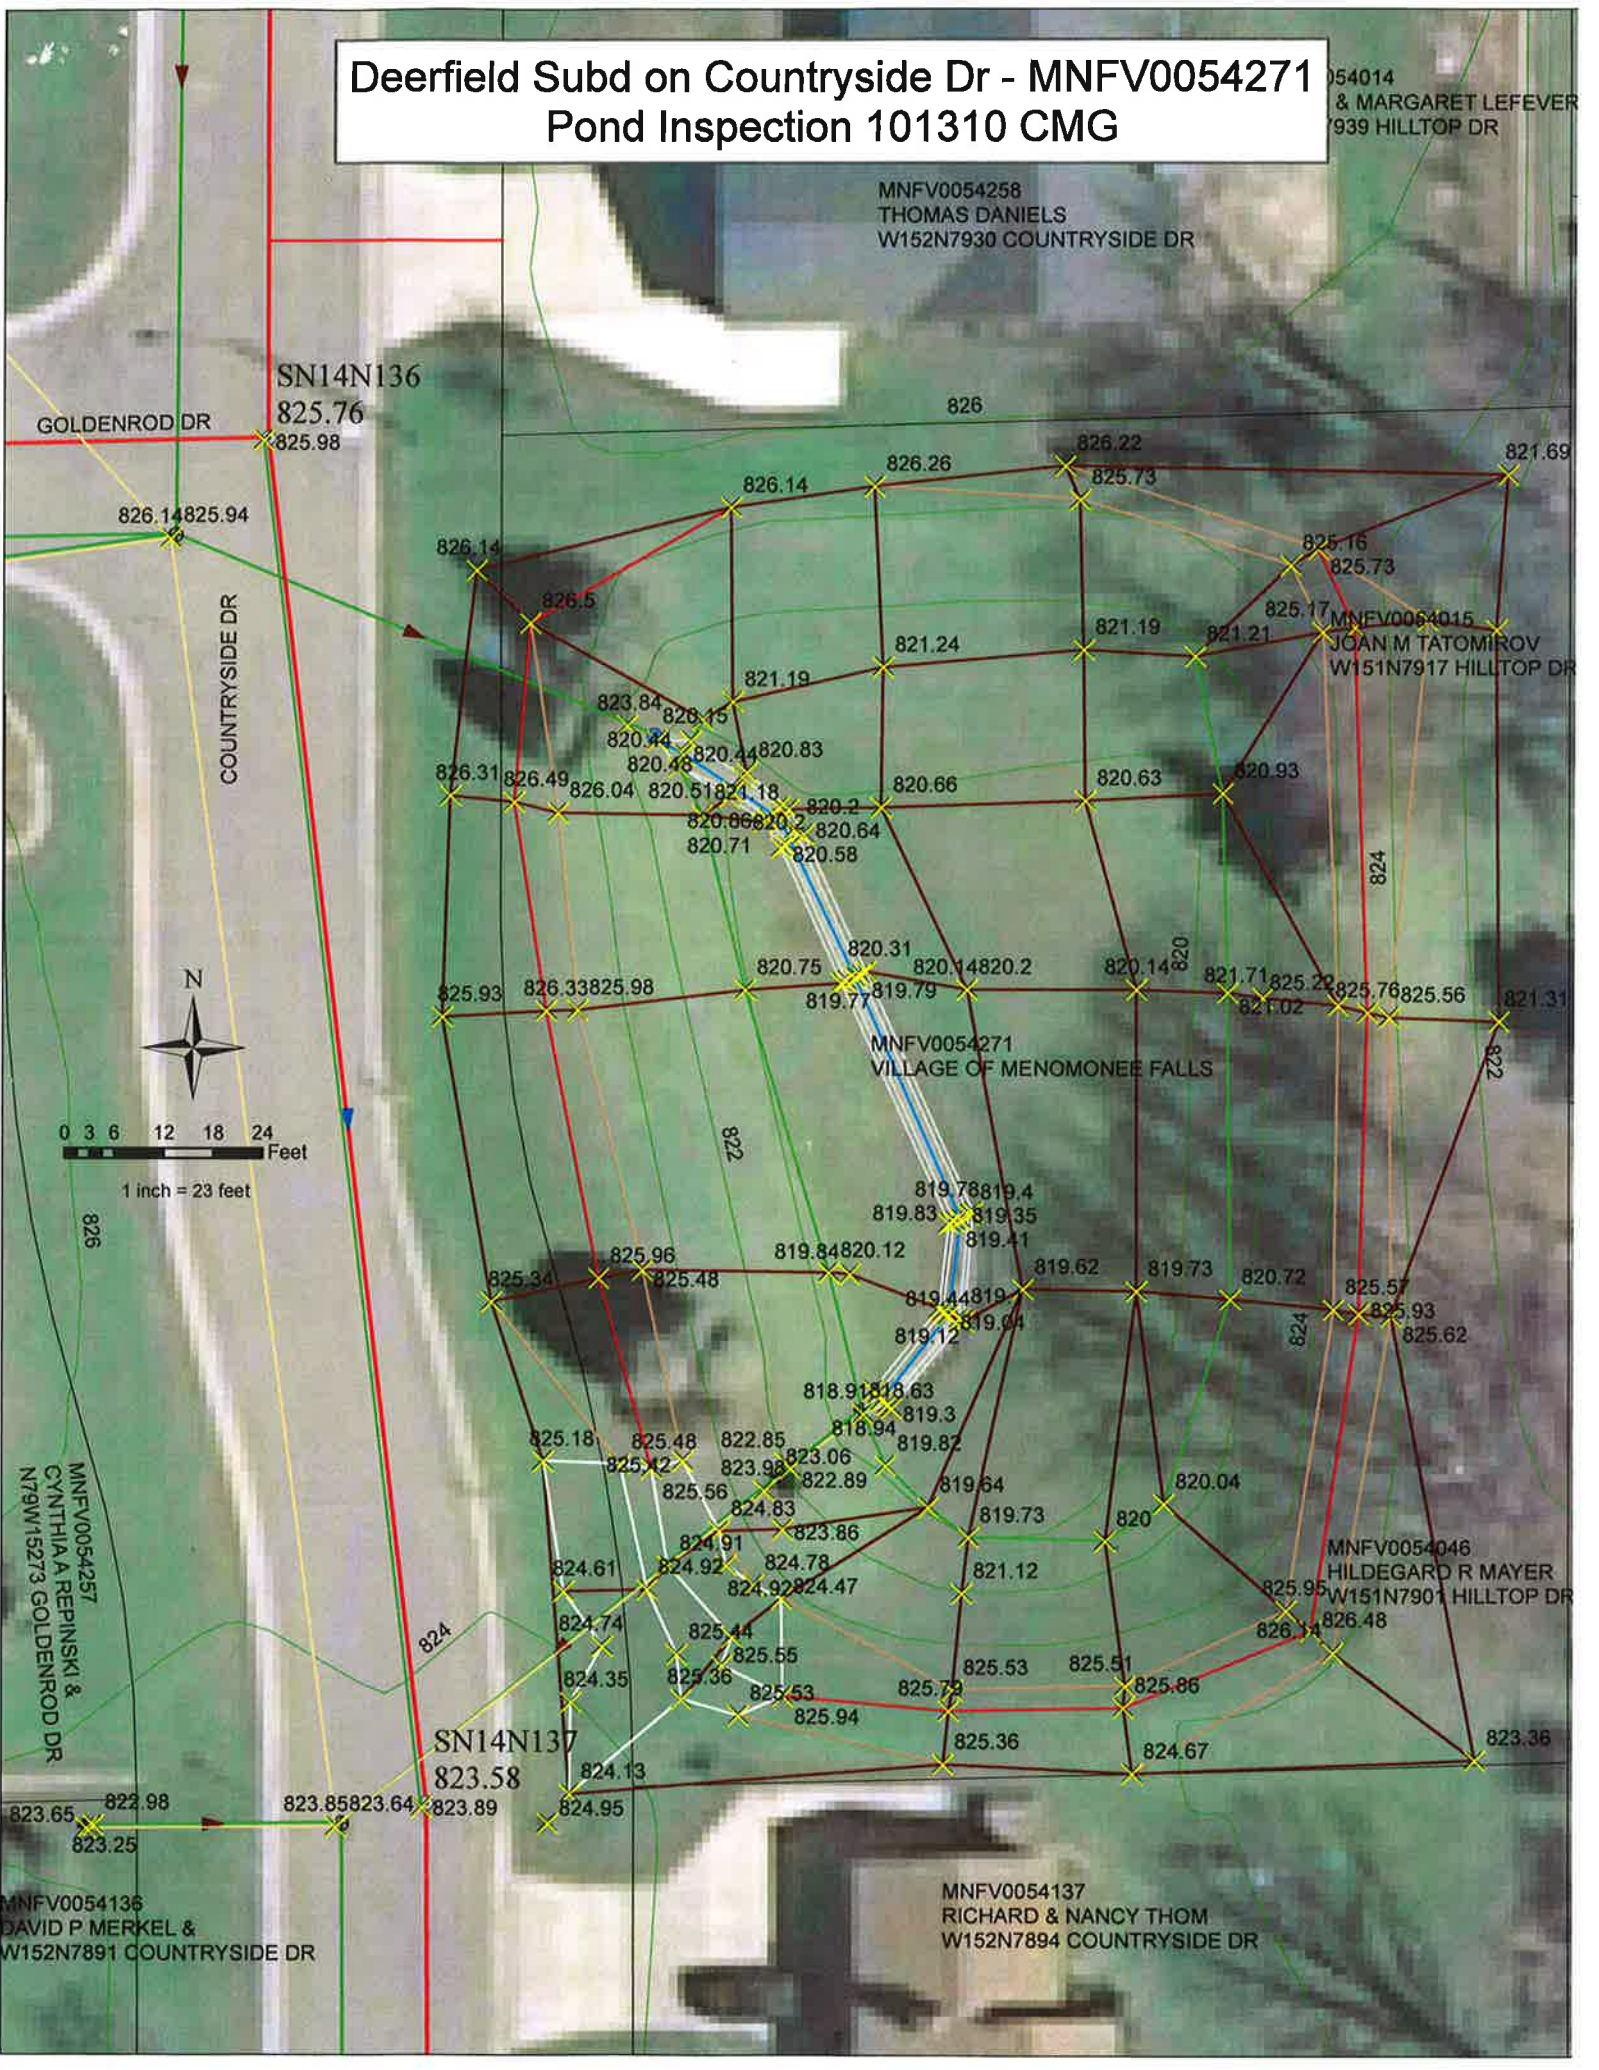
Deerfield Subd on Countryside Dr - MNFV0054271 Pond Inspection 101310 CMG

SN14N136
825.76
825.98

SN14N137
823.58
824.95
