## STORMWATER MANAGEMENT FACILITIES OPERATION AND INSPECTION REPORT

Description: SWP23N006  
P-0074, U-0146

Location Of Pond SOUTH OF GOOD HOPE RD &  
WEST OF LILLY RD...  
NEAR TERRACE DR & DENNIS  
DROESE DR

# Oakwood Park Retention Pond – SWP23N006

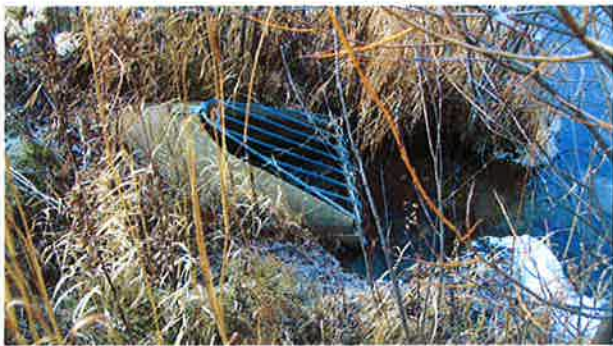
Outlet OT23N002

| Compliance Verification | Design | Actual | Compliant<br>Yes    No | | Comments | |
|---|---|---|---|---|---|---|
| Outfall 1 (OT23N002) | RCP – 18” | | SOUTHEAST POND | | GOOD CONDITION | |

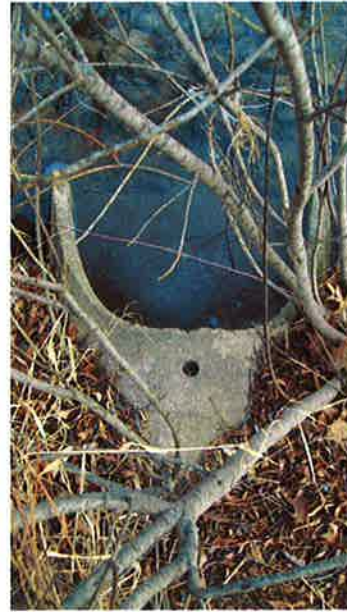
Outlet OT23N003

| Compliance Verification | Design | Actual | Compliant<br>Yes    No | | Comments | |
|---|---|---|---|---|---|---|
| Outfall 2 (OT23N003) | RCP – 15” | | SOUTH POND | | GOOD CONDITION, REMOVE VGTN | |

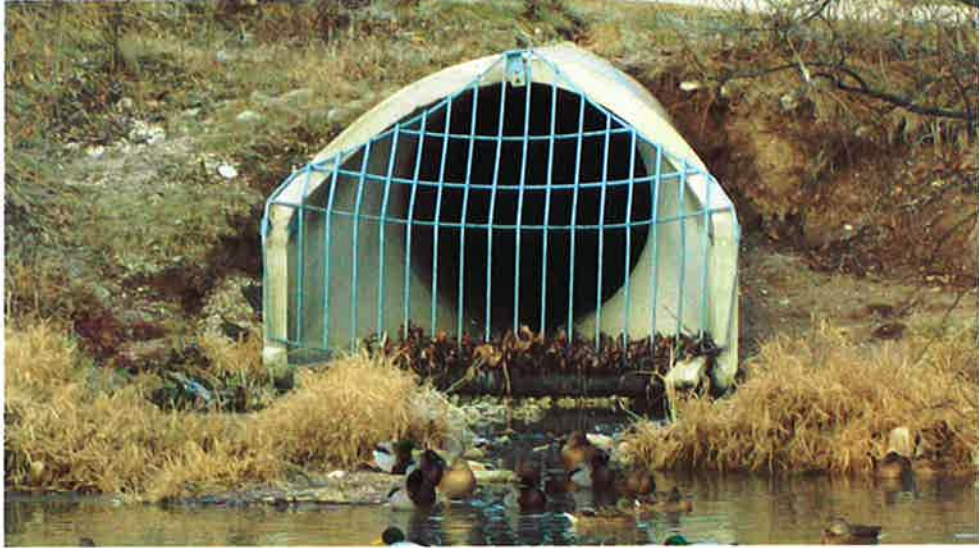
Outlet OT23N005

| Compliance Verification | Design | Actual | Compliant<br>Yes    No | | Comments | |
|---|---|---|---|---|---|---|
| Outfall 3 (OT23N005) | RCP – 72” | | WEST POND | | \END SECTIONS OFF OF STORM | |

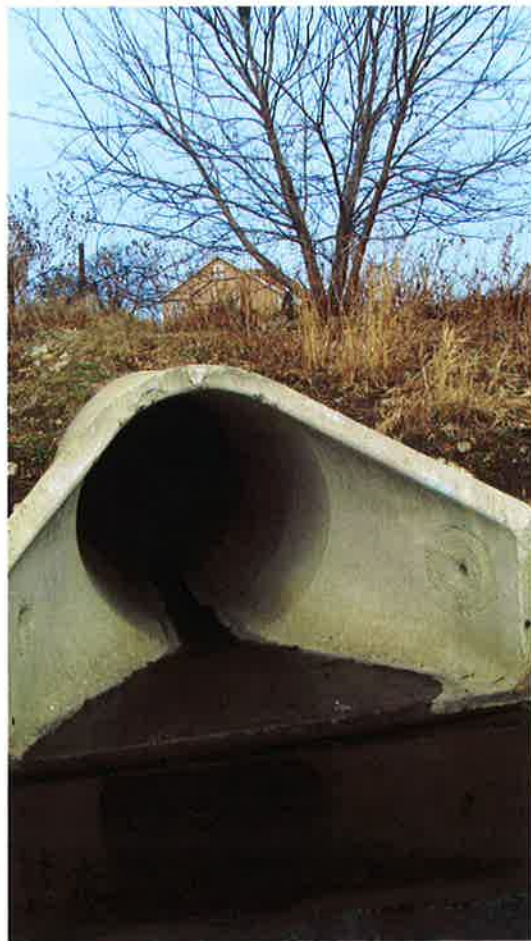
Outlet OT23N006

| Compliance Verification | Design | Actual | Compliant<br>Yes    No | | Comments | |
|---|---|---|---|---|---|---|
| Outfall 4 (OT23N006) | RCP – 72” | | NORTHEAST POND | | /SEWER SEVERAL INCHES | |

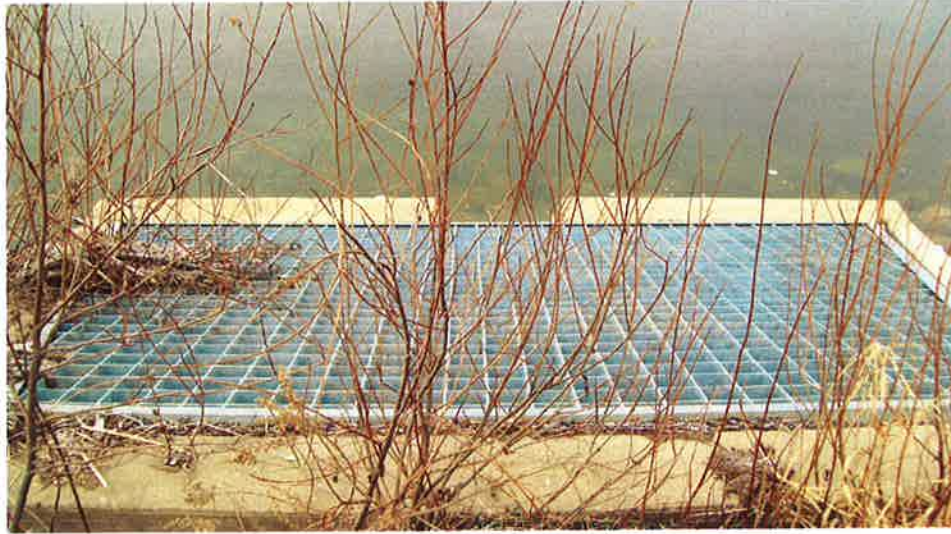
Overflow Structure ST23N021

| Compliance Verification | Design (Non-AsBuilt) | Actual (GPS) | Compliant Yes | No | Comments (Condition of Structure) |
|---|---|---|---|---|---|
| Opening Diameter (inches) | | 96" X 96" BOX | - | - | RCP |
| Elevation | | 779.00 | - | - | @ TOP OF LOWEST ENTRY POINT FOR WATER ABOVE WEIR |
| Opening Diameter (inches) (ST23N021) | N/A | SEE NOTE | - | - | V-NOTCH WEIR INTO 48" RCP |

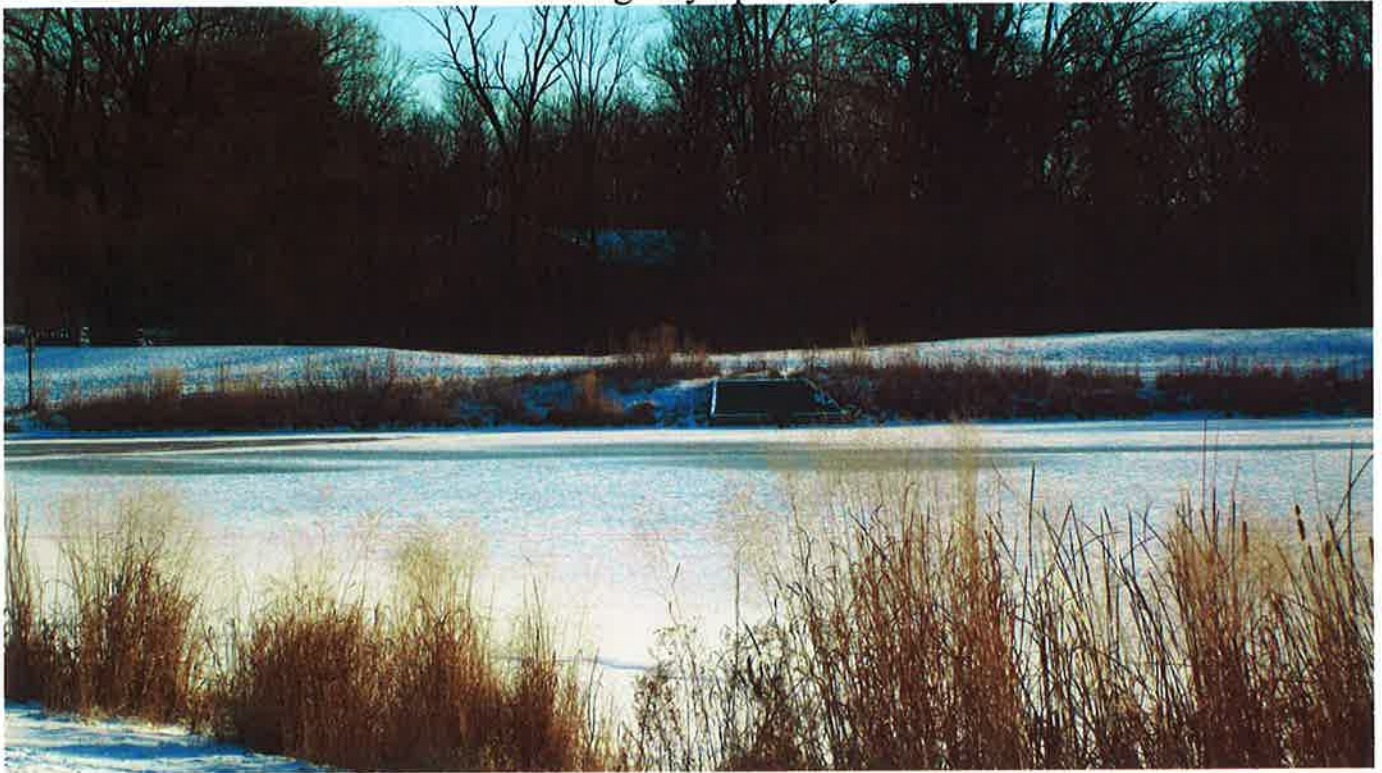
Emergency Spillway

| Compliance Verification | Design | Actual | Compliant<br>Yes    No | | Comments | |
|---|---|---|---|---|---|---|
| Elevation | 784.05 | 784.05 | - | - | | |
| Length of spillway (feet) | 50.0 FT | 58.4 FT | - | - | | |

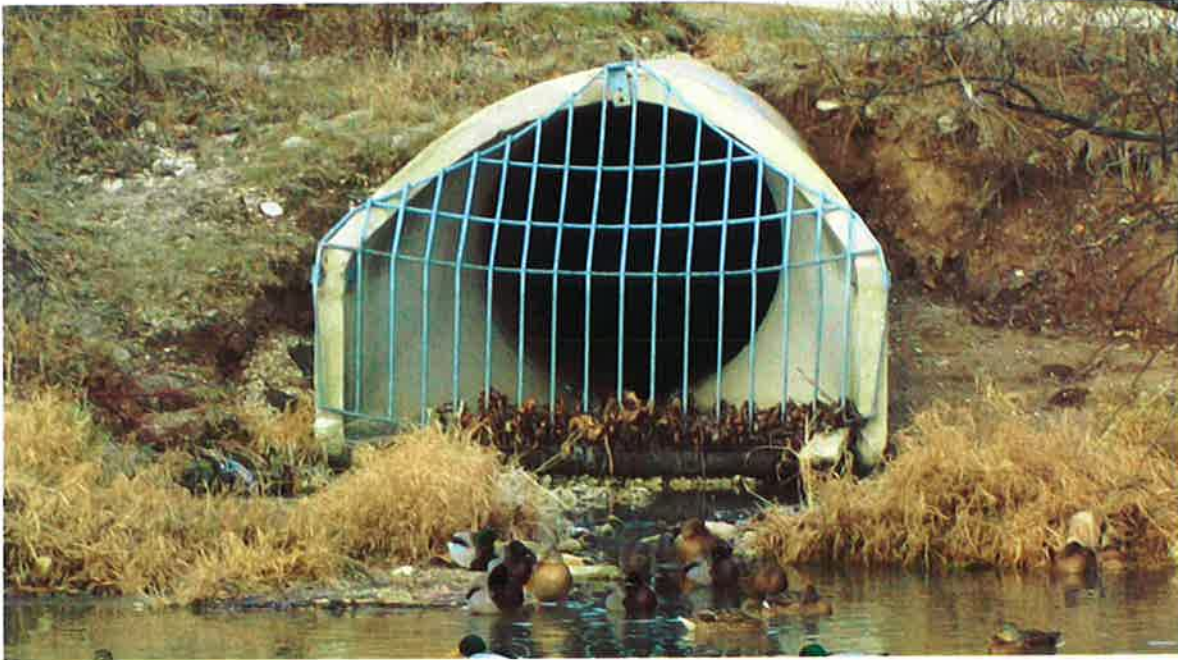
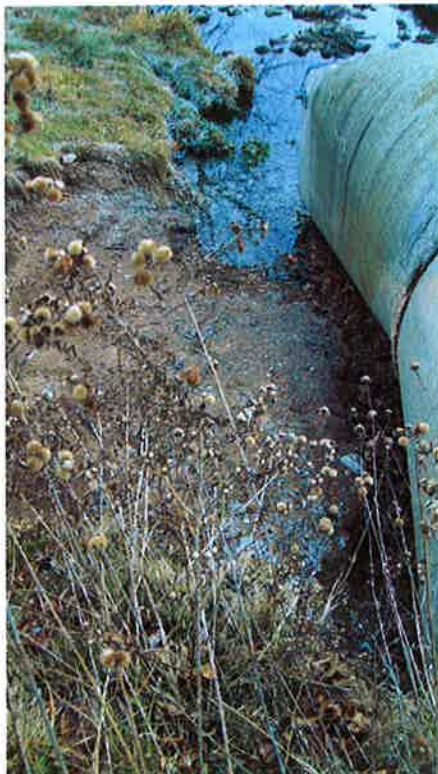
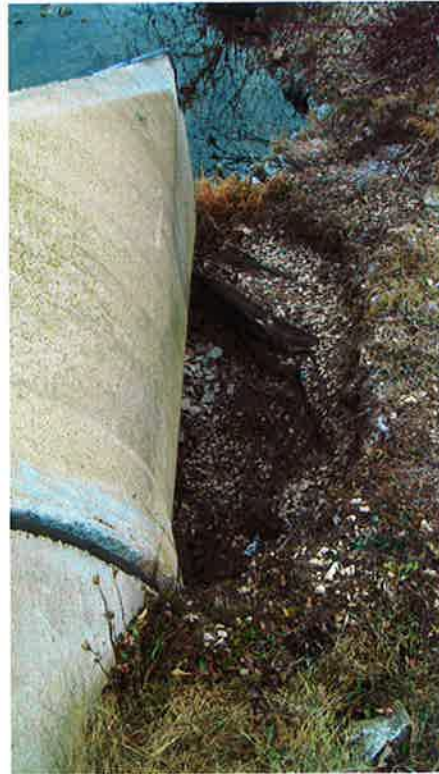
Outlet OT23N005

- Much erosion and undermining.
- End section of pipe has been pushed off.

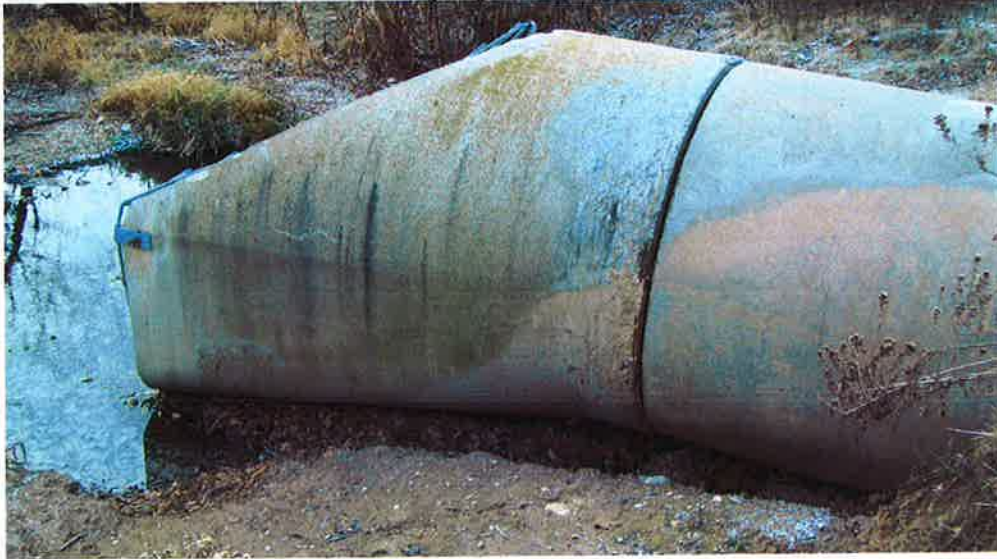
Outlet OT23N005 (Continued)

- Riprap disturbed

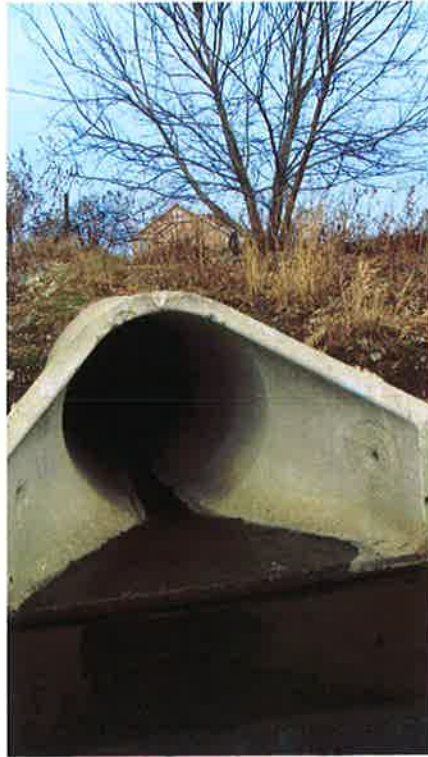
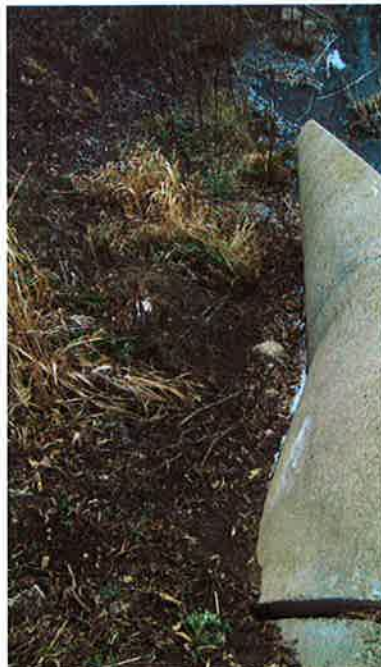
### Outlet OT23N006

- Evidence of erosion present, slight undermining.
- End section pushed off

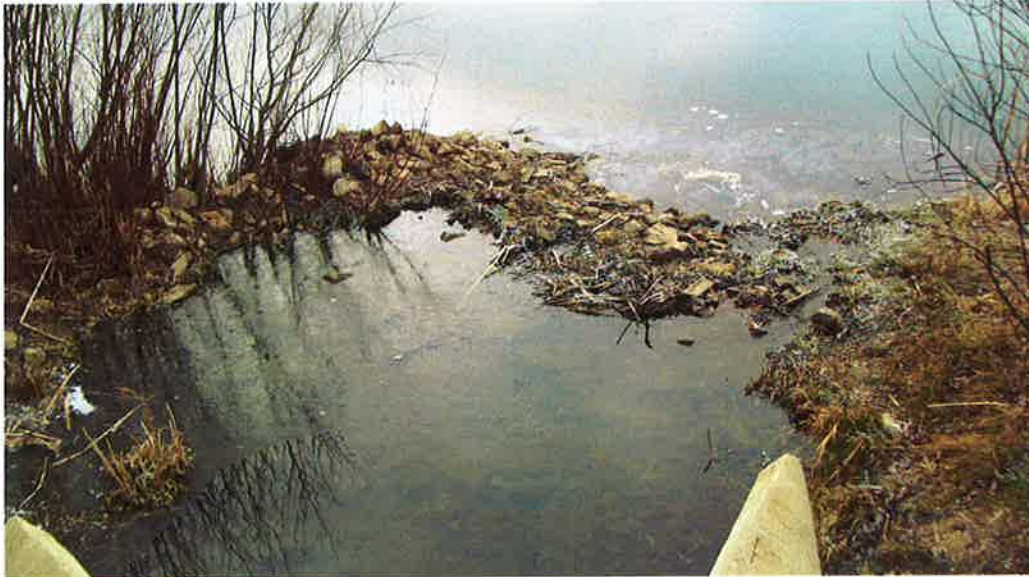
Outlet OT23N006 (Continued)

- Riprap disturbed

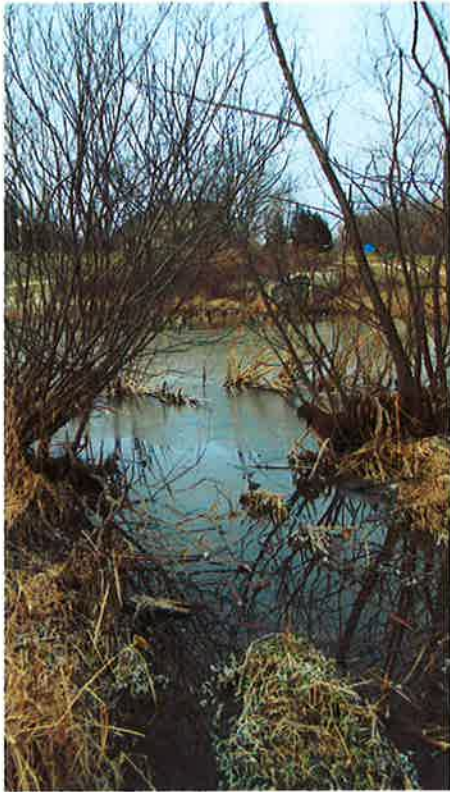
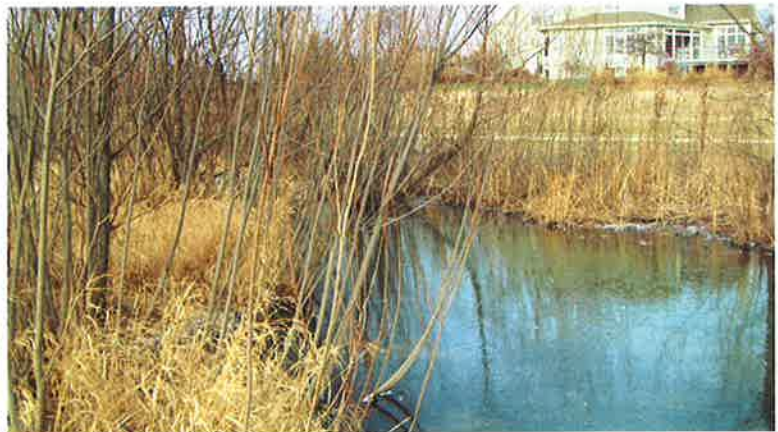
| Compliance Verification | Design | Actual | Compliant<br>Yes    No | | Comments | |
|---|---|---|---|---|---|---|
| Unauthorized Plantings, trees, or woody vegetation | Y | - | REMOVE WOODY VEGETATION | | | |

- Woody vegetation in basin(s)

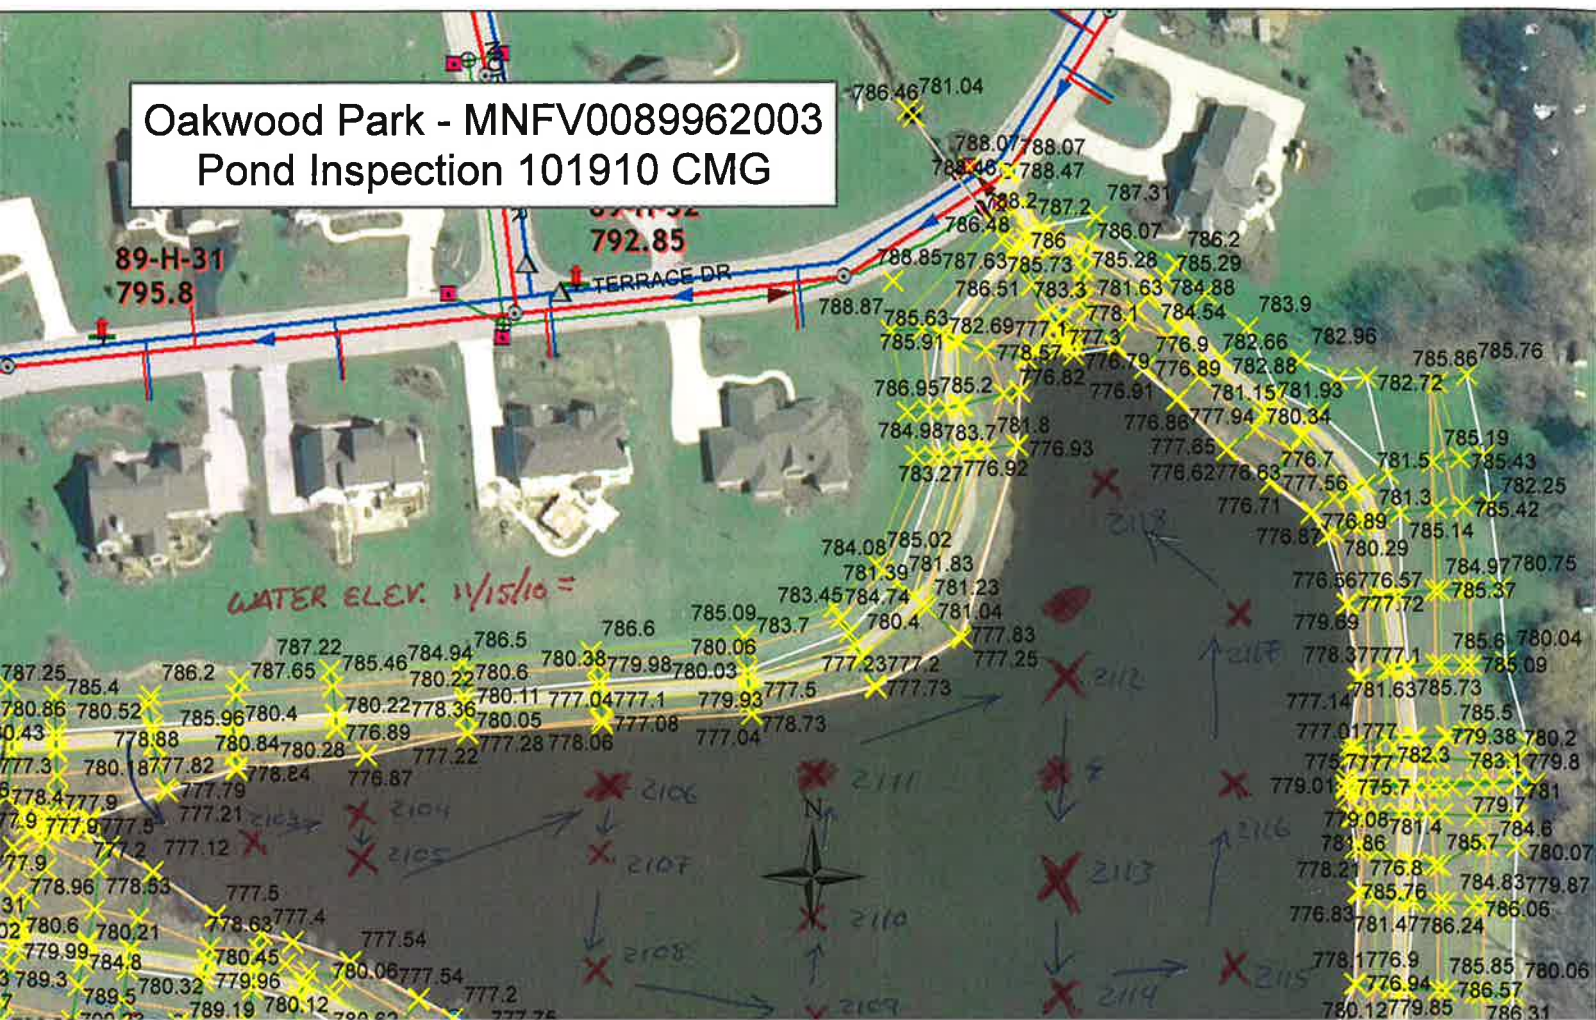
Oakwood Park - MNFV0089962003  
Pond Inspection 101910 CMG

$$H = 6.59'$$

$$A_1 = 4.945 \text{ AC}$$

$$A_2 = 9.024 \text{ AC}$$

$$V = \left( \frac{H}{3} \right) (A_1 + A_2 + \sqrt{A_1 A_2})$$

$$\underline{\underline{V = 38.96 \text{ AC FT}}}$$
