STORMWATER MANAGEMENT FACILITIES OPERATION AND INSPECTION REPORT

SW 1/4 Sec 33 Name of Business/Subdivision Cranes Crossing
0131064 Address of Property N48 W18200 Lisbon Road

Pond ID: SWP 33s002
Temporary Pond P4

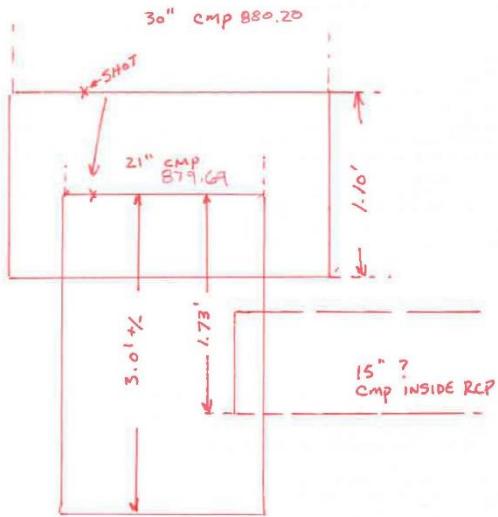
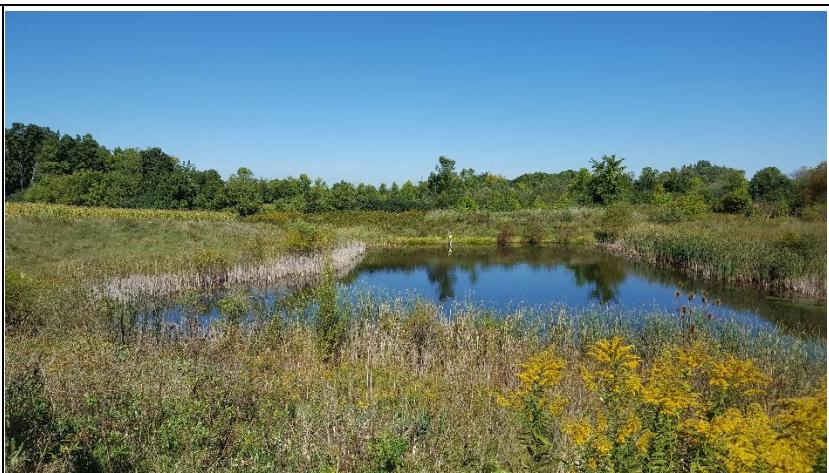
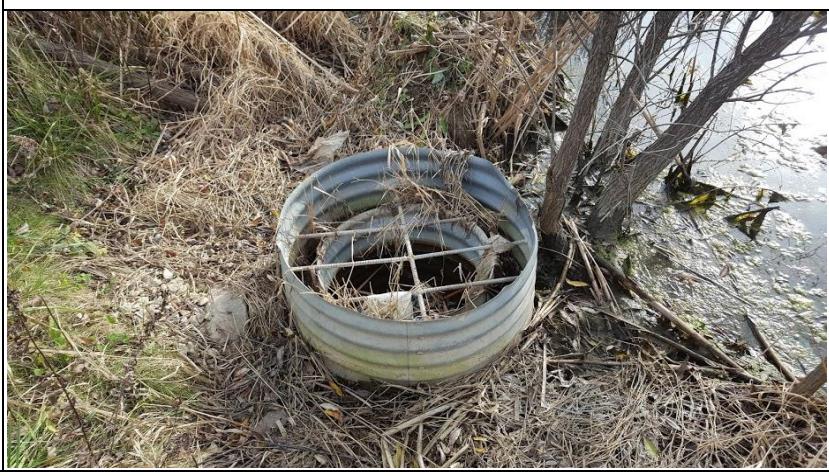
Sketch Outlet or Attach to Document

Compliance Verification	Design	Actual	Compliant Yes	No	Comments (Condition of Structure)
Primary Outlet Pipe					Outlet Pipe Material
Opening Diameter (inches)	15"	15"	X		CMP stub into RCP
Upstream Invert	878.00	877.91	X		
Downstream Invert	877.88	877.81		X	Downstream pipe appears to be blocked. Downstream MH full of water.
Length (feet)	32.03	35.4	X		
Slope (%)	0.381	0.28	X		
Secondary Outlet Pipe	(If Applicable)				Outlet Pipe Material
Opening Diameter (inches)					Not Applicable (NA)
Upstream Invert					
Downstream Invert					
Length (feet)					
Slope (%)					
Riser	(If Applicable)				Riser Material
Opening Diameter (inches)	18"	21"		X	Corrugated Metal Pipe with rebar trash grate
Elevation	879.75	879.69	X		
Upper Discharge Control	(If Applicable)				
Opening Diameter (inches)					NA
Elevation

Compliance Verification	Design	Actual	Compliant Yes	No	Comments
Lower Discharge Control	(If Applicable)				
Opening Diameter (inches)	2-4" dia.			X	Cannot determine – underwater and not visible.
Elevation	878.00			X	
Other (Description)					
Opening Type and Size (inches)					NA
Elevation					
Emergency Spillway					
Elevation	885.75	885.4±	X		
Length of spillway (feet)	12.0	12±	X		
Embankment	Present Yes		Comments/Maintenance Requirements		
Unauthorized Plantings, trees, or woody vegetation	X		Woody vegetation adjacent to outlet structure		
Animal burrows or slope erosion		X			
Storm Sewer Outfalls	Type & Size		Location		Comments
Outfall 1	V-channel		SW corner		Good condition
Outfall 2	24" RCP		South side		Good condition
Outfall 3	18" RCP		SE corner		Good Condition
Storage Properties	Design	Actual	Compliant Yes	No	Equipment Used
Normal Water Elevation (Wet Ponds)	878.00	879.06	X		Total station & GPS
Design High Water Elevation	885.75	885.4	X
