STORMWATER MANAGEMENT FACILITIES OPERATION AND INSPECTION REPORT

Quarter Section NE 1/4 SEC 24-8-19 Name of Business/Subdivision _____
Property Tax ID Number 0093-947-004 Address of Property – NORTHFIELD DR MENOMONEE FALLS, WI 53051

Description: 24N001 POND #8

Inspector Name: RIZAL ISKANDARSJACH
Inspection Date: MAY 17, 2010

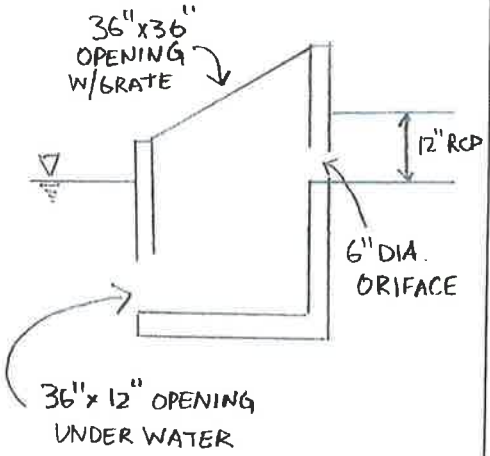
Sketch Outlet

Compliance Verification	Design	Actual	Compliant Yes	Compliant No	Comments (Condition of Structure)
Primary Outlet Pipe					
Opening Diameter	12"	12"			
Upstream Invert	795.00	795.02			
Downstream Invert	794.00	793.69			
Length	500.0'	499.4'			
Slope	0.20%	0.27%			
Secondary Outlet Pipe	(If Applicable)				
Opening Diameter					
Upstream Invert					
Downstream Invert					
Length					
Slope					
Riser	(If Applicable)				
Opening Diameter					
Elevation					
Upper Discharge Control	(If Applicable)				
Opening Diameter					
Elevation

Compliance Verification	Design	Actual	Compliant Yes	No	Comments
Lower Discharge Control	(If Applicable)				
Opening Diameter					
Elevation					
Other (Description)					
Opening Type VERT. ORIFACE	5" DIA.	6" DIA			
Elevation	795.00	795.02			
Emergency Spillway					
Elevation	799.50	798.5			
Length of spillway	20.0'	16.5'			
Embankment			Present Yes	No	
Unauthorized plantings, trees, or woody vegetation					
Animal burrows or slope erosion

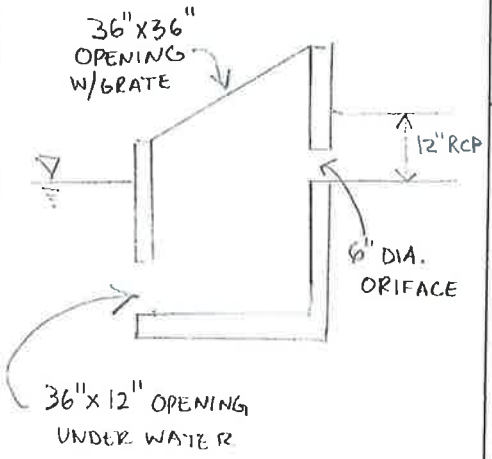
Sketch Outlet

Compliance Verification	Design	Actual	Compliant Yes	Compliant No	Comments (Condition of Structure)
Primary Outlet Pipe					
Opening Diameter	12"	12"			
Upstream Invert	784.00	784.02			
Downstream Invert	783.00	782.90			
Length	90.0'	78.1'			
Slope	1.11%	1.43%			
Secondary Outlet Pipe	(If Applicable)				
Opening Diameter					
Upstream Invert					
Downstream Invert					
Length					
Slope					
Riser	(If Applicable)				
Opening Diameter					
Elevation					
Upper Discharge Control	(If Applicable)				
Opening Diameter					
Elevation

Compliance Verification	Design	Actual	Compliant Yes	No	Comments
Lower Discharge Control	(If Applicable)				
Opening Diameter					
Elevation					
Other (Description)					
Opening Type VERT. ORIFACE	4.5" DIA	6" DIA			
Elevation	784.00	784.02			
Emergency Spillway					
Elevation	789.50	788.4			
Length of spillway	20.0'	24'			
Embankment			Present Yes	No	
Unauthorized plantings, trees, or woody vegetation					
Animal burrows or slope erosion

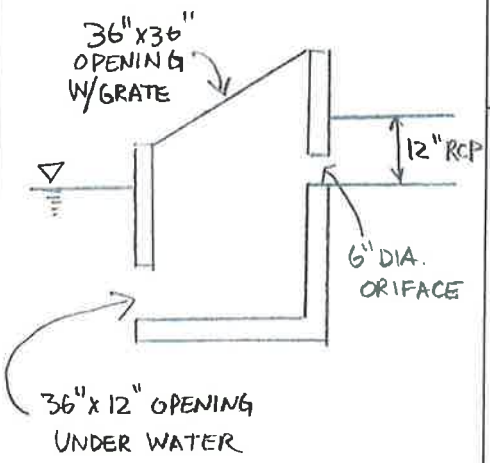
Sketch Outlet

Compliance Verification	Design	Actual	Compliant Yes	Compliant No	Comments (Condition of Structure)
Primary Outlet Pipe					
Opening Diameter	12"	12"			
Upstream Invert	776.00	776.08			
Downstream Invert	775.97	775.66			
Length	56.0'	43.4'			
Slope	0.05%	0.97%			
Secondary Outlet Pipe	(If Applicable)				
Opening Diameter					
Upstream Invert					
Downstream Invert					
Length					
Slope					
Riser	(If Applicable)				
Opening Diameter					
Elevation					
Upper Discharge Control	(If Applicable)				
Opening Diameter					
Elevation

Compliance Verification	Design	Actual	Compliant Yes	Compliant No	Comments
Lower Discharge Control	(If Applicable)				
Opening Diameter					
Elevation					
Other (Description)					
Opening Type VERT. ORIFACE	6.5" DIA.	6" DIA			
Elevation	776.00	776.08			
Emergency Spillway					
Elevation	781.50	780.0			
Length of spillway	20.0'	20'			
Embankment			Present Yes	Present No	
Unauthorized plantings, trees, or woody vegetation					
Animal burrows or slope erosion

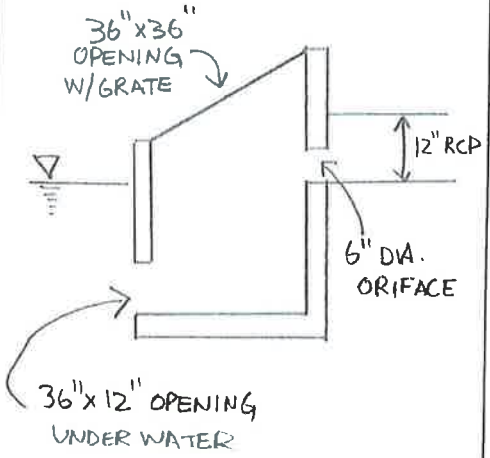
Sketch Outlet

Compliance Verification	Design	Actual	Compliant Yes	Compliant No	Comments (Condition of Structure)
Primary Outlet Pipe					
Opening Diameter	12"	12"			
Upstream Invert	775.00	774.99			
Downstream Invert	774.00	774.20			
Length	52.0'	48.5'			
Slope	1.92%	1.63%			
Secondary Outlet Pipe	(If Applicable)				
Opening Diameter					
Upstream Invert					
Downstream Invert					
Length					
Slope					
Riser	(If Applicable)				
Opening Diameter					
Elevation					
Upper Discharge Control	(If Applicable)				
Opening Diameter					
Elevation

Compliance Verification	Design	Actual	Compliant Yes	Compliant No	Comments
Lower Discharge Control	(If Applicable)				
Opening Diameter					
Elevation					
Other (Description)					
Opening Type VERT. ORIFACE	4" DIA.	6" DIA.			
Elevation	775.00	774.99			
Emergency Spillway					
Elevation	781.50	781.3			
Length of spillway	20.0'	22.5'			
Embankment			Present Yes	Present No	
Unauthorized plantings, trees, or woody vegetation					
Animal burrows or slope erosion

781.5 Top

780.5 weir

779.75 des. elev. ±

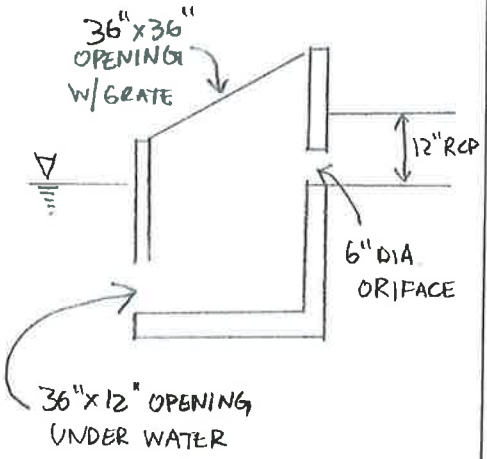
Sketch Outlet

Compliance Verification	Design	Actual	Compliant Yes	Compliant No	Comments (Condition of Structure)
Primary Outlet Pipe					
Opening Diameter	12"	12"			
Upstream Invert	783.00	783.24			
Downstream Invert	782.00	782.16			
Length	42.0'	41.8'			
Slope	2.38%	2.58%			
Secondary Outlet Pipe	(If Applicable)				
Opening Diameter					
Upstream Invert					
Downstream Invert					
Length					
Slope					
Riser	(If Applicable)				
Opening Diameter					
Elevation					
Upper Discharge Control	(If Applicable)				
Opening Diameter					
Elevation

Compliance Verification	Design	Actual	Compliant Yes	No	Comments
Lower Discharge Control	(If Applicable)				
Opening Diameter					
Elevation					
Other (Description)					
Opening Type VERT. ORIFACE	6.5" DIA.	6" DIA.			
Elevation	783.00	783.24			
Emergency Spillway					
Elevation	788.50	787.8			
Length of spillway	20.0'	19.5'			
Embankment			Present Yes	No	
Unauthorized plantings, trees, or woody vegetation					
Animal burrows or slope erosion

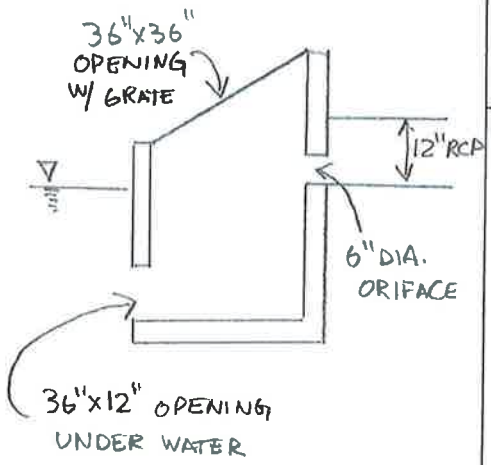
Sketch Outlet

Compliance Verification	Design	Actual	Compliant Yes	Compliant No	Comments (Condition of Structure)
Primary Outlet Pipe					
Opening Diameter	12"	12"			
Upstream Invert	790.00	789.79			
Downstream Invert	789.00	788.75			
Length	150.0'	148.6'			
Slope	0.67%	0.70%			
Secondary Outlet Pipe	(If Applicable)				
Opening Diameter					
Upstream Invert					
Downstream Invert					
Length					
Slope					
Riser	(If Applicable)				
Opening Diameter					
Elevation					
Upper Discharge Control	(If Applicable)				
Opening Diameter					
Elevation

Compliance Verification	Design	Actual	Compliant Yes	Compliant No	Comments
Lower Discharge Control	(If Applicable)				
Opening Diameter					
Elevation					
Other (Description)					
Opening Type VERT. ORIFACE	6" DIA.	6" DIA.			
Elevation	790.00	789.79			
Emergency Spillway					
Elevation	793.50	793.2			
Length of spillway	20.0'	18'			
Embankment			Present Yes	Present No	
Unauthorized plantings, trees, or woody vegetation					
Animal burrows or slope erosion

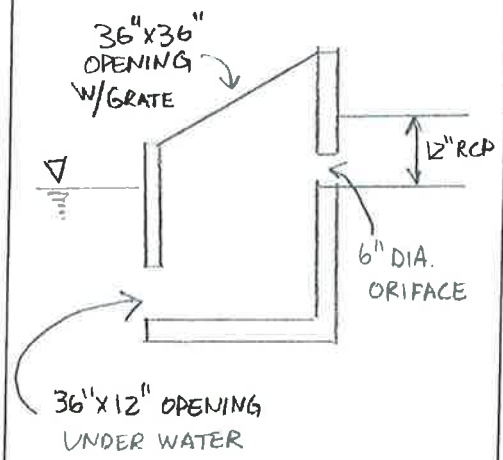
Sketch Outlet

Compliance Verification	Design	Actual	Compliant Yes	Compliant No	Comments (Condition of Structure)
Primary Outlet Pipe					
Opening Diameter	12"	12"			
Upstream Invert	790.00	789.93			
Downstream Invert	788.50	788.02			
Length	254.0'	250.0'			
Slope	0.59%	0.76%			
Secondary Outlet Pipe	(If Applicable)				
Opening Diameter					
Upstream Invert					
Downstream Invert					
Length					
Slope					
Riser	(If Applicable)				
Opening Diameter					
Elevation					
Upper Discharge Control	(If Applicable)				
Opening Diameter					
Elevation

Compliance Verification	Design	Actual	Compliant Yes	Compliant No	Comments
Lower Discharge Control	(If Applicable)				
Opening Diameter					
Elevation					
Other (Description)					
Opening Type VERT. ORIFICE	4.5" DIA.	6" DIA			
Elevation	790.00'	789.93			
Emergency Spillway					
Elevation	793.95	793.6			HYDROCAD MODELING SHOWS 793.95 CONST. DETAILS SHOWS 792.5
Length of spillway	20.0'	34'			
Embankment			Present Yes	Present No	
Unauthorized plantings, trees, or woody vegetation					
Animal burrows or slope erosion

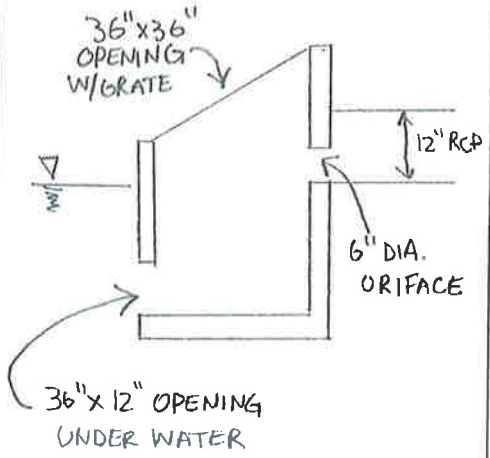
Sketch Outlet

Compliance Verification	Design	Actual	Compliant Yes	Compliant No	Comments (Condition of Structure)
Primary Outlet Pipe					
Opening Diameter	12"	12"			
Upstream Invert	788.00	788.03			
Downstream Invert	787.00	787.85			
Length	150.0'	117.8			
Slope	0.67%	0.15%			
Secondary Outlet Pipe	(If Applicable)				
Opening Diameter					
Upstream Invert					
Downstream Invert					
Length					
Slope					
Riser	(If Applicable)				
Opening Diameter					
Elevation					
Upper Discharge Control	(If Applicable)				
Opening Diameter					
Elevation

Compliance Verification	Design	Actual	Compliant Yes	Compliant No	Comments
Lower Discharge Control	(If Applicable)				
Opening Diameter					
Elevation					
Other (Description)					
Opening Type VERT. ORIFICE	6" DIA.	6" DIA.			
Elevation	788.00	788.03			
Emergency Spillway					
Elevation	793.50	794.8			
Length of spillway	20.0'	25'			
Embankment			Present Yes	Present No	
Unauthorized plantings, trees, or woody vegetation					
Animal burrows or slope erosion
