## STORMWATER MANAGEMENT FACILITIES OPERATION AND INSPECTION REPORT

Quarter Section 33 SE Name of Business/Subdivision RIDGEFIELD SUBDIVISION  
Property Tax ID Number 0132176 Address of Property WETLAND

Description: SWP33S006  
Q-166 U-331 U-337 U-377

# Ridgefield Subdivision Retention Pond – SWP33S006 (Sheffield & Greenview)

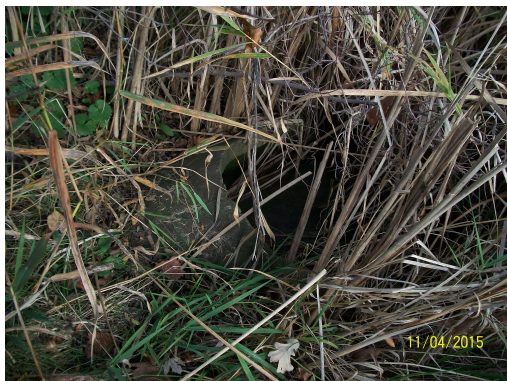
Inlet ST011276

| Compliance Verification | Design (Non-AsBuilt) | Actual (GPS) | Compliant Yes | No | Comments (Condition of Structure) |
|---|---|---|---|---|---|
| Opening Diameter (inches) | 15" RCP | 15" RCP | - | - | 15" RCP IN GOOD CONDITION<br><br>ELEVATIONS TO VARY SLIGHTLY FROM YEAR TO YEAR DUE TO GPS TECHNOLOGY |

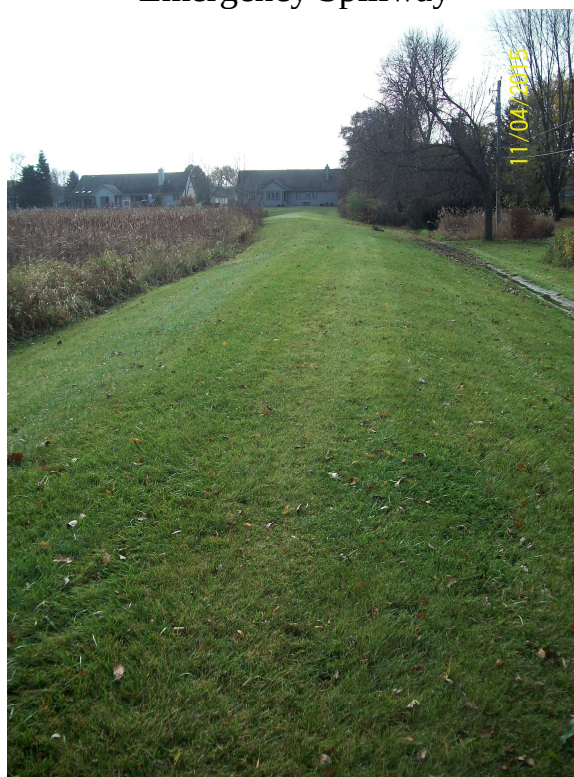
Emergency Spillway

| Compliance Verification | Design | Actual | Compliant<br>Yes    No | | Comments | |
|---|---|---|---|---|---|---|
| Elevation | N/A | 891.67 | - | - | | |
| Length of spillway (feet) | N/A | 85.0 FT | - | - | | |

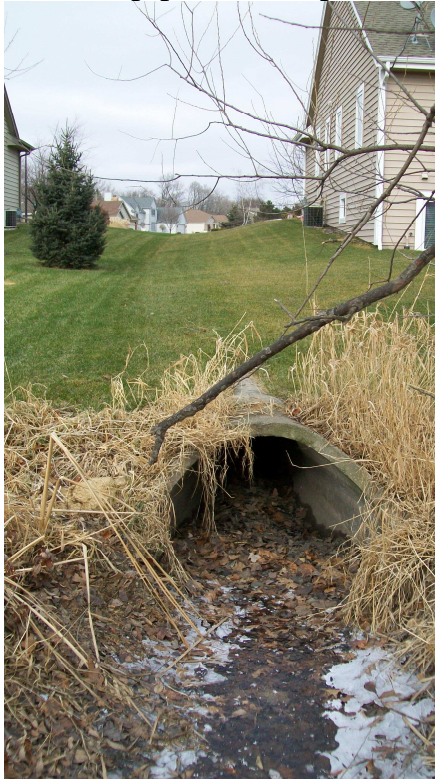
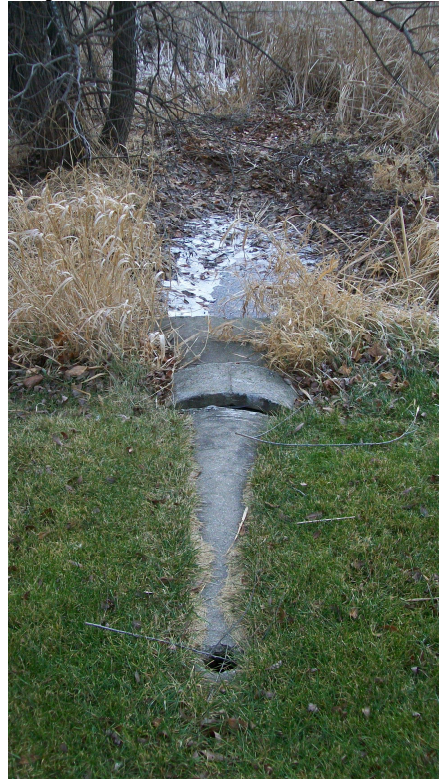
### Outlet ST007816

- End pipe section pushed away from storm sewer pipe.

## Repairs Needed (10/2015)
