STORMWATER MANAGEMENT FACILITIES OPERATION AND INSPECTION REPORT

Quarter Section	11 NW	Name of Business/Subdivision	MENO. FALLS VILLAGE HALL
Property Tax ID Number	0042964001	Address of Property	W156N8480 PILGRIM RD MENO. FALLS, WI 53051

Dry Pond		Description: SWP11N006 P-0145	Location Of Pond	2 ND NORTHERLY MOST POND AT
Wet Pond				NW CORNER OF VLG HALL
Other	X			CAMPUS

Village Hall Metcalfe Parking Lot Retention Pond – SWP11N006

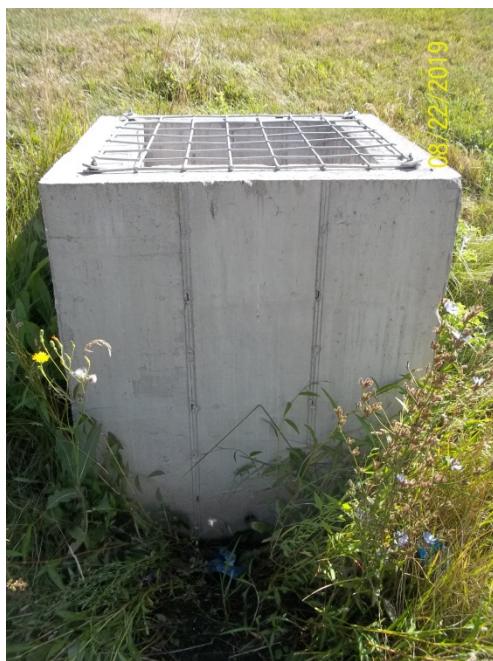
Overflow Structure ST013439

Compliance Verification	Design	Actual	Compliant Yes	No	Comments	
Lower Discharge Control	(ST013439)					
Opening Diameter (inches)	1"	1"	X	-		
Elevation	781.00	780.99	X	-		
Other (Description)	N/A					
Opening Type and Size (inches)			-	-		
Elevation			-	-		
Emergency Spillway						
Elevation	784.00	784.02	X	-		
Length of spillway (feet)	11.0 FT	10.8 FT	X	-		
Embankment	Present Yes		Comments/Maintenance Requirements			
Unauthorized Plantings, trees, or woody vegetation	-	X				
Animal burrows or slope erosion or hole	-	X				
Storm Sewer Outfalls	Type & Size		Location		Comments	
Outfall 1 (ST013446)	RCP 15"		WEST SIDE OF POND		GOOD CONDITION	
Outfall 2	-		-		-	
Outfall 3	-		-		-	
Storage Properties	Design (NON-ASBUILT)	Actual (GPS)	Compliant Yes	No	Not Applicable	Equipment Used
Normal Water Elevation (Wet Ponds)	N/A	N/A	-	-	N/A	GPS EQUIPMENT: GEOMAX ZENITH 35 & CARLSON SURVEYOR 2 WITH SURV CE v5.04
Design High Water Elevation	785.00	784.04	X	-

No Repairs Needed (8/22/2019) CMG

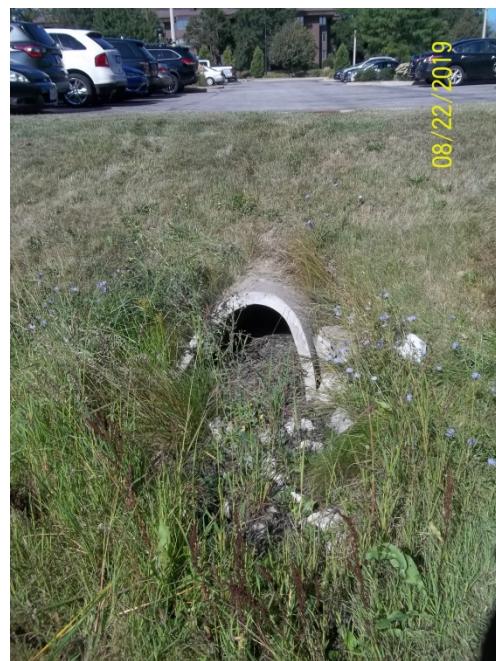
Outlet ST013446

Compliance Verification	Design (Non-AsBuilt)	Actual (GPS)	Compliant Yes	No	Comments (Condition of Structure)
Primary Outlet Pipe (ST010392)					Outlet Pipe Material
Opening Diameter (inches)	12" RCP	12" RCP	X	-	12" RCP IN GOOD CONDITION ELEVATIONS TO VARY SLIGHTLY FROM YEAR TO YEAR DUE TO GPS TECHNOLOGY
Upstream Invert	781.00	780.87	X	-	
Downstream Invert	779.50	779.45	X	-	
Length (feet)	33.2 FT	35.2 FT	X	-	
Slope (%)	0.0452',	0.0403',	X	-	
Secondary Outlet Pipe	N/A				Outlet Pipe Material
Opening Diameter (inches)			-	-	
Upstream Invert			-	-	
Downstream Invert			-	-	
Length (feet)			-	-	
Slope (%)			-	-	
Riser	N/A				Riser Material
Opening Diameter (inches) (ST013439)	24"	24"	X	-	GOOD CONDITION
Elevation	784.25	784.04	X	-	
Upper Discharge Control	N/A				
Opening Diameter (inches)			-	-	
Elevation			-	-
