## STORMWATER MANAGEMENT FACILITIES OPERATION AND INSPECTION REPORT

Quarter Section \_\_\_\_\_ Name of Business/Subdivision Breezy Hill  
Property Tax ID Number 0021990001 Address of Property N96W21627 County Line Road  
Date 8/18/16

Pond 1 Forebay- Center of  
Property

Pond ID: SWP 6 N 003

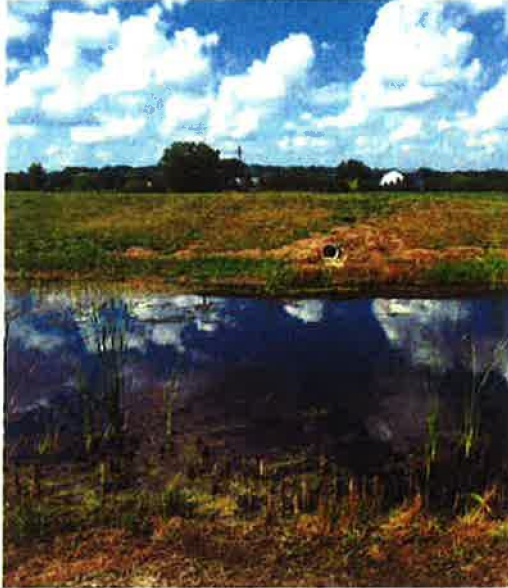
*Sketch Outlet or Attach to Document*

Compliance Verification	Design	Actual	Compliant Yes No		Comments ( Condition of Structure)
<b>Primary Outlet Pipe</b>					<b>Outlet Pipe Material</b>
Opening Diameter (inches)	12"	12"	Y		RCP; excellent condition
Upstream Invert	924	924.04	Y		
Downstream Invert	923.0	922.92	Y		
Length (feet)	54	52.5	Y		
Slope (%)	1.85%	2.13%	Y		
<b>Secondary Outlet Pipe</b>	(If Applicable)				<b>Outlet Pipe Material</b>
Opening Diameter (inches)	N/A				
Upstream Invert					
Downstream Invert					
Length (feet)					
Slope (%)					
<b>Riser</b>	(If Applicable)				<b>Riser Material</b>
Opening Diameter (inches)	N/A				
Elevation					
<b>Upper Discharge Control</b>	(If Applicable)				
Opening Diameter (inches)	N/A				
Elevation

*See photo: RCP culvert; discharge into infiltration basin.*

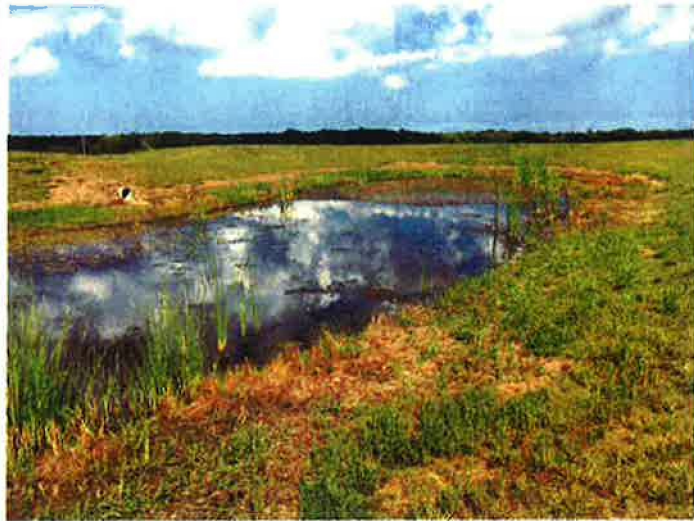
*Place Photograph of Pond or Attach to Document*

Compliance Verification	Design	Actual	Compliant Yes No		Comments	
<b>Lower Discharge Control</b>	<b>(If Applicable)</b>					
Opening Diameter (inches)	N/A					
Elevation						
<b>Other (Description)</b>						
Opening Type and Size (inches)	N/A					
Elevation						
<b>Emergency Spillway</b>						
Elevation	927.0	927.02	Y			
Length of spillway (feet)	24	42	Y			
<b>Embankment</b>	<b>Present Yes no</b>		<b>Comments/Maintenance Requirements</b>			
Unauthorized Plantings, trees, or woody vegetation		X	Well maintained grass; no signs of woody growth or animal burrows.			
Animal burrows or slope erosion		X				
<b>Storm Sewer Outfalls</b>	<b>Type &amp; Size</b>		<b>Location</b>		<b>Comments</b>	
Outfall 1						
Outfall 2						
Outfall 3						
<b>Storage Properties</b>	<b>Design</b>	<b>Actual</b>	<b>Compliant Yes No</b>		<b>Not Applicable</b>	<b>Equipment Used</b>
Normal Water Elevation (Wet Ponds)	924.0	924.04	Y			As surveyed; pictures on 8/18/16 show the water elevation about 1' below outlet.
