## STORMWATER MANAGEMENT FACILITIES OPERATION AND INSPECTION REPORT

Description: SWP11N005  
P-145

Location Of  
Pond  
NEW PARKING LOT @ NW  
CORNER-METCALFE LOT  
WESTERLY POND

Village Hall Metcalfe Parking Lot Retention Pond – SWP11N005

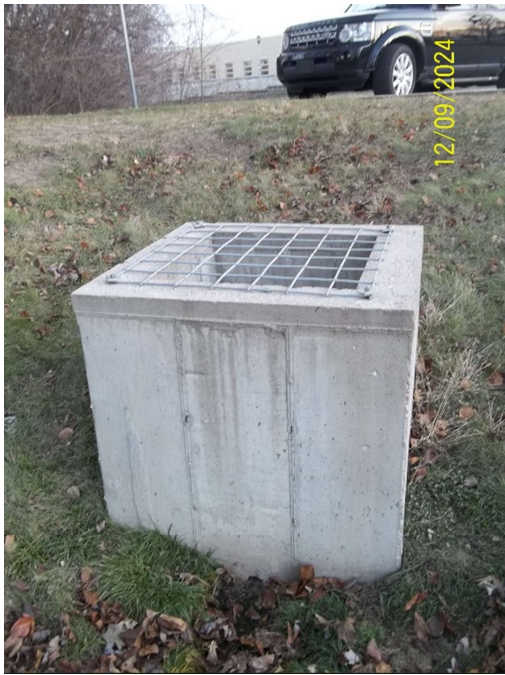
Overflow Structure ST013440

| Compliance Verification | Design (Non-AsBuilt) | Actual (GPS) | Compliant Yes | No | Comments (Condition of Structure) |
|---|---|---|---|---|---|
| Opening Diameter (inches) | 21" | 21" | X | - | * ELEV AT RIM OF OVERFLOW STRUCTURE |

| Compliance Verification | Design | Actual | Compliant<br>Yes    No | | Comments | |
|---|---|---|---|---|---|---|
| Opening Diameter (inches) | 1.5" | 1.5" | X | - | * INVERT ELEVATION OF 1.5" LOWER OPENING IN LARGE OVERFLOWSTRUCTURE<br>LARGE OVERFLOW LEADS TO 12" RCP | |

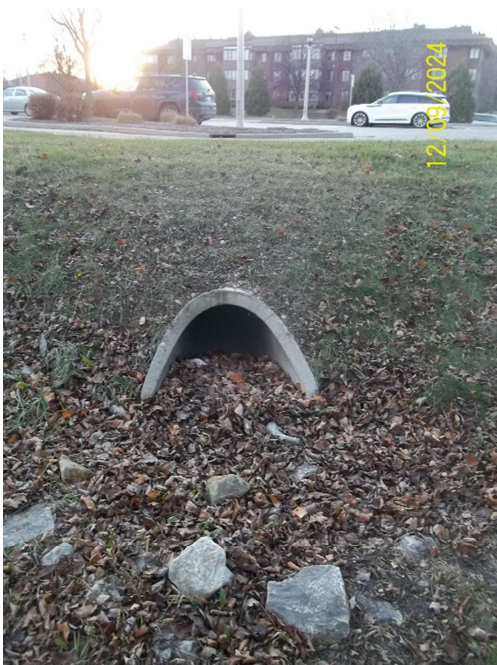
Outlet ST013447

| Compliance Verification | Design | Actual | Compliant<br>Yes    No | | Comments | |
|---|---|---|---|---|---|---|
| Outfall 1 (ST013447) | 15" RCP | | W SIDE OF POND | | GOOD CONDITION | |

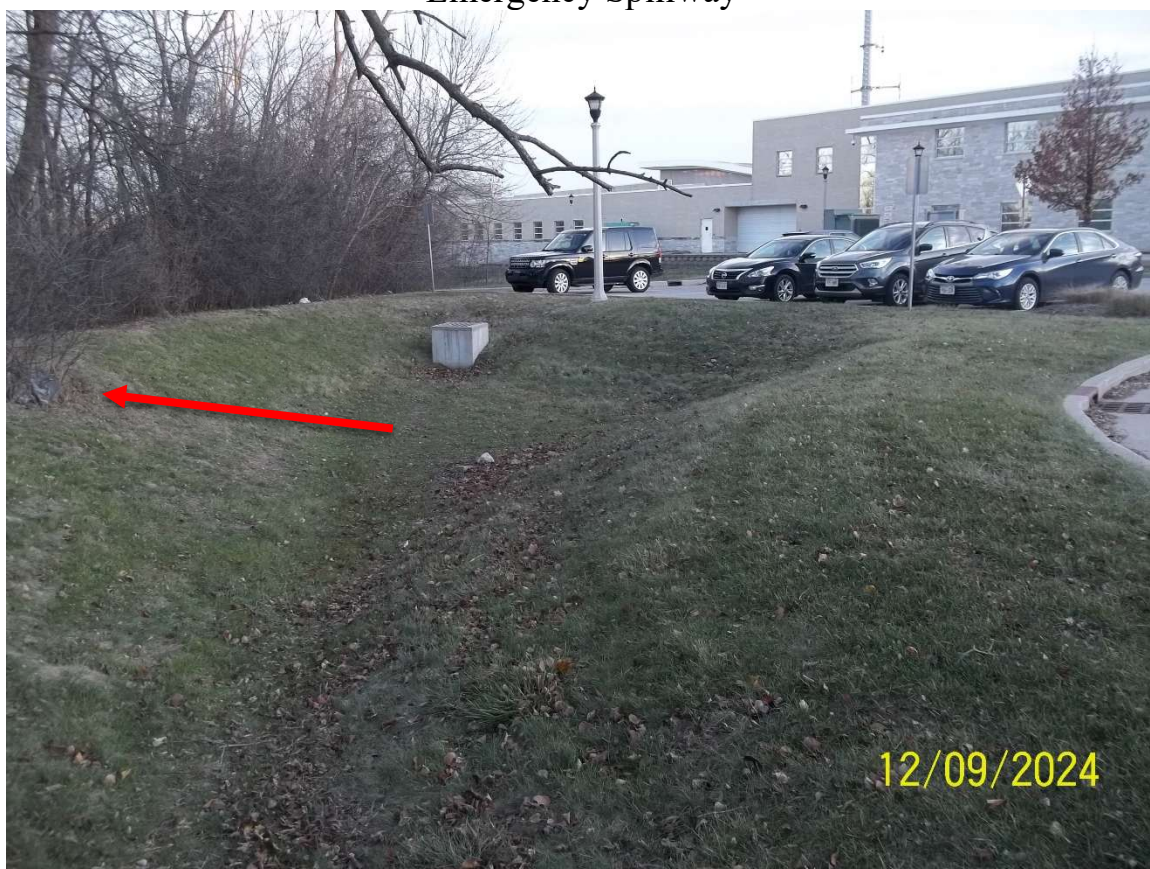
Emergency Spillway

| Compliance Verification | Design | Actual | Compliant<br>Yes    No | | Comments | |
|---|---|---|---|---|---|---|
| Elevation | 785.00 | 784.87* | X | - | * ELEVATION AT BOTTOM OF RIPRAP, LOW POINT | |
| Length of spillway (feet) | 10.0 FT | 6.5 FT | X | - | | |

| Compliance Verification | Design | Actual | Compliant<br>Yes    No | | Comments | |
|---|---|---|---|---|---|---|
| Unauthorized Plantings, trees, or woody vegetation | X | - | REMOVE WOODY VEGETATION IN SPILLWAY | | | |
