STORMWATER MANAGEMENT FACILITIES OPERATION AND INSPECTION REPORT

Quarter Section 11 NW Name of Business/Subdivision VMF COMMUNITY CENTER
 Property Tax ID Number 0042973005 Address of Property W153 N8681 MARGARET RD
MENOMONEE FALLS, WI 53051

Description: SWP11N002

Margaret Rd Retention Pond (West) - SWP11N002

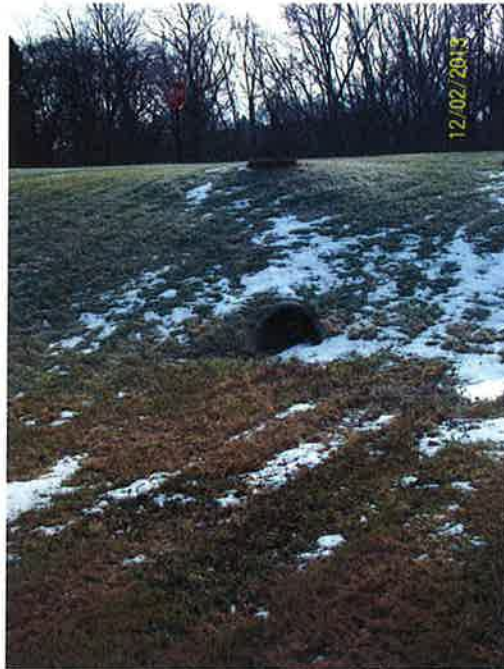
Manhole ST11N026 & Inlet IN11N009

Compliance Verification	Design (Non-AsBuilt)	Actual (GPS)	Compliant		Comments (Condition of Structure)
			Yes	No	
Primary Outlet Pipe (IN11N009)					Outlet Pipe Material
Opening Diameter (inches)	NOT LISTED	15"	-	-	15" RCP IN GOOD CONDITION ELEVATIONS TO VARY SLIGHTLY FROM YEAR TO YEAR DUE TO GPS TECHNOLOGY
Upstream Invert	756.50	757.61	-	-	
Downstream Invert	756.41	757.24	-	-	
Length (feet)	20.0 FT	15.0 FT	-	-	
Slope (%)	0.0045',	0.0224',	-	-	
Secondary Outlet Pipe	N/A				Outlet Pipe Material
Opening Diameter (inches)			-	-	
Upstream Invert			-	-	
Downstream Invert			-	-	
Length (feet)			-	-	
Slope (%)			-	-	
Riser	N/A				Riser Material
Opening Diameter (inches)			-	-	
Elevation			-	-	
Upper Discharge Control	N/A				
Opening Diameter (inches)			-	-	
Elevation			-	-

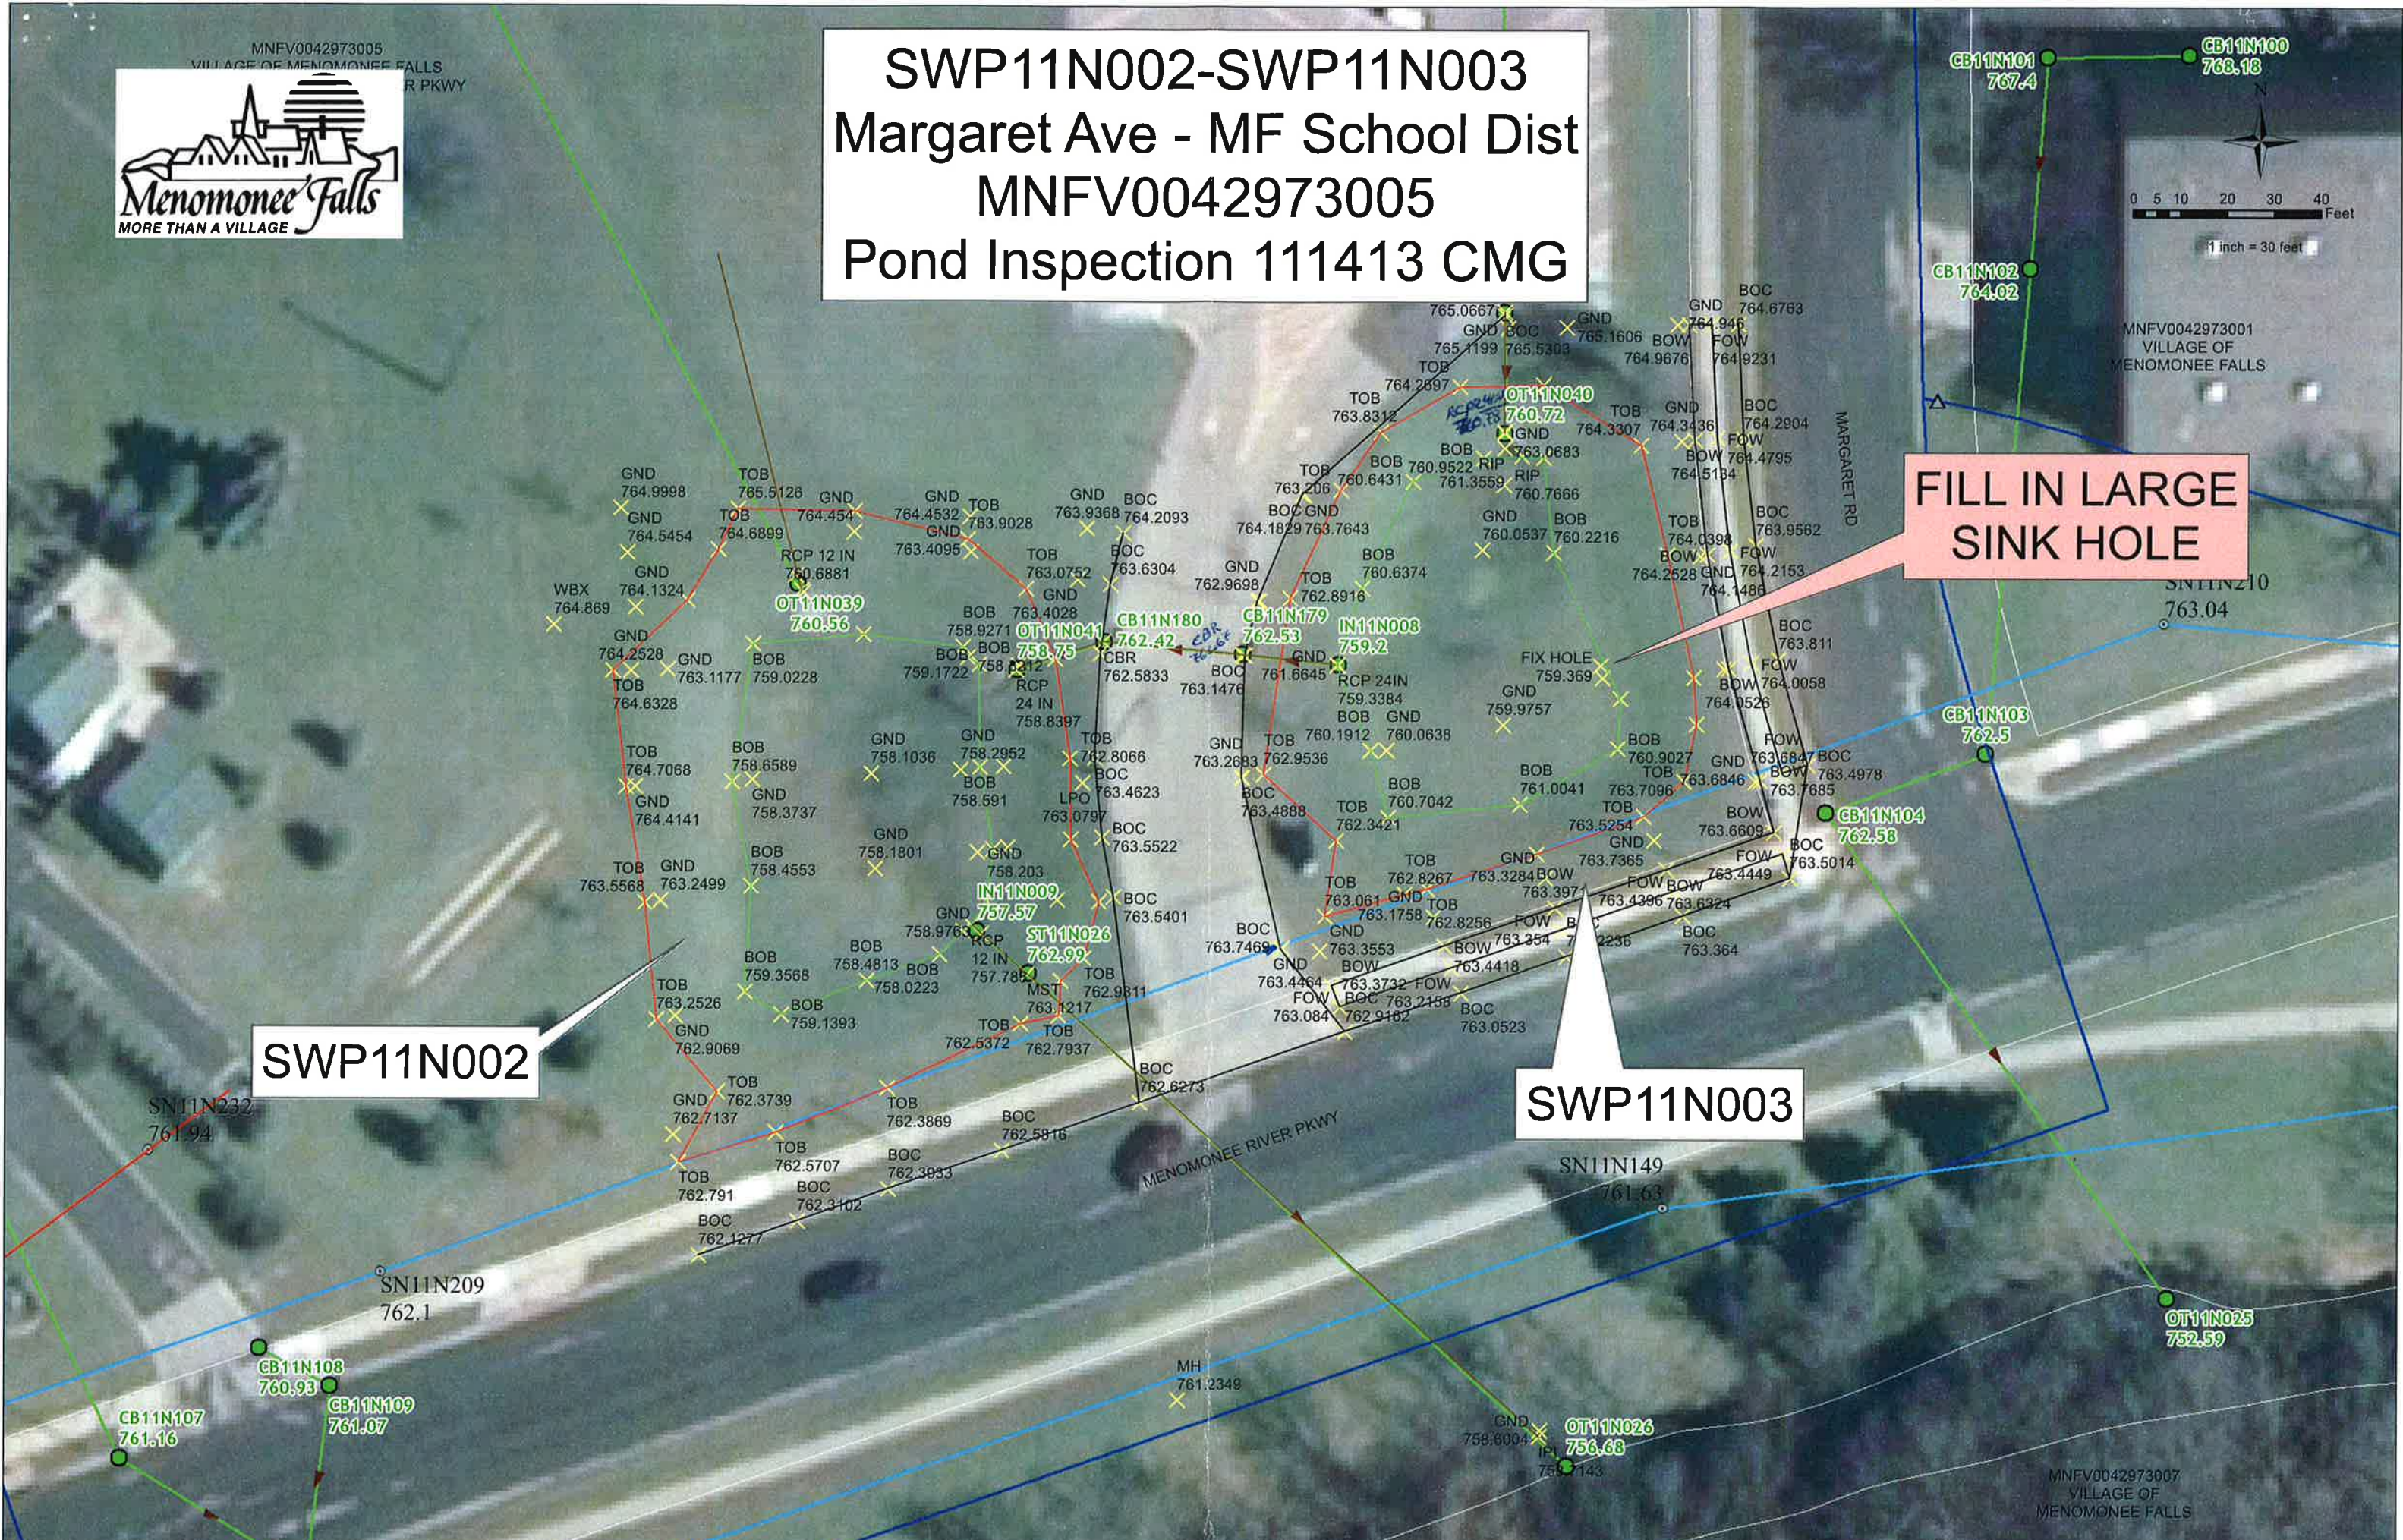
SWP11N002

FILL IN LARGE SINK HOLE
