STORMWATER MANAGEMENT FACILITIES OPERATION AND INSPECTION REPORT

Quarter Section 5-8N-20E Name of Business/Subdivision Grace Evangelical Lutheran Church
 Property Tax ID Number _____ Address of Property N87 W16171 Kenwood Boulevard
 Date July 1, 2015 Menomonee Falls, WI 53051

Pond ID: SWP

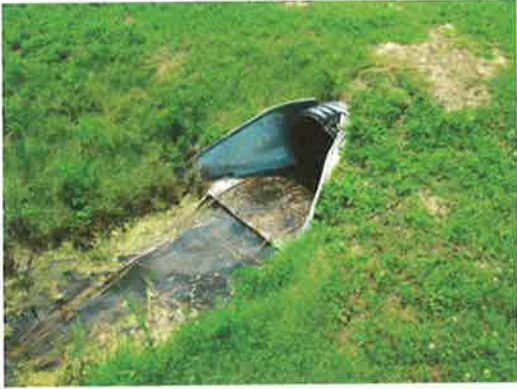
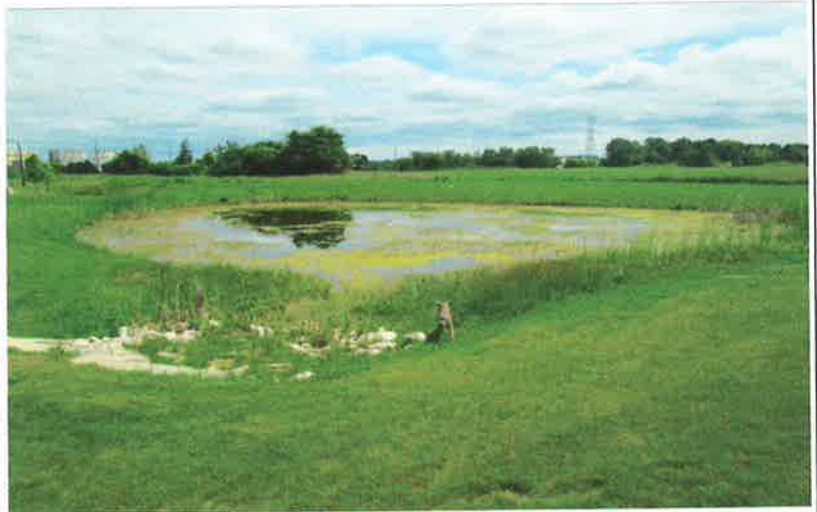
Sketch Outlet or Attach to Document

Compliance Verification	Design	Actual	Compliant		Comments (Condition of Structure)
			Yes	No	
Primary Outlet Pipe					Outlet Pipe Material
Opening Diameter (inches)	18	18	X		Outlet pipe in good condition, end section structure also in good condition.
Upstream Invert	872.00	871.91	X		
Downstream Invert	871.50	871.65	X		
Length (feet)	50	46.56	X		
Slope (%)	1.00	0.56	X		
Secondary Outlet Pipe (If Applicable)					Outlet Pipe Material
Opening Diameter (inches)					
Upstream Invert					
Downstream Invert					
Length (feet)					
Slope (%)					
Riser (If Applicable)					Riser Material
Opening Diameter (inches)					
Elevation					
Upper Discharge Control (If Applicable)					
Opening Diameter (inches)					
Elevation
