Site Photos • June 4, 2015

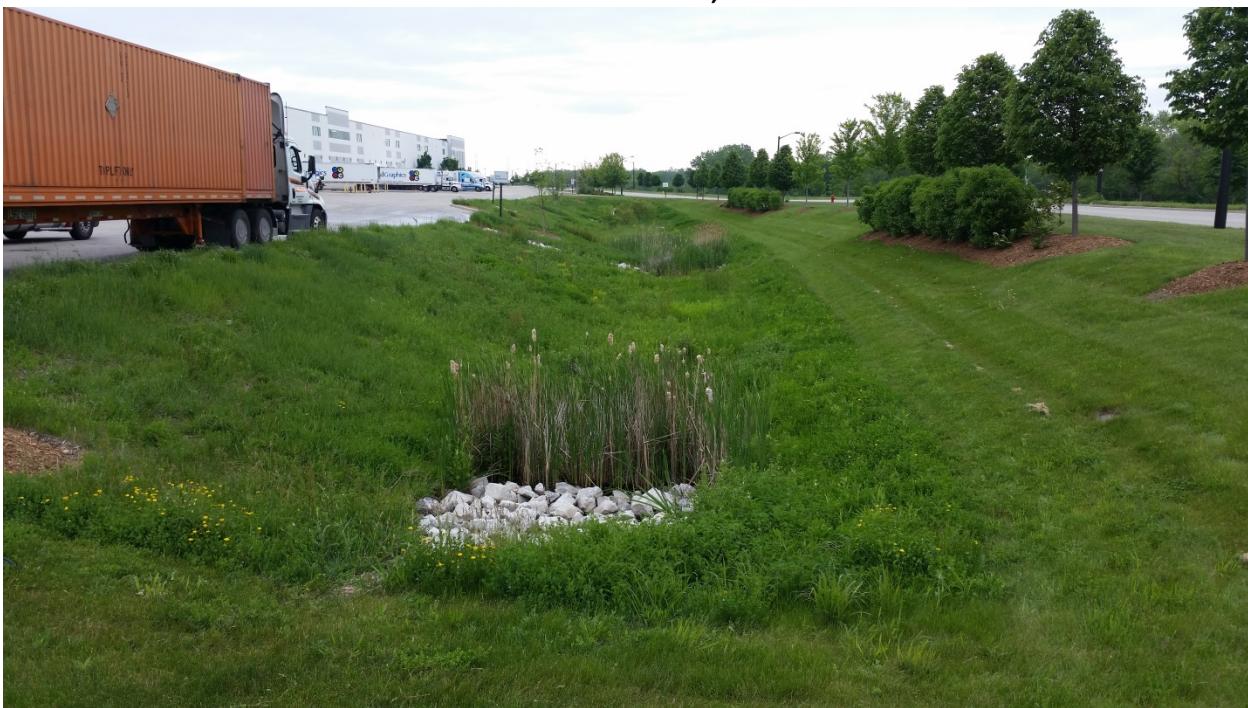
Photo 1: Vegetation along basin banks generally provides adequate cover. Photo taken from west side of basin looking east.

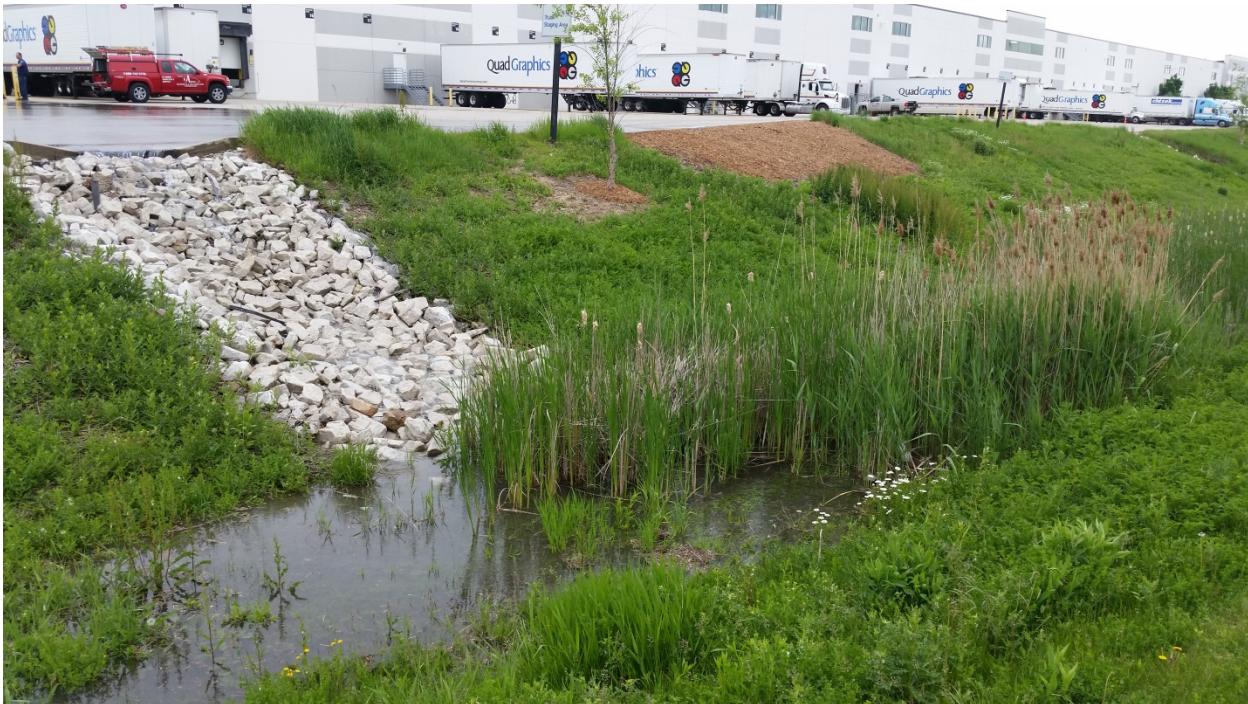
Photo 2: Appropriate treatment to help reduce invasive species (*Phragmites australis*, Common reed grass and other species such as *Lythrum salicaria*, Purple loosestrife) is recommended while problem areas remain relatively "small". Photo taken on southwest end of basin looking north toward western curb cut. **\* NOTE: The DNR's BMPs pertaining to NR 40 vegetative control management should be implemented by a licensed, professional landscape contractor as part of the basin's ongoing maintenance plan.**

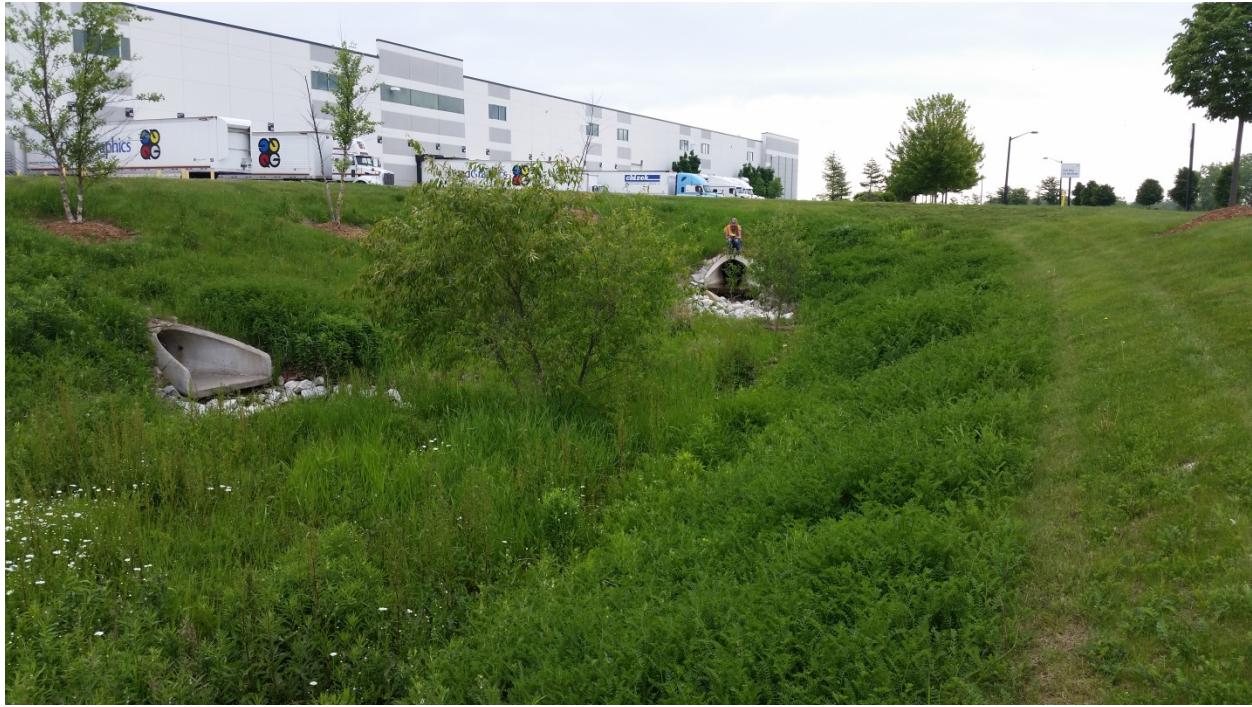
Photo 3: Photo taken looking northeast at pond basin and structures. Woody vegetation (willows) within basin can be removed.

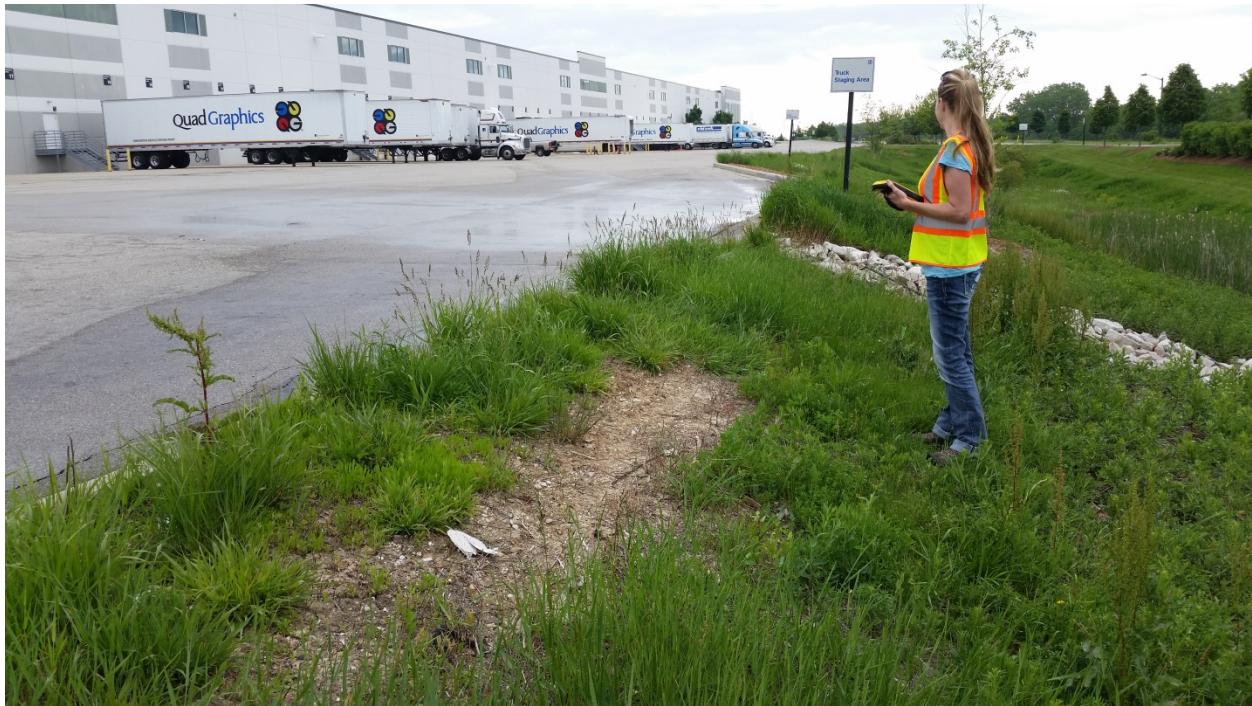
Photo 4: Flows carried downslope toward basin have led to some scouring particularly on north side of basin. Some additional seeding and restoration may be necessary as well as potentially replacing topsoil.

\*NOTE: In the event that land disturbance will occur as part of pond maintenance, please contact the Village to determine if an erosion control permit or any other permits will be needed.

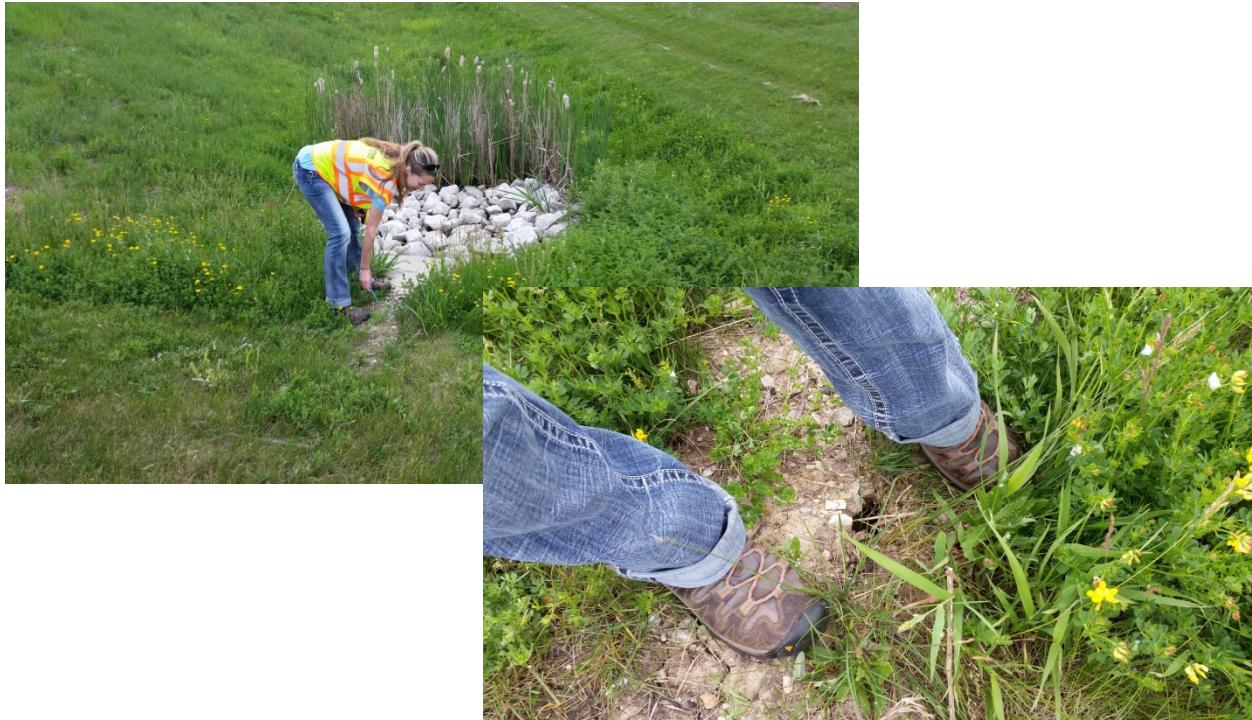
Photos 5 & 6: Top of west pond inlet pipe requires some restoration (replacement of topsoil, seed and stabilization).

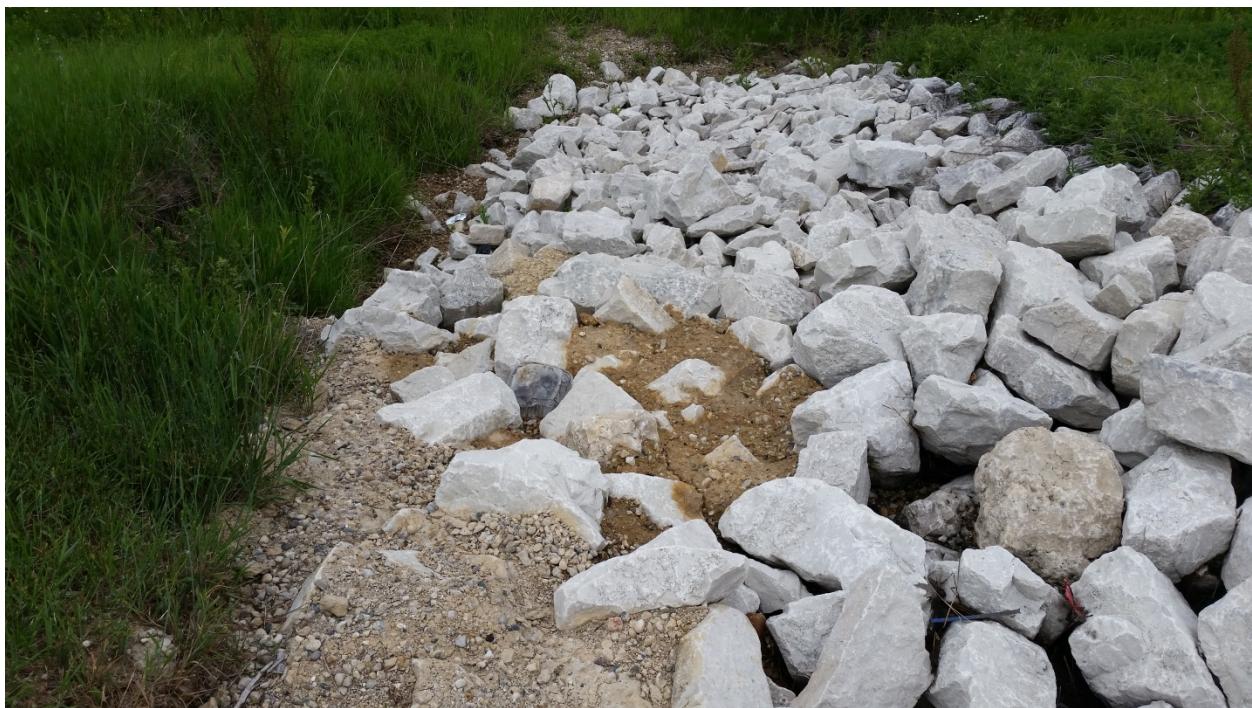
Photo 7: Deposition of sediment within basin. \*NOTE: If removal of sediment within basin is planned, make sure to contact local (Village of Menomonee Falls) and State (Department of Natural Resources) regulators for any prior authorization/permitting which may be necessary. Sediment may need to be tested prior to transport to ensure proper precautions are taken for disposal.

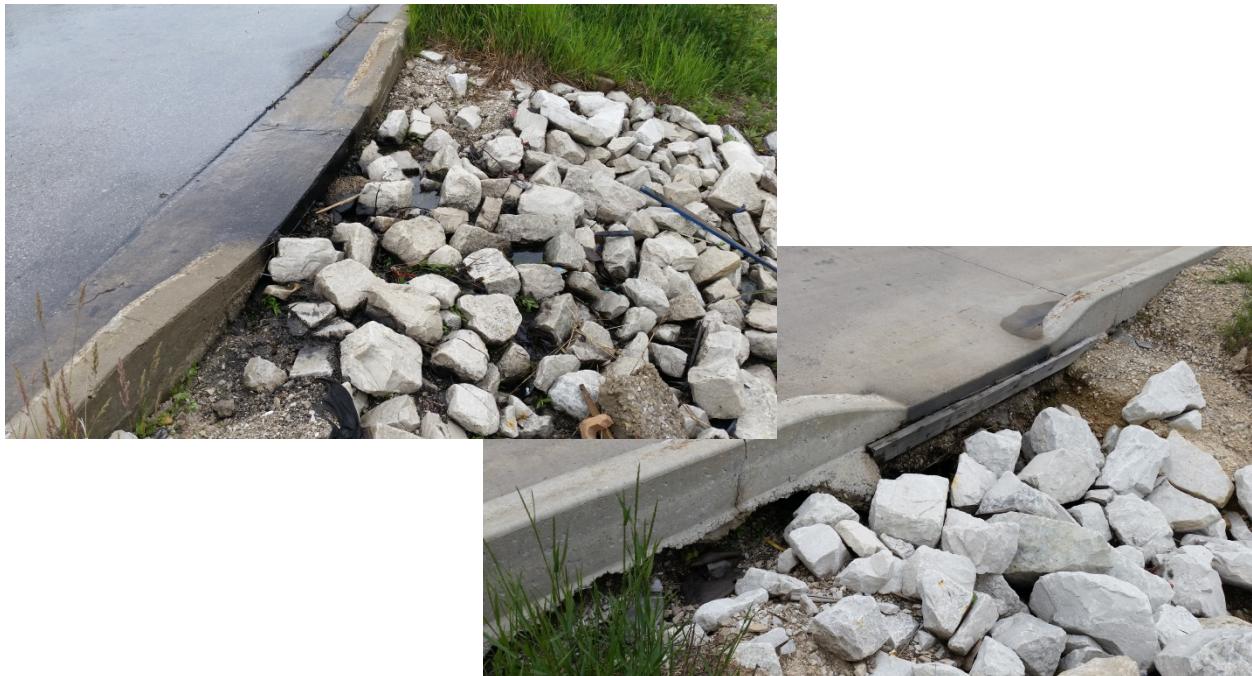
Photos 8 & 9: Flows carried downslope toward basin from curb cuts at Quad Graphics plant has led to some undermining of hard surface pavement.

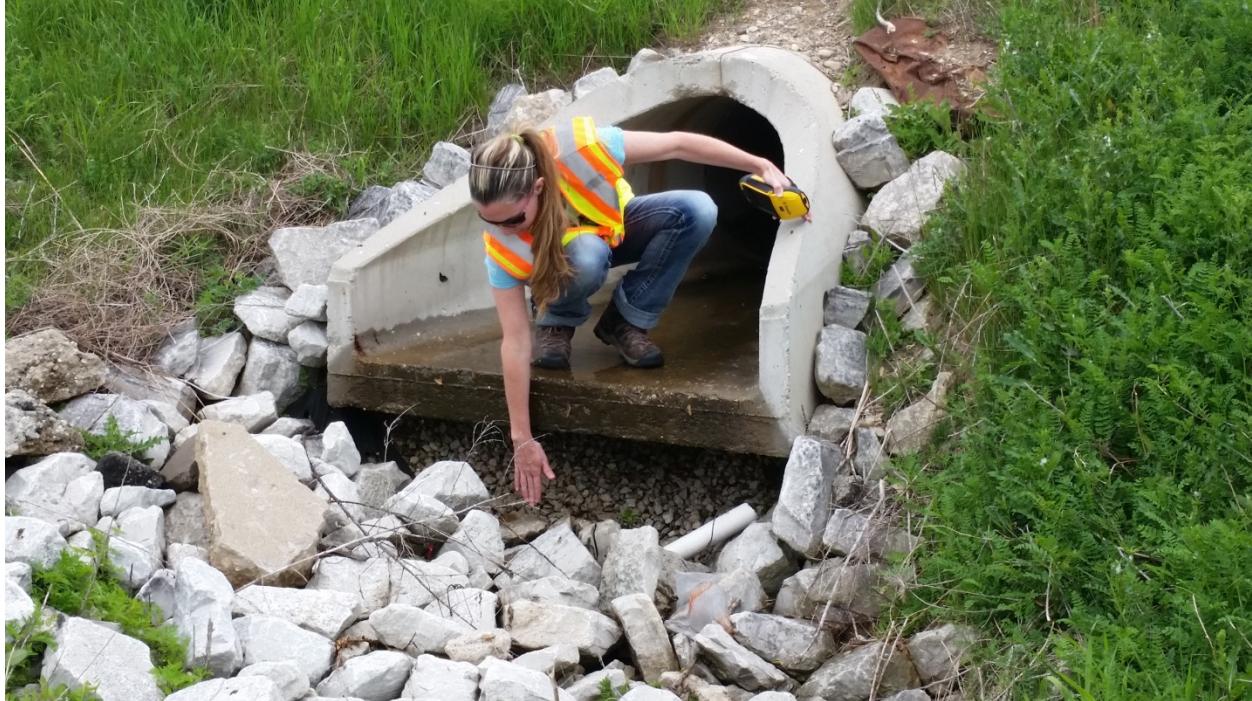
Photo 10: Rip rap has moved as a result of flows and gravity. Rip rap should be replaced to minimize voids between flow paths and structures. \*NOTE: In the event that land disturbance will occur as part of basin maintenance, please contact the Village to determine if an erosion control permit or any other permits will be needed.
